PRINTED: 02/27/2025  
FORM APPROVED  
OMB NO. 0938-0391DEPARTMENT OF HEALTH AND HUMAN SERVICES  
CENTERS FOR MEDICARE & MEDICAID SERVICES

| STATEMENT OF DEFICIENCIES<br>AND PLAN OF CORRECTION | | (X1) PROVIDER/SUPPLIER/CLIA<br>IDENTIFICATION NUMBER:<br><br><b>205106</b> | (X2) MULTIPLE CONSTRUCTION<br>A. BUILDING 01<br><br>B. WING _____ | (X3) DATE SURVEY<br>COMPLETED<br><br><b>02/24/2025</b> |
| NAME OF PROVIDER OR SUPPLIER<br><br><b>EASTSIDE CENTER FOR HEALTH &amp; REHABILITATION, LLC</b> | | | STREET ADDRESS, CITY, STATE, ZIP CODE<br><b>516 MT HOPE AVENUE<br/>BANGOR, ME 04401</b> | |
| K 000 | INITIAL COMMENTS<br><br>Federal Recertification Survey:<br>Date: 02/24/25<br><br>Eastside Center for Health & Rehabilitation, a<br>Long Term Care Facility, was surveyed to the<br>National Fire Protection Association 101 Life<br>Safety Code 2012 Edition as reference on 42<br>CFR 483.90 (a-d) physical environment and is not<br>in substantial compliance. | K 000 | | |

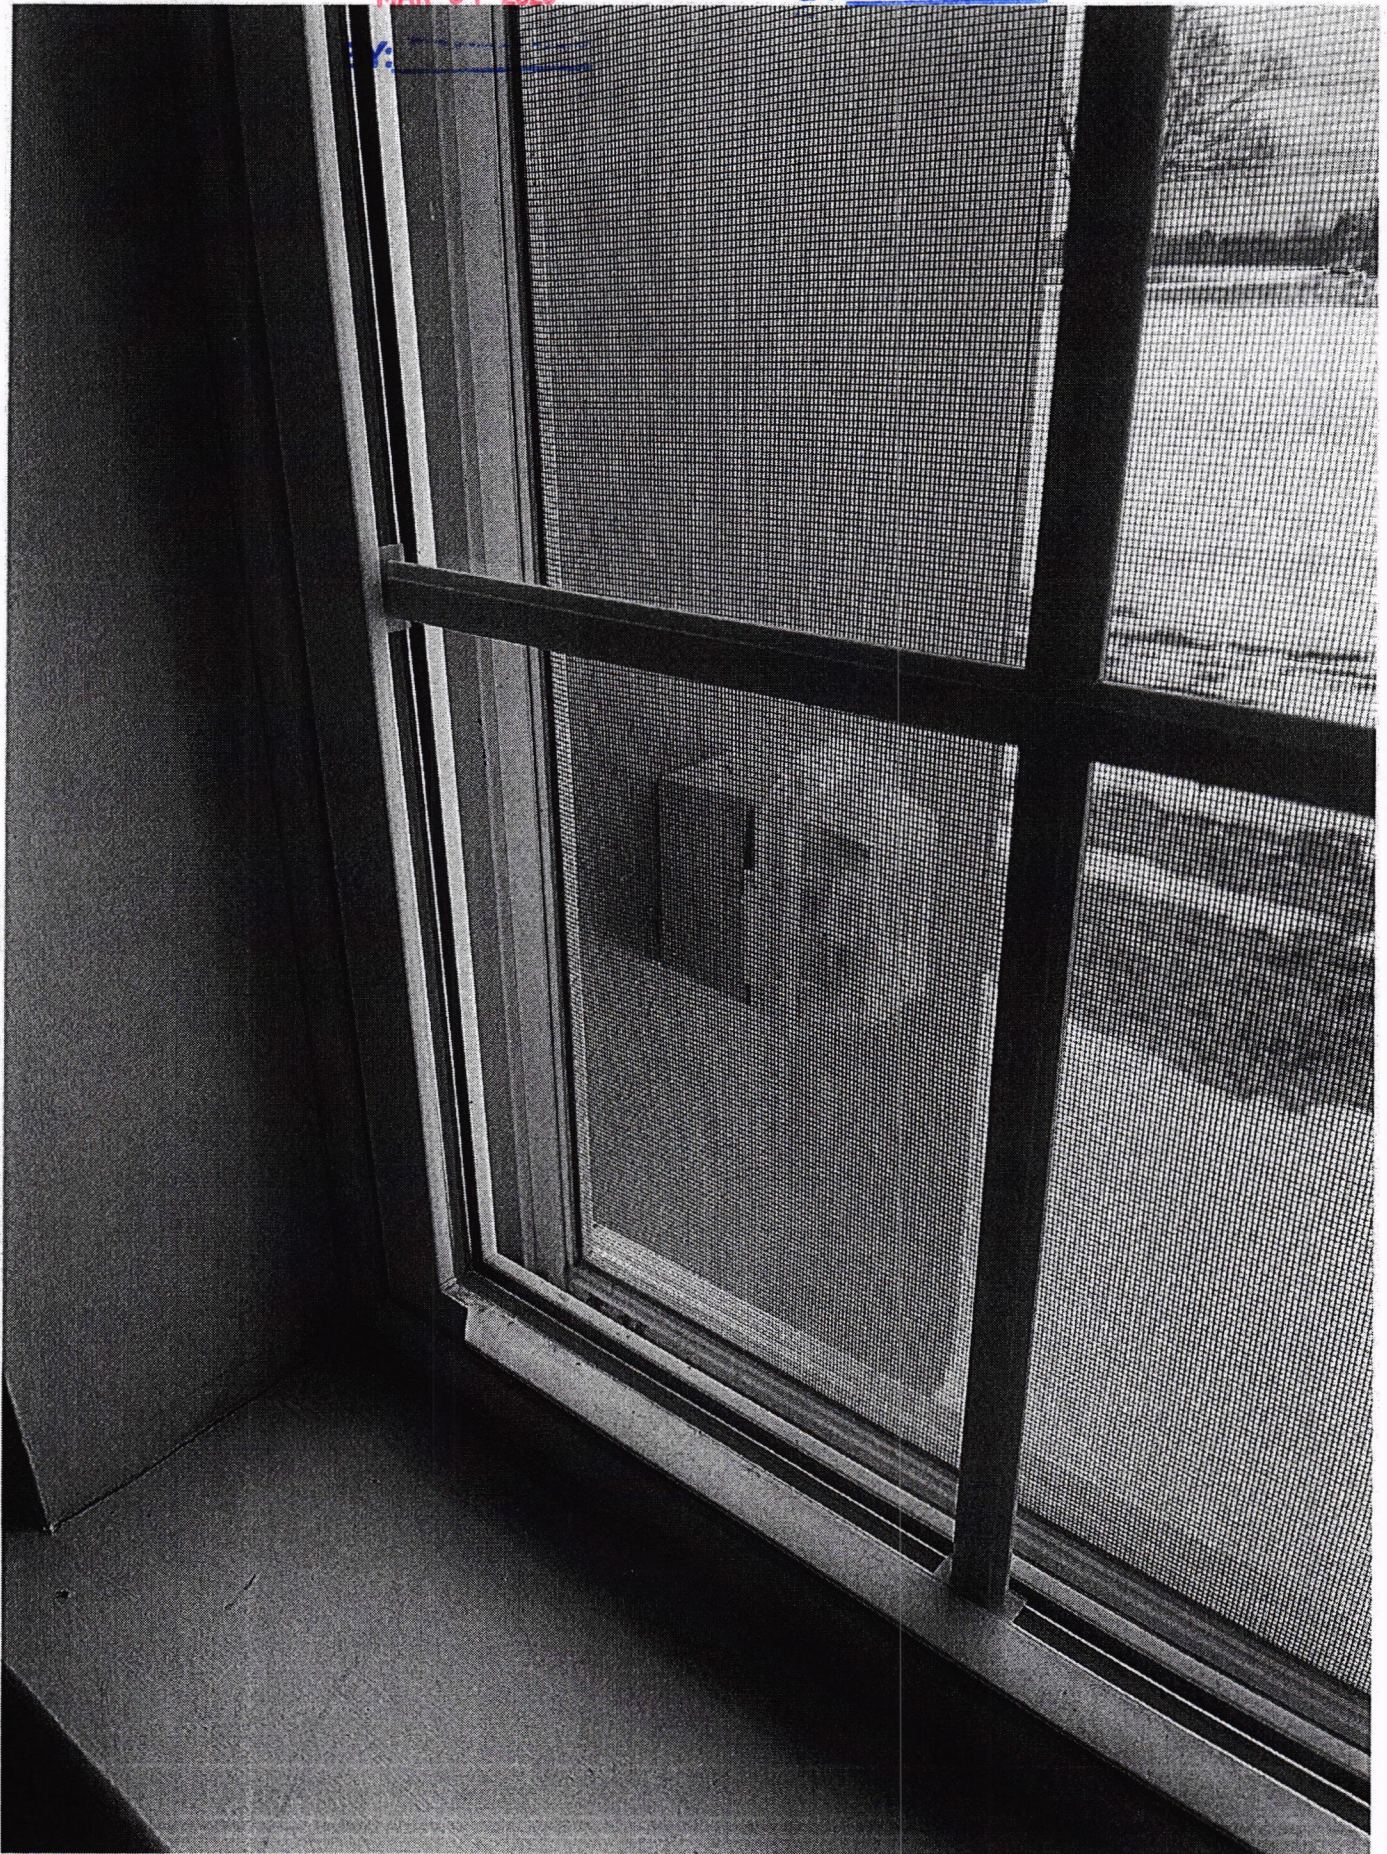
**GENERATOR  
EMERGENCY  
SHUTOFF**

| K 918 | Continued From page 6<br>Maintenance Director and observed the following:<br><br>1. All generating stations shall have a labeled<br>remote manual stop device on the premises<br>where the prime mover is located outside the<br>building, outside of the generator housing. The<br>generator did not have an labeled remote manual<br>stop device located outside of the generator<br>housing.<br><br>The surveyor confirmed this finding with the<br>Interim Maintenance Director at the time of the<br>observation. | K 918 | | | |

An emergency generator shutoff is installed on the side of the building.

A sign has been ordered labeling the emergency generator shut off button.
