DEPARTMENT OF HEALTH AND HUMAN SERVICES  
CENTERS FOR MEDICARE & MEDICAID SERVICES

| NAME OF PROVIDER OR SUPPLIER<br><br><b>MARSHWOOD CENTER</b> | | | STREET ADDRESS, CITY, STATE, ZIP CODE<br><b>33 ROGER STREET<br/>LEWISTON, ME 04240</b> | | |

| K 000 | INITIAL COMMENTS<br><br>Federal Recertification Survey<br>Survey Date: 09.19.2023<br><br>Marshwood Center, a Long Term Care Facility<br>was surveyed pursuant to the National Fire<br>Protection Association 101 Life Safety Code,<br>2012 Edition as referenced in 42 CFR 483.90 (a -<br>d) - Physical Environment is not in substantial<br>compliance. | K 000 | In filing this plan of correction, we seek to<br>comply with the federal survey and<br>certification requirements, however the filing<br>of this plan of correction does not constitute an<br>admission that the alleged deficiencies existed. | | | |

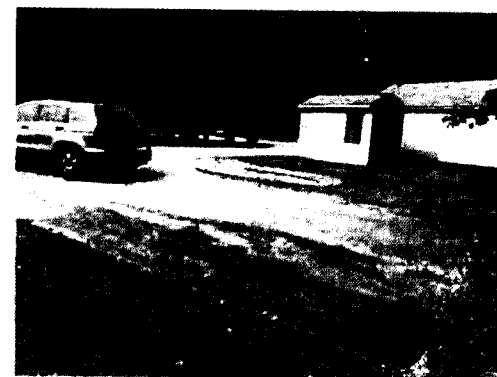
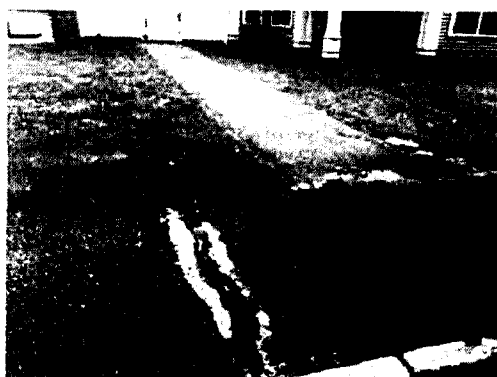
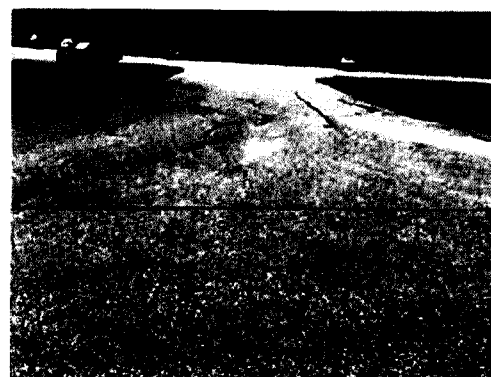
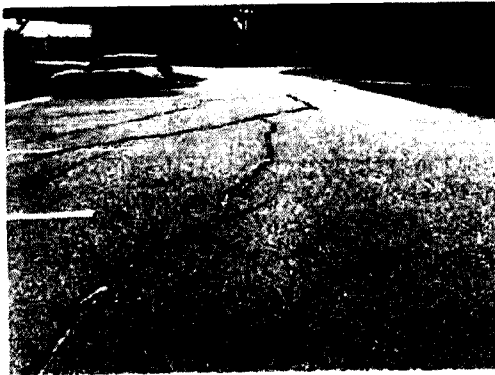
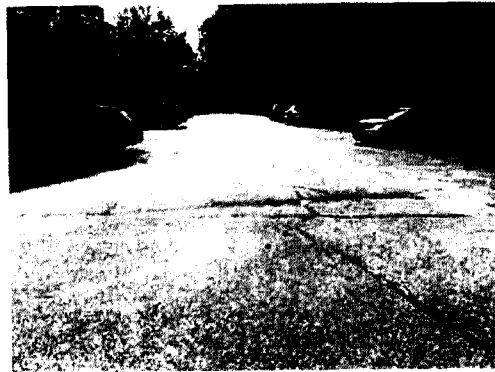
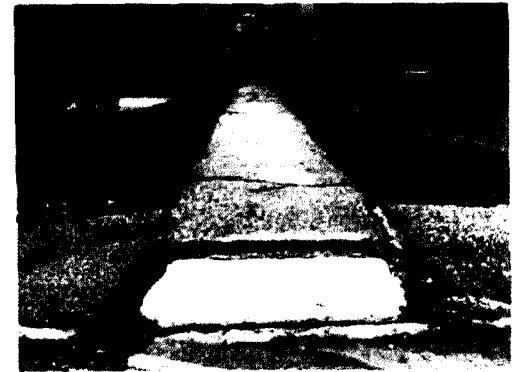
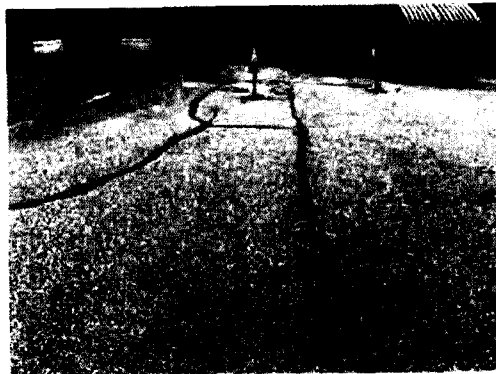
## Photographic Report

| K 211 | <p>Continued From page 2</p> <p>On 09/19/2023, between 09:15 AM and 1:45 PM, a surveyor, with the Maintenance Director, present, observed the following:</p> <ol style="list-style-type: none"> <li>During the inspection of the courtyard serving Adams Wing, and Carter Wing, the maintenance director and the staff in the immediate area were not able to provide the keypad code for the gate preventing instant egress to the public way from the courtyard.</li> <li>The exterior exit door leading to the courtyard from Buchanan Wing was obstructed by the threshold at the bottom of the door and required excessive force to open this exit door.</li> <li>The courtyard exterior exit discharge paths to the public way has pavement that is excessively cracking, uneven and has ridges greater than 1/4 inch in height.</li> </ol> <p>The surveyor confirmed these findings with the Maintenance Director at the time of the observation.</p> | K 211 | <ol style="list-style-type: none"> <li>Staff have been inserviced on the proper code to exit the courtyard serving Adams Wing and Carter Wing.</li> <li>The threshold at the bottom of the exterior exit door leading to the courtyard from Buchanan has been replaced.</li> <li>The discharge paths at the exterior exit door leading to the courtyard from Buchanan will be repaired to provide a smooth service. Attachment A</li> </ol> <p>A random sample of staff assigned to Adams Wing &amp; Carter Wing will be quized monthly for the next three months to ensure they are aware of the keypad code for the gate in the courtyard. Findings will be reviewed at the monthly QAPI Committee meeting.</p> <p>Exterior exit door leading to the courtyard from Buchanan and the discharge paths will be inspected monthly for the next three months and findings will be reviewed at the monthly QAPI Committee meeting.</p> | | 10.25.23 | |

#### **Asphalt Removal and Replacement - 1,550 Square Feet | 2 Areas | 3" Depth**

- Repair areas will be saw cut and the failed asphalt will be removed to a depth of 3 inches.
- The removed material will be hauled off-site and disposed of at an approved location.
- Exposed base will be inspected, compacted and vertical edges will be tacked in order to promote proper adhesion between existing and newly installed hot mix asphalt.
- Hot mix asphalt will be installed in multiple lifts with compaction after each.
  - The first lift will include 1.5 inches of compacted binder material.
  - The second lift will include 1.5 inches of compacted surface material.
- Hot mix asphalt will be installed and compacted at a depth of 3 inches.
- The repair areas will be compacted using a multi-ton roller.
