Jun. 15. 2023 10:22AM firemarshall me state  
 DEPARTMENT OF HEALTH AND HUMAN SERVICES  
 CENTERS FOR MEDICARE & MEDICAID SERVICES

| STATEMENT OF DEFICIENCIES<br>AND PLAN OF CORRECTION | (X1) PROVIDER/SUPPLIER/CLIA<br>IDENTIFICATION NUMBER:<br><br>205134 | (X2) MULTIPLE CONSTRUCTION<br>A. BUILDING 01<br><br>B. WING _____ | (X3) DATE SURVEY<br>COMPLETED<br><br>06/13/2023 |

| NAME OF PROVIDER OR SUPPLIER<br><br>ST JOSEPH'S REHABILITATION AND RESIDENCE | STREET ADDRESS, CITY, STATE, ZIP CODE<br>1133 WASHINGTON AVE<br>PORTLAND, ME 04103 |

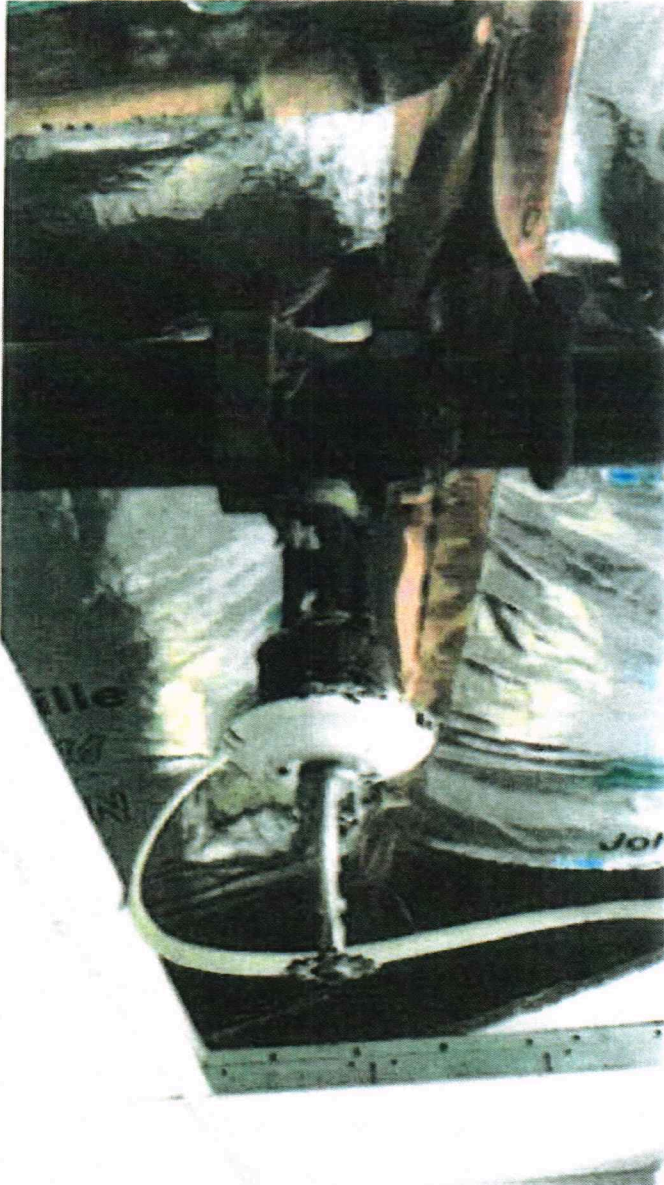
Broken sprinkler pipe elbow dirty utility room D Wing.

Broken fitting in D Wing dirty utility room

Once at the facility High tech fire removed the damaged section of pipe and isolated the problem until the repair could be made. Approximately 10 feet of two-inch pipe was measured for and then replaced.

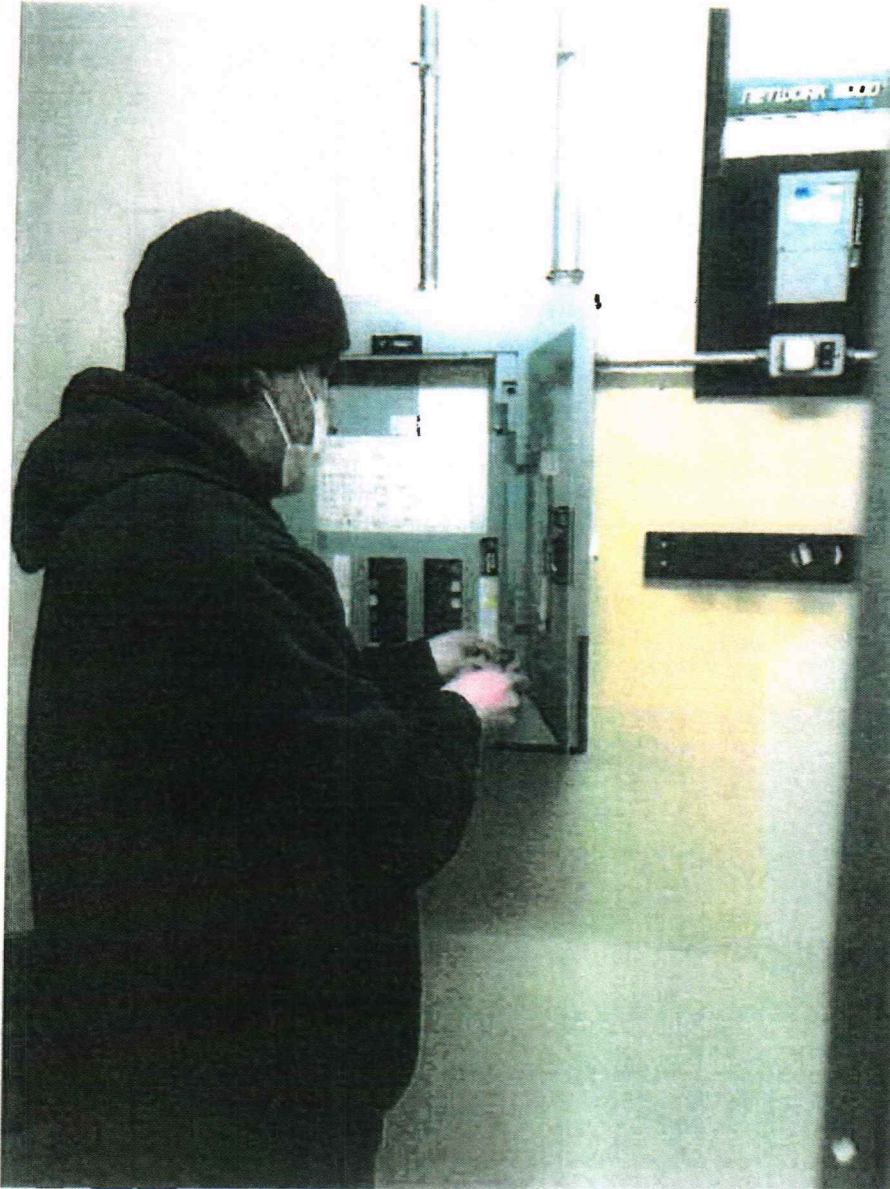
Collins Electric inspecting the electrical panel on unit D after the sprinkler head break

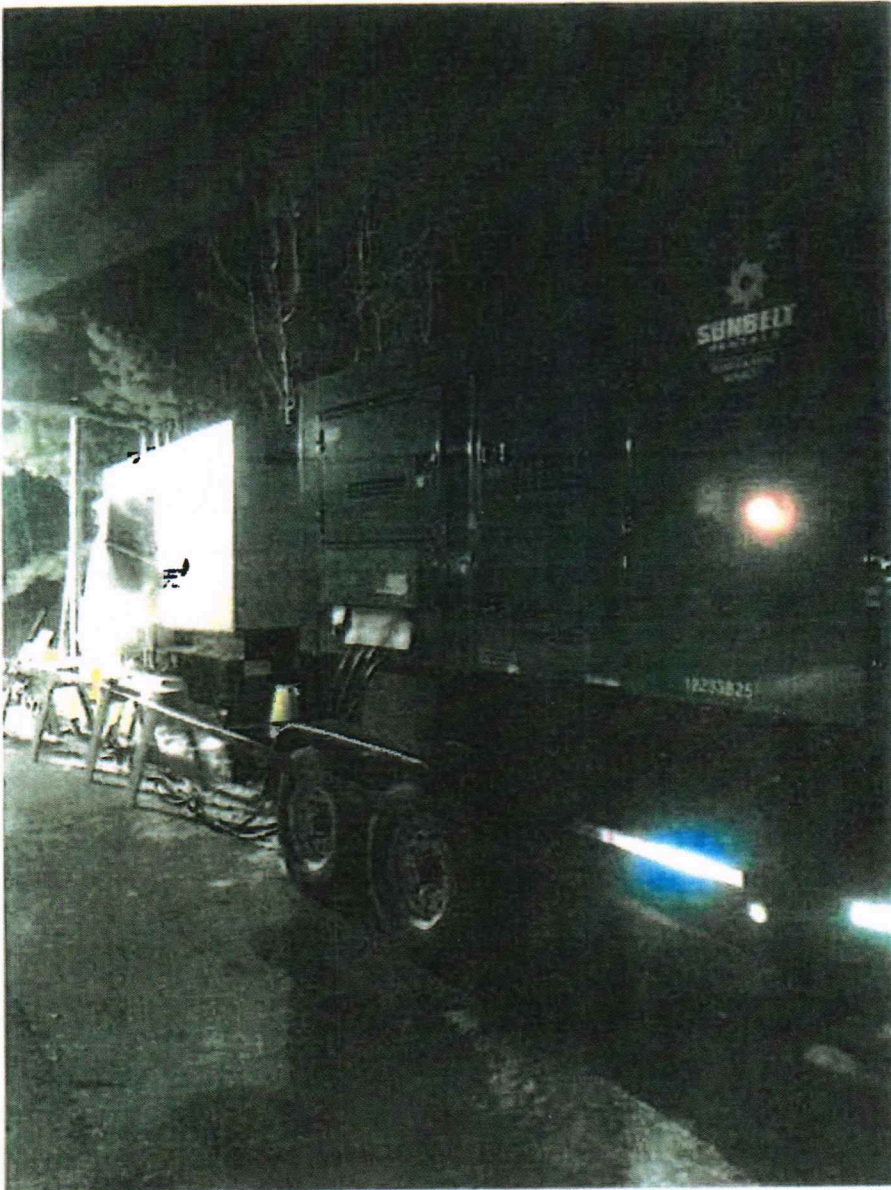
Temporary rental standby generator supplied by Power Products.

Back-up generator arrived and installed. SJR stable and repairs <sup>BY:</sup> ~~scheduled for its~~ generator and power pad cable.

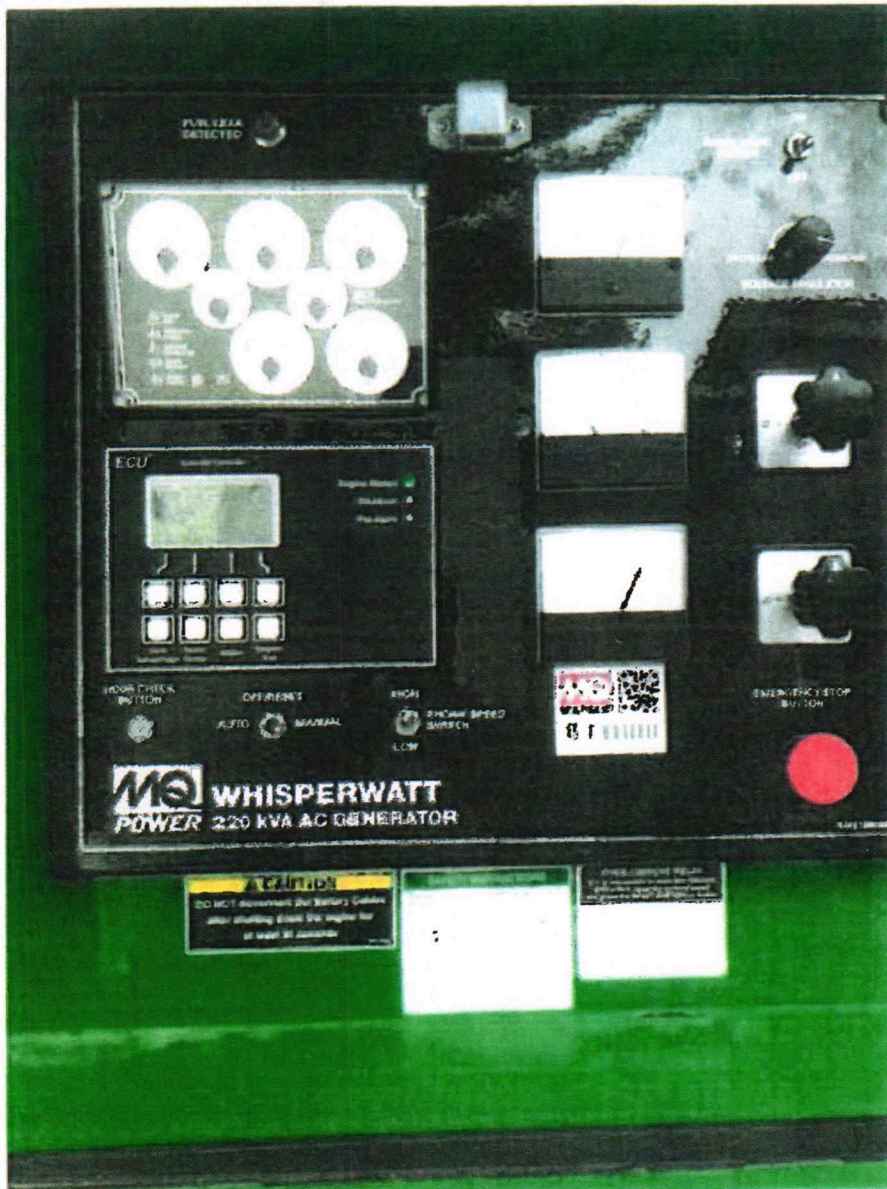
Rental generator control panel readings .

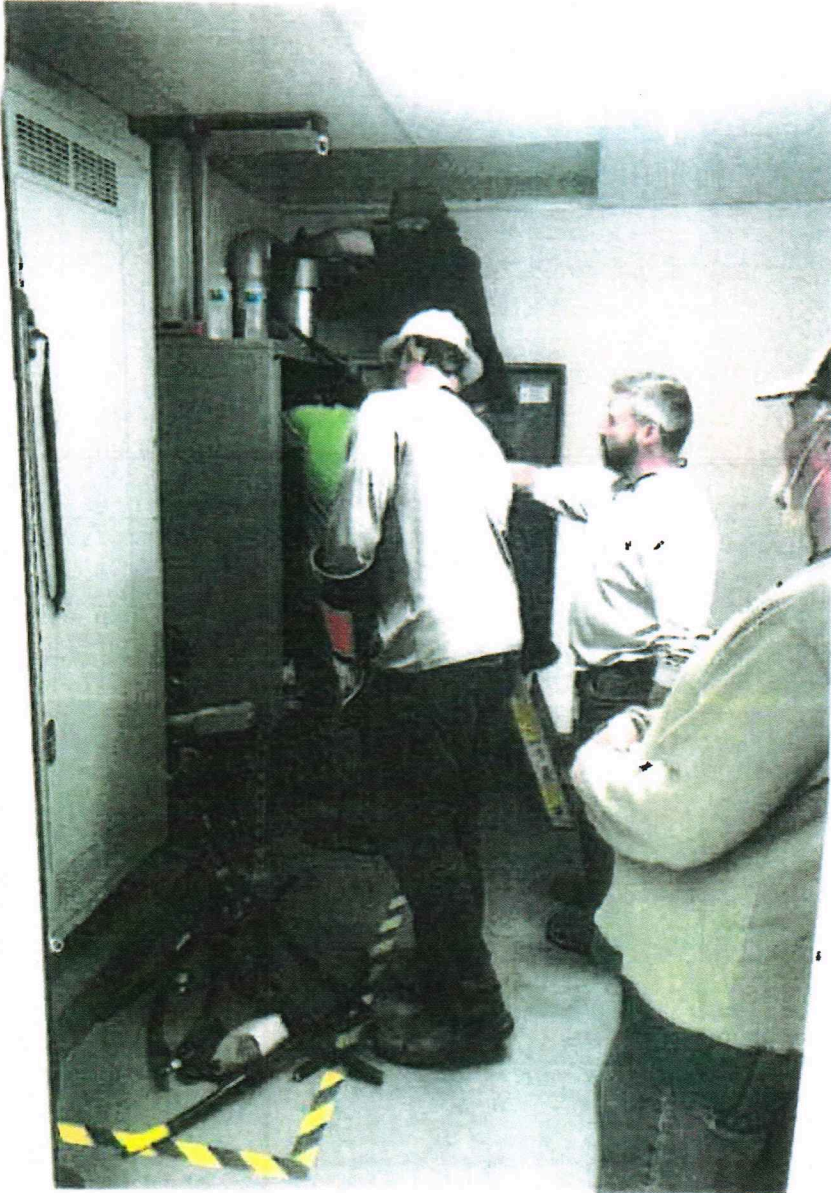
Collins Electric and CMP pulling new feed from CMP transformer.

By then CMP techs had arrived to assess the situation for their expertise. They tested the underground line feed from the Power Pad in the Courtyard to the Power Switch panel. Their test concluded the line was compromised and must be replaced. They assisted in securing a Contractor, but getting the new power cable onsite and installed would be measured in days.

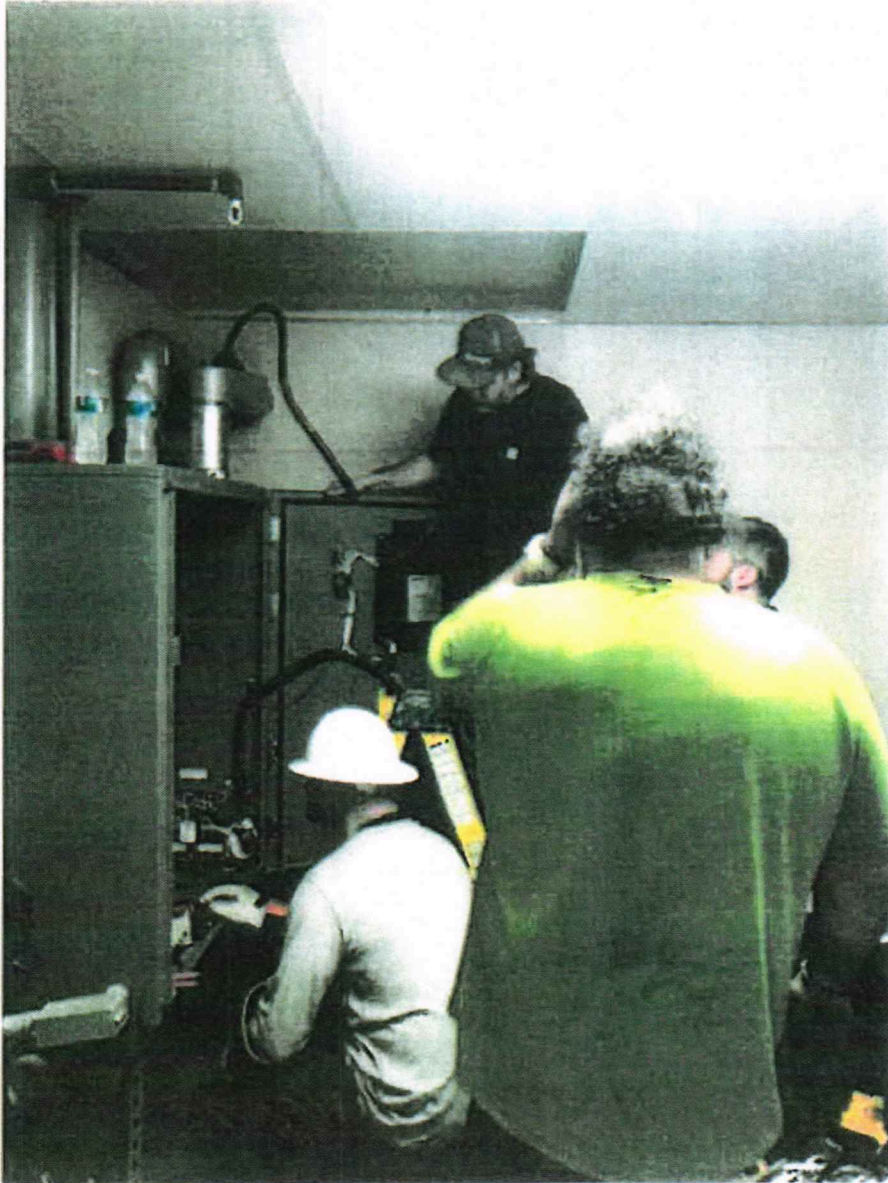
Collins Electric and CMP pulling new feed from CMP transformer

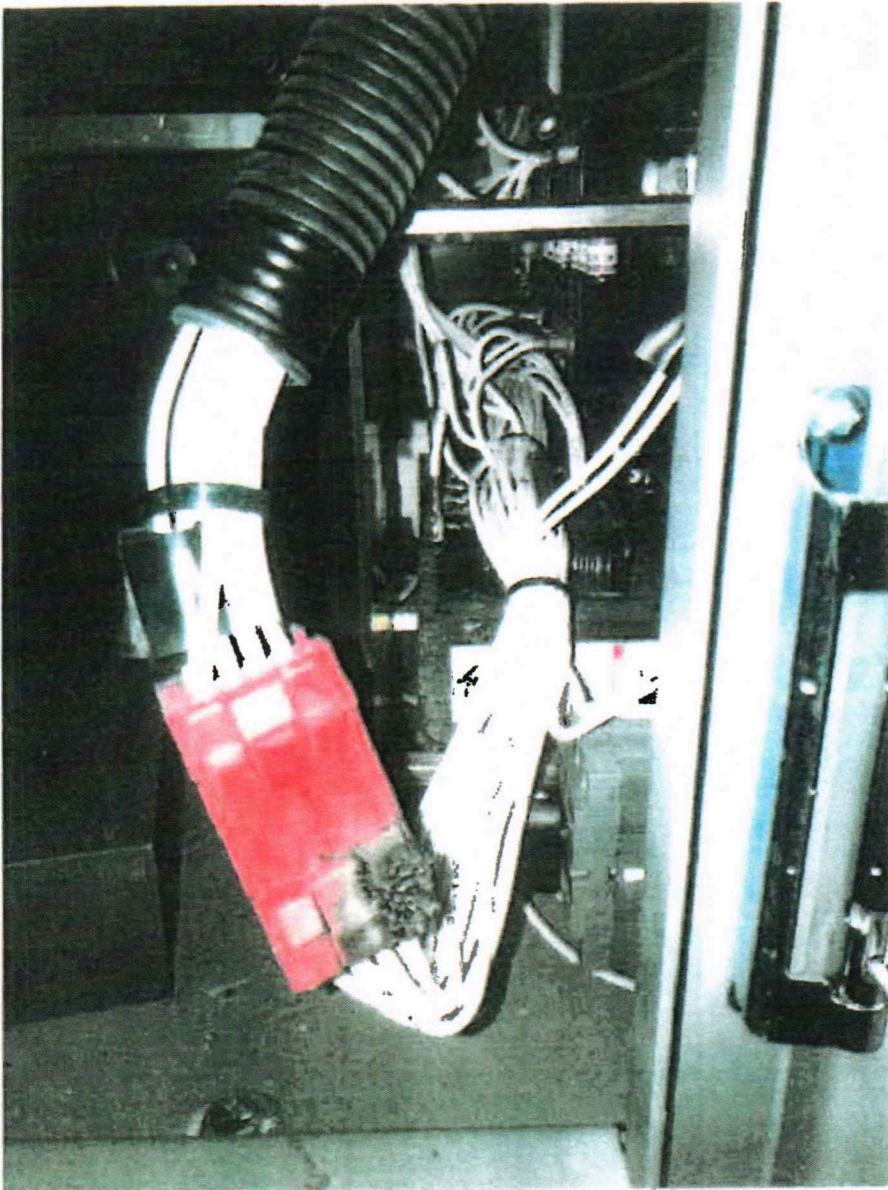
Damaged wiring harness to Kohler transfer switch.

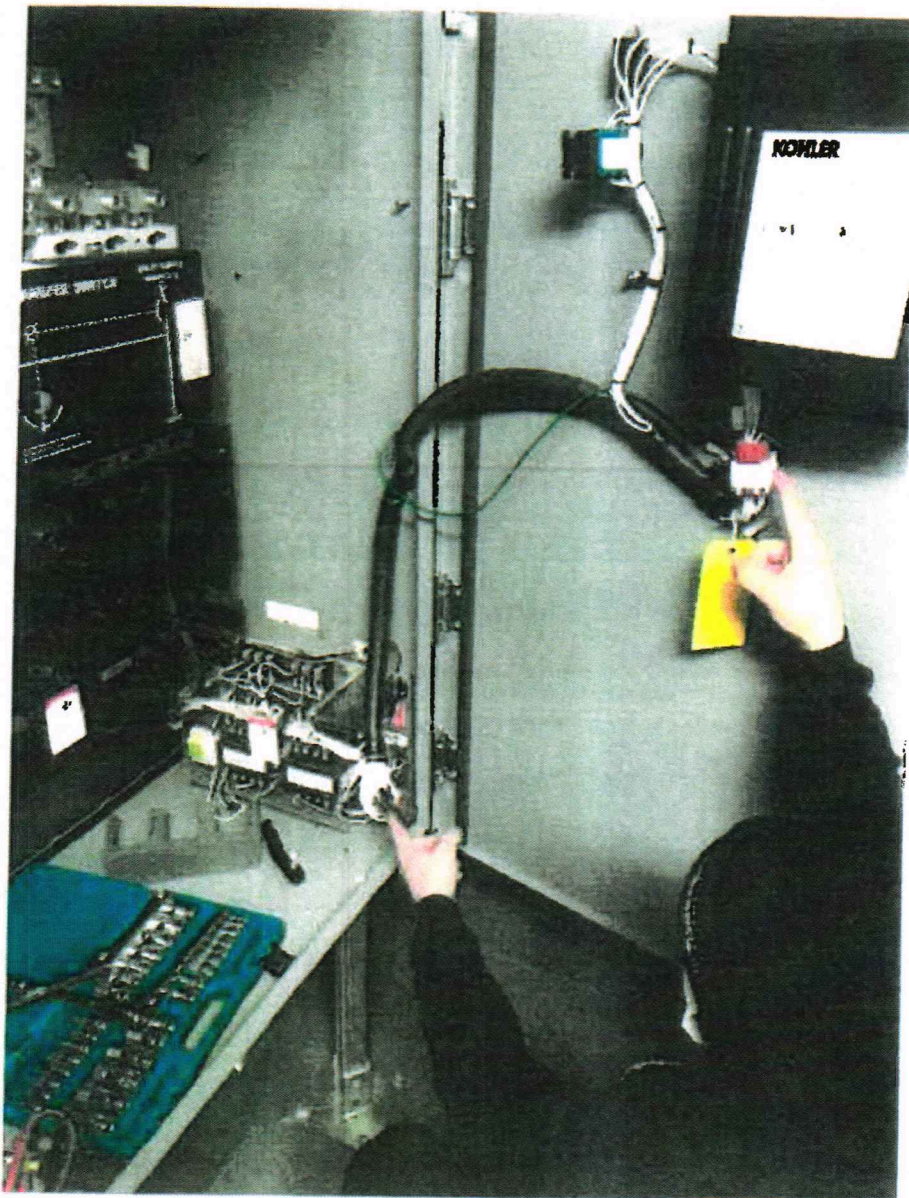
Damaged transfer switch wiring harness.
