BANGOR NURSING &  
REHABILITATION CENTER

DEPARTMENT OF HEALTH AND HUMAN SERVICES  
CENTERS FOR MEDICARE & MEDICAID SERVICES

BNRC Photos for documentation for POC.

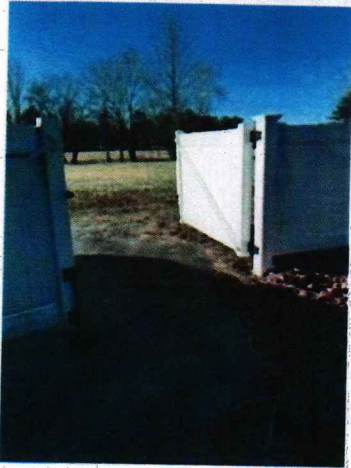
K 222 - #2 Dual Gates - South end secured in open position (Fence company visited 1/6/25)

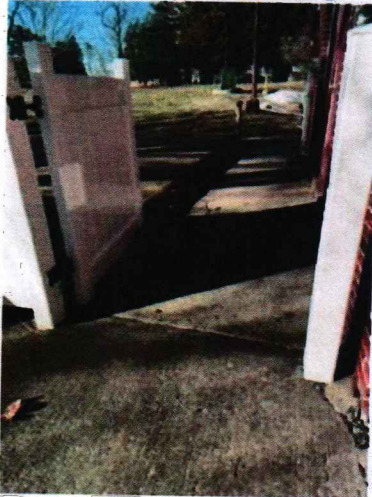
K 222 - #3 Gate outside dining room (East) secured in open position.

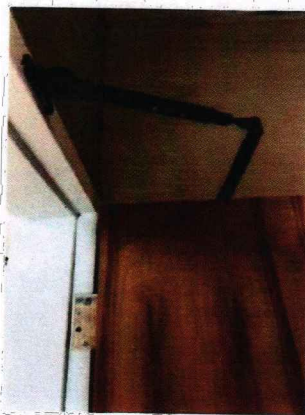
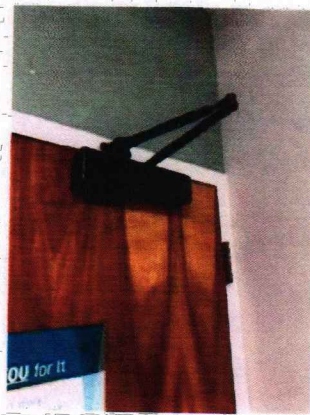
K223 - Self-Closing functionality in place. Door Self -Closes with closer fixed.

| K 223<br>SS=D | Doors with Self-Closing Devices<br>CFR(s): NFPA 101<br><br>Doors with Self-Closing Devices<br>Doors in an exit passageway, stairway enclosure, or horizontal exit, smoke barrier, or hazardous area enclosure are self-closing and kept in the closed position, unless held open by a release device complying with 7.2.1.8.2 that automatically closes all such doors throughout the smoke compartment or entire facility upon activation of:<br>* Required manual fire alarm system; and<br>* Local smoke detectors designed to detect smoke passing through the opening or a required smoke detection system; and<br>* Automatic sprinkler system, if installed; and<br>* Loss of power.<br>18.2.2.2.7, 18.2.2.2.8, 19.2.2.2.7, 19.2.2.2.8<br>This REQUIREMENT is not met as evidenced | K 223 | I. Self Closing device on door to supply room repaired to function as intended and door now self closes.<br><br>II. All residents have potential to be impacted by this practice.<br><br>III. Staff educated on K 223 and self closing door devices.<br><br>IV. Maintenance preventive maintenance rounds will now include the supply room. Documentation of PM will be brought to QAPI. | 12/24/24 | | |

| K 223 | Continued From page 8<br>by:<br>Based on observation, the facility failed to ensure that doors in an exit passageway, stairway enclosure, or horizontal exit, smoke barrier, or hazardous area enclosure are self-closing and kept in the closed position, unless held open by a release device complying with 7.2.1.8.2 that automatically closes all such doors throughout the smoke compartment or entire facility upon activation of required manual fire alarm system, and local smoke detectors designed to detect smoke passing through the opening or a required smoke detection system; and automatic sprinkler system, if installed; and loss of power per the requirements of NFPA 101 2012 edition Chapter 19 section 19.2.2.2.7 and 19.2.2.2.8<br><br>Findings:<br><br>On 12-17-2024 between hours of 10:00 am and 4:00 pm. this surveyor accompanied with Plant Operations Manager and District Manager did observe the following:<br><br>1. The door to the CNA Supply Room a hazardous area, located across from Room 26 is held open with a electromagnetic hold opening device. The door would not self-close upon release of the electromagnetic device as part of the self closing device was removed.<br><br>The surveyor confirmed this finding with the Plant Operations Manager and District Manager at the time of the observation. | K 223 | RECEIVED<br>JAN 03 2025<br>BY: _____ | | |

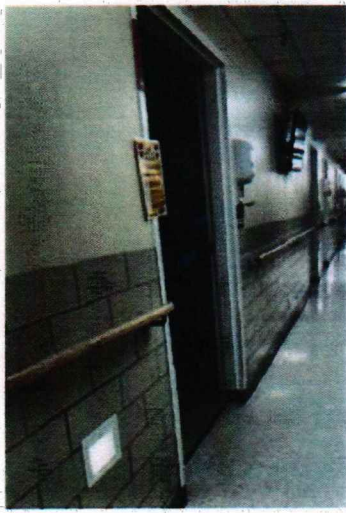
K232

Drink cart no longer in hallway

| K 232 | <p>Continued From page 9</p> <p>2012 EXISTING</p> <p>The width of aisles or corridors (clear or unobstructed) serving as exit access shall be at least 4 feet and maintained to provide the convenient removal of nonambulatory patients on stretchers, except as modified by 19.2.3.4, exceptions 1-5.</p> <p>19.2.3.4, 19.2.3.5</p> <p>This REQUIREMENT is not met as evidenced by:</p> <p>Based on observations, the long-term care facility failed to maintain exit corridor width per NFPA 101, Life Safety Code, 2012 Edition, Section 19.2.3.4. Any required aisle, corridor, or ramp shall not be less than 48" in clear width where serving as a means of egress from patient sleeping rooms unless permitted by one of the following: 1-5.</p> <p>Finding:</p> <p>On 12/17/24, between 10:00 AM and 4:00 PM, surveyors, with the Plant Operations Director and District Manager, observed the following:</p> <ol style="list-style-type: none"> <li>1. The Long Term Care Corridor had a cart with water and supplies stored in the exit corridor located across from the Nurses Station. This deficient practice could impede egress while in the corridor.</li> <li>2. Five separate portable vital signs devices were stored along the corridor wall in the skilled unit located outside of resident room 35.</li> </ol> <p>The surveyor confirmed this finding with the Plant Operations Director and District Manager at the</p> | K 232 | <p>I. Water cart has been eliminated. Vital sign monitors will be stored in closet or office when not in use. Defibrillator will be will be relocated to a hallway nook, where it will not protrude into a hallway.</p> <p>II. All residents have potential to be impacted by this practice.</p> <p>III. Staff will receive education regarding K 232 and maintaining exit corridors per regulation.</p> <p>IV. Maintenance manager or designee will audit that hallways are free of the water cart, vital sign monitors not in use and maintenance of 48" width. Audits will be brought to QAPI.</p> | 1/30/25 | | | |

| K 232 | Continued From page 10<br>time of the observation.<br><br>Based on observations, the long-term care facility<br>failed to maintain exit corridor width per NFPA<br>101, Life Safety Code, 2012 Edition, Section<br>19.2.3.4. Any required aisle, corridor, or ramp<br>shall not be less than 48" in clear width where<br>serving as a means of egress from patient<br>sleeping rooms unless permitted by one of the<br>following: 1-5.<br><br>Finding:<br><br>On 12/17/24, between 10:00 AM and 4:00 PM,<br>surveyors, with the Plant Operations Director and<br>District Manager, observed the following:<br><br>1. In the corridor adjacent to the steam room on<br>the opposing wall an Automatic External<br>Defibrillator was mounted to the corridor wall<br>protruding 6 3/4 inches<br><br>The surveyor confirmed this finding with the Plant<br>Operations Director and District Manager at the<br>time of the observation. | K 232 | RECEIVED<br>JAN 03 2025<br>BY: _____ | | |

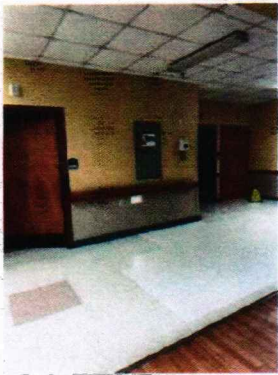
Outside Room 35 -Vital Sign machines moved.

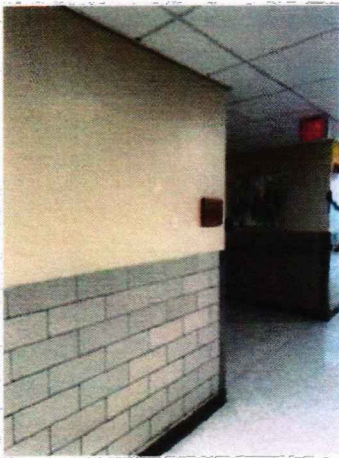
Defibrillator Removed from wall

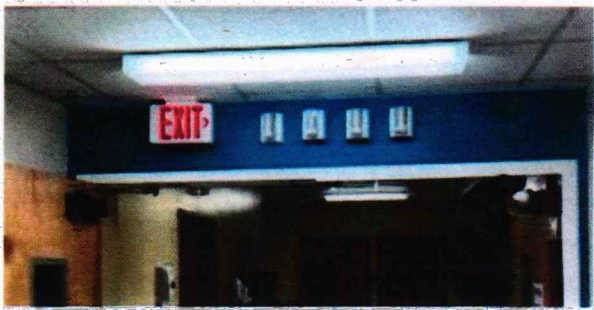
K 298 #1

New Exit sign to second means of egress SNF unit - living room end of building.

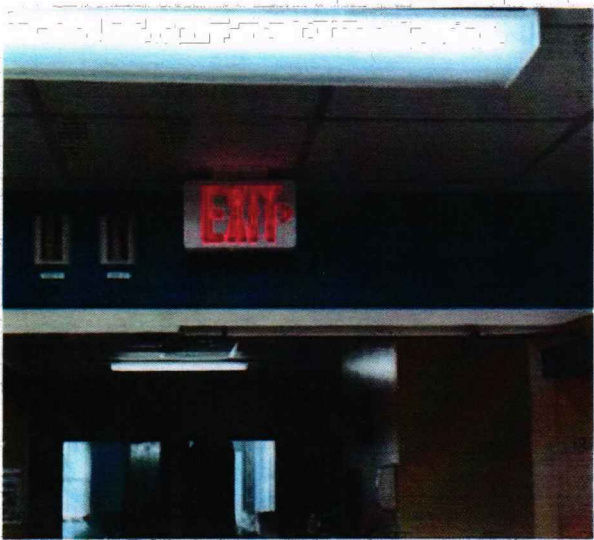
New Exit sign to second means of egress LTC unit - living room end of building.

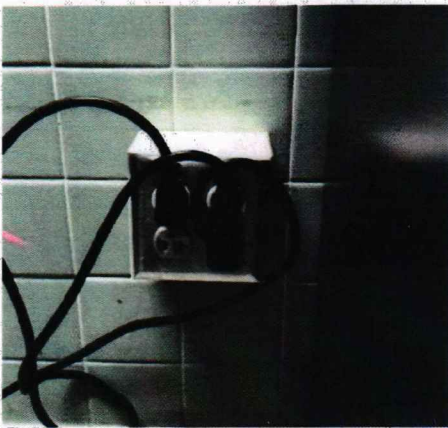
New Electric outlet in Medication storage room. Power strip removed.

| K 920<br>SS=D | Electrical Equipment - Power Cords and Extens<br>CFR(s): NFPA 101<br><br>Electrical Equipment - Power Cords and<br>Extension Cords<br>Power strips in a patient care vicinity are only<br>used for components of movable<br>patient-care-related electrical equipment<br>(PCREE) assemblies that have been assembled<br>by qualified personnel and meet the conditions of<br>10.2.3.6. Power strips in the patient care vicinity<br>may not be used for non-PCREE (e.g., personal<br>electronics), except in long-term care resident<br>rooms that do not use PCREE. Power strips for<br>PCREE meet UL 1363A or UL 60601-1. Power<br>strips for non-PCREE in the patient care rooms<br>(outside of vicinity) meet UL 1363. In non-patient<br>care rooms, power strips meet other UL<br>standards. All power strips are used with general<br>precautions. Extension cords are not used as a<br>substitute for fixed wiring of a structure.<br>Extension cords used temporarily are removed<br>immediately upon completion of the purpose for<br>which it was installed and meets the conditions of<br>10.2.4.<br>10.2.3.6 (NFPA 99), 10.2.4 (NFPA 99), 400-8<br>(NFPA 70), 590.3(D) (NFPA 70), TIA 12-5 | K 920 | I. Power strip removed. Electrician<br>installed approved outlets for use.<br><br>II. All residents have the potential to be<br>impacted by this practice.<br><br>III. Staff will be educated on K 920.<br><br>IV. Maintenance will audit for use of<br>power strips, remove power strips that<br>are noncompliant and educate staff at the<br>time of the finding. Audits will be brought<br>to QAPI. | | 12/31/24 | |

| K 920 | <p>Continued From page 19</p> <p>This REQUIREMENT is not met as evidenced by:</p> <p>Based on observation and interview, the long-term care facility failed to ensure that power strips are not used for non-PCREE (Patient-care-related electrical equipment) and that power strips are not used as a substitute for fixed wiring in accordance with NFPA 99 Chapter 10, NFPA 70 chapter 4 {400.8(1)}</p> <p>On 12/17/24, between 10:00 AM and 4:00 PM, surveyor 39983, with the Plant Operations Director and District Manager, observed the following:</p> <p>1. In the Medication Room located across from the nurses station, 2 refrigerators and medical dispensing cabinet were found plugged into a power strip as a permanent power source.</p> <p>The surveyor 39983 confirmed this finding with the Plant Operations Director and District Manager at the time of the observation.</p> | K 920 | <p>RECEIVED</p> <p>BY: _____</p> | |
