Division of Health Service Regulation

| STATEMENT OF DEFICIENCIES AND PLAN OF CORRECTION | | (X1) PROVIDER/SUPPLIER/CLIA IDENTIFICATION NUMBER:<br><br><b>FCL034092</b> | (X2) MULTIPLE CONSTRUCTION<br>A. BUILDING: <b>01</b><br><br>B. WING: _____ | (X3) DATE SURVEY COMPLETED<br><br><b>03/22/2016</b> |
| NAME OF PROVIDER OR SUPPLIER<br><br><b>WAMU'S FAMILY CARE HOME</b> | | STREET ADDRESS, CITY, STATE, ZIP CODE<br><b>1251 SHELTER COVE<br/>WINSTON-SALEM, NC 27106</b> | | |

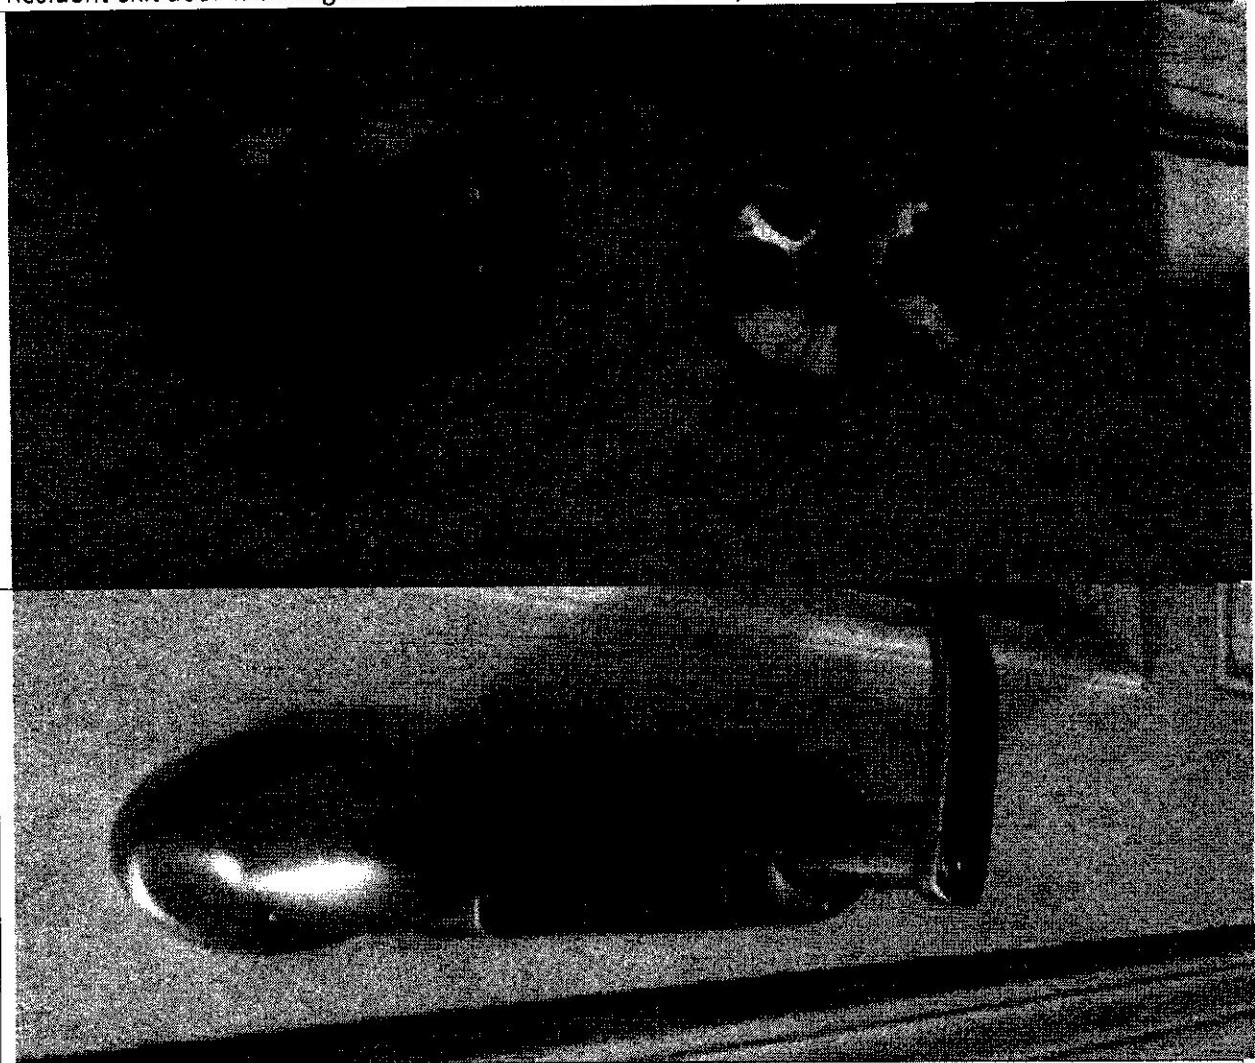
| C 147 | <p>Outside Entrances/Exits-Single Hand Motion</p> <p>SECTION .0300 - THE BUILDING</p> <p>10A NCAC 13G .0312 OUTSIDE ENTRANCE AND EXITS</p> <p>(d) All exit door locks shall be easily operable, by a single hand motion, from the inside at all times without keys. Existing deadbolts or turn buttons on the inside of exit doors shall be removed or disabled. This Rule is not met as evidenced by: Observations revealed that the door hardware on all of the exit doors is not single action. Have a qualified technician repair or replace the door hardware with single action exiting hardware. Provide receipts and photo documentation to the DHSR Construction Section when this repair is complete.</p> | C 147 | <p>Photo documentation provided showing the exterior doors hardware with single action. This is a unique situation that had not been pointed in previous inspection. Administrator will ensure that only single action locks are installed in residents exterior doors</p> | May 23, 2016 |

Resident exit door with single action locks. 2<sup>nd</sup> one is a dummy lock with no latch

*Have any  
2 knobs -  
1 over one not  
working. Remove*

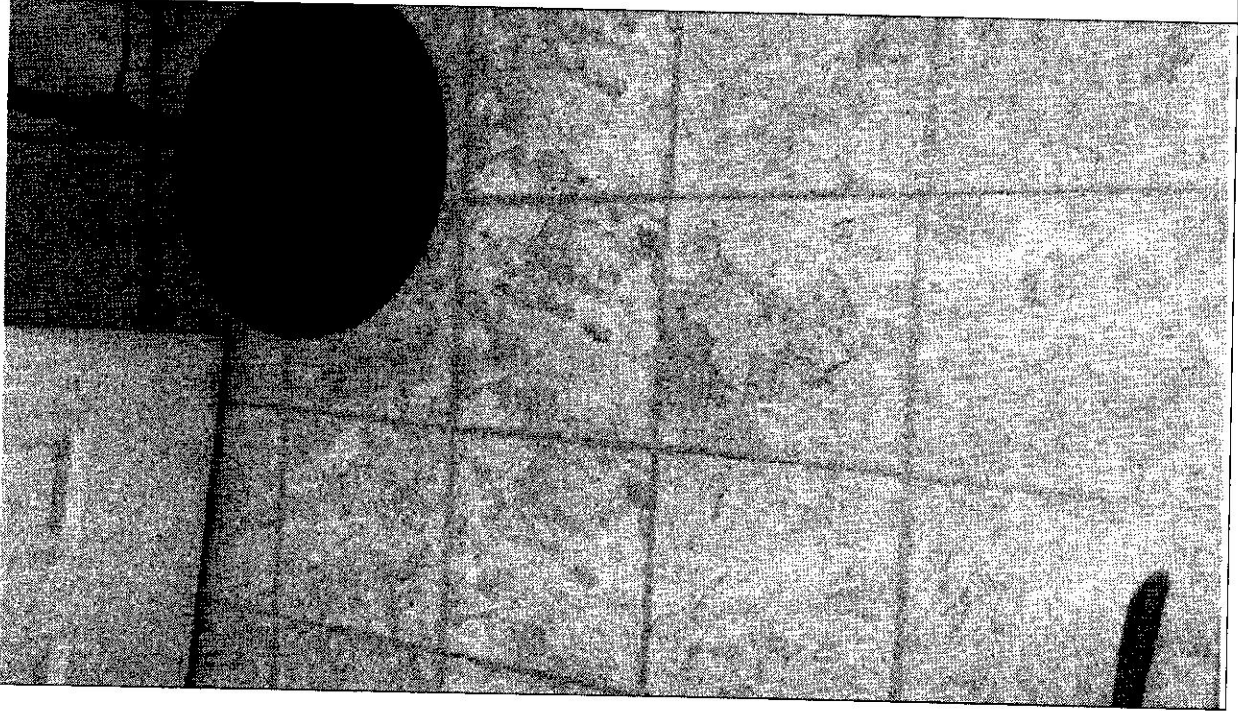
| C 174 | <p>SECTION .0300 - THE BUILDING</p> <p>10A NCAC 13G .0317 BUILDING SERVICE EQUIPMENT</p> <p>(a) The building and all fire safety, electrical, mechanical, and plumbing equipment in a family care home shall be maintained in a safe and operating condition.</p> <p>(j) This Rule shall apply to new and existing family care homes.</p> <p>This Rule is not met as evidenced by:</p> <ol style="list-style-type: none"> <li>1. Observations revealed that a smoke detector was missing from its base in the basement living quarters outside the staff bedroom. Have a qualified technician replace the missing smoke detector. Provide receipts and photo documentation of the completed repair to the DHSR Construction Section.</li> <li>2. Observations revealed an exposed seam in the kitchen floor that could pose a trip hazard. Have a qualified technician repair the exposed seam. Provide receipts and photo documentation to the DHSR Construction Section when this repair is complete.</li> <li>3. Observations revealed missing siding and soffit on the right side of the facility and the rear of the facility is coming loose. Have a qualified technician replace the missing siding and repair the soffit. Provide receipts and photo documentation to the DHSR Construction Section when the repair is complete.</li> <li>4. Observations revealed multiple holes in the ceiling in the basement. Have a qualified technician repair or replace the damaged sheetrock in the basement. Provide receipts and photo documentation to the DHSR Construction Section when this repair is complete.</li> <li>5. Observations revealed mold or mildew on the exterior siding. Clean the siding. Provide photo documentation to the DHSR Construction Section when this item is complete.</li> </ol> | <p>C 174</p> <p>SF</p> <p>SF</p> <p>siding missing</p> <p>SF</p> <p>SF</p> | <p>Administrator will regularly inspect the building and ensure any trip hazards are fixed, smoke detectors are working, exterior sidings are attached, sheetrock has no holes and exterior siding have no mildew.</p> <ol style="list-style-type: none"> <li>1. Photo documentation provided showing the smoke detector cover has been re-attached.</li> <li>2. Photo documentation provided showing the kitchen has a new kitchen floor</li> <li>3. Photo documentation provided showing both the siding and soffit on the rear right side have been re-attached</li> <li>4. A photo documentation provided showing the 2 small sheetrock holes in the basement have been sealed</li> <li>5. Photo documentation provided showing the mildew on the back exterior siding have been cleaned and removed</li> </ol> | <p>May 23, 2016</p> <p>May 23, 2016</p> <p>May 23, 2016</p> <p>May 23, 2016</p> <p>May 23, 2016</p> |

New Kitchen floor
