BethAmy Retirement Center  
909 N Salisbury Ave  
Spencer, NC 28159  
704-633-1985

April 27, 2017

Enclosed is the hard copy of my response to your construction survey of March 14, 2017.

| C 000 | Initial Comments<br><br>Report of a Construction Section Biennial Survey<br>by Ed Miller, conducted on March 14, 2017.<br><br>Records indicates this facility was first licensed<br>on December 1, 1975 as a Home for the Aged<br>serving 29 residents. On February 17, 1997 a 14<br>bed addition was built bringing the current<br>capacity up to 43 residents. The North Side was<br>presumed to be the 1996 addition. Therefore the<br>older section of the facility must meet the 1971<br>and the applicable portions of the 2005 Rules for<br>the Licensing of Adult Care Homes, and, the 1967<br>NC State Building Code for D-2 Institutional<br>Occupancy. The newer section of the facility<br>must meet the 1996 and the applicable portions<br>of the 2005 Rules for the Licensing of Adult Care<br>Homes, and, the 1996 NC State Building Code<br>for I-2 Institutional Occupancy.<br><br>Deficiencies were cited that require a Plan of<br>Correction. | C 000 | | |

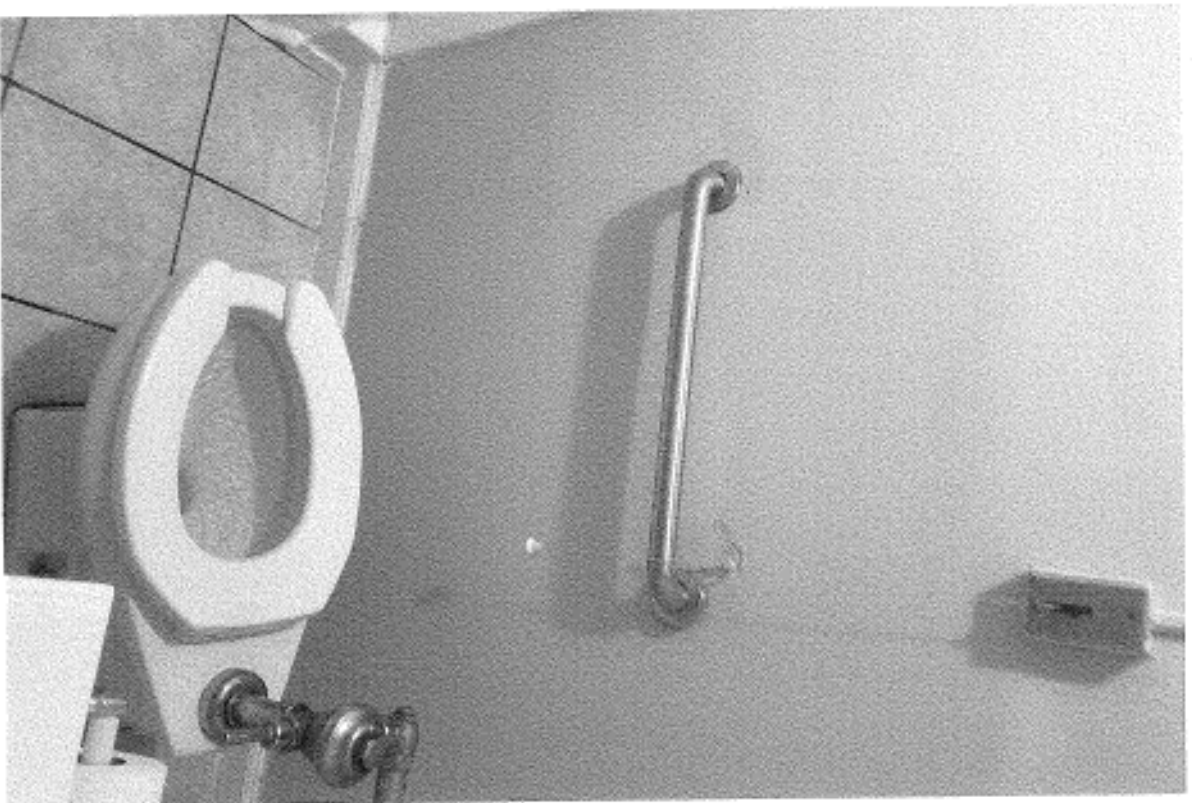
Exhibit 6a

| C 133 | Bathrooms-Hand Grips<br><br>SECTION .0300 - PHYSICAL PLANT<br>10A NCAC 13F .0305 PHYSICAL ENVIRONMENT<br>(e) The requirements for bathrooms and toilet rooms are:<br>(6) Hand grips shall be installed at all commodes, tubs and showers used by or accessible to residents;<br><br>This Rule is not met as evidenced by:<br>1. Based on observation, the facility failed to provide commodes, tubs and showers accessible to residents with hand grips. This deficiency affects all residents who use these fixtures by not providing increased safety, controlled against instability/balance, and maneuverability at the fixtures.<br>Findings on March 14, 2017:<br>a. Restroom near Large Staff Station - there were no hand grips (grab bar) for the commode. | C 133 | Exhibit 4<br><br>hand grips installed | 3-21-17 |

Restroom grab bar  
page 3 - C-133 a

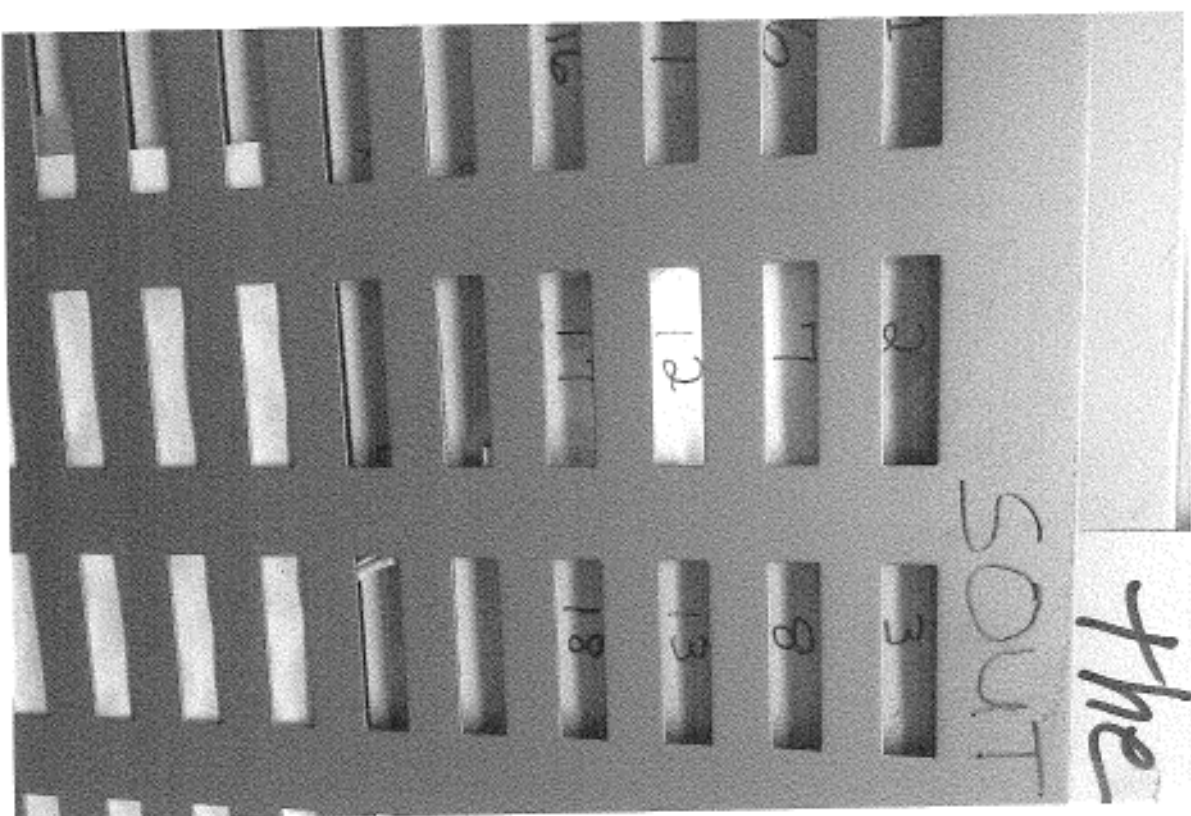
Exhibit 9

| C 189 | Continued From page 5<br><br>requested.<br>Findings on March 14, 2017:<br>a. Bedrooms and Bathroom - there was a pattern exhibited where many of the activators of the electrically operated resident call system were activated and the annunciation devices above the door did not function.<br>b. Bedrooms and Bathroom - there was a pattern exhibited where many of the activators of the electrically operated resident call system were activated and the annunciation devices at the staff stations did not function. | C 189 | all devices repaired by replacing burned out bulbs<br>Exhibit - 9 | 3-28-17 | |

page 6-C189-6  
cell system repaired

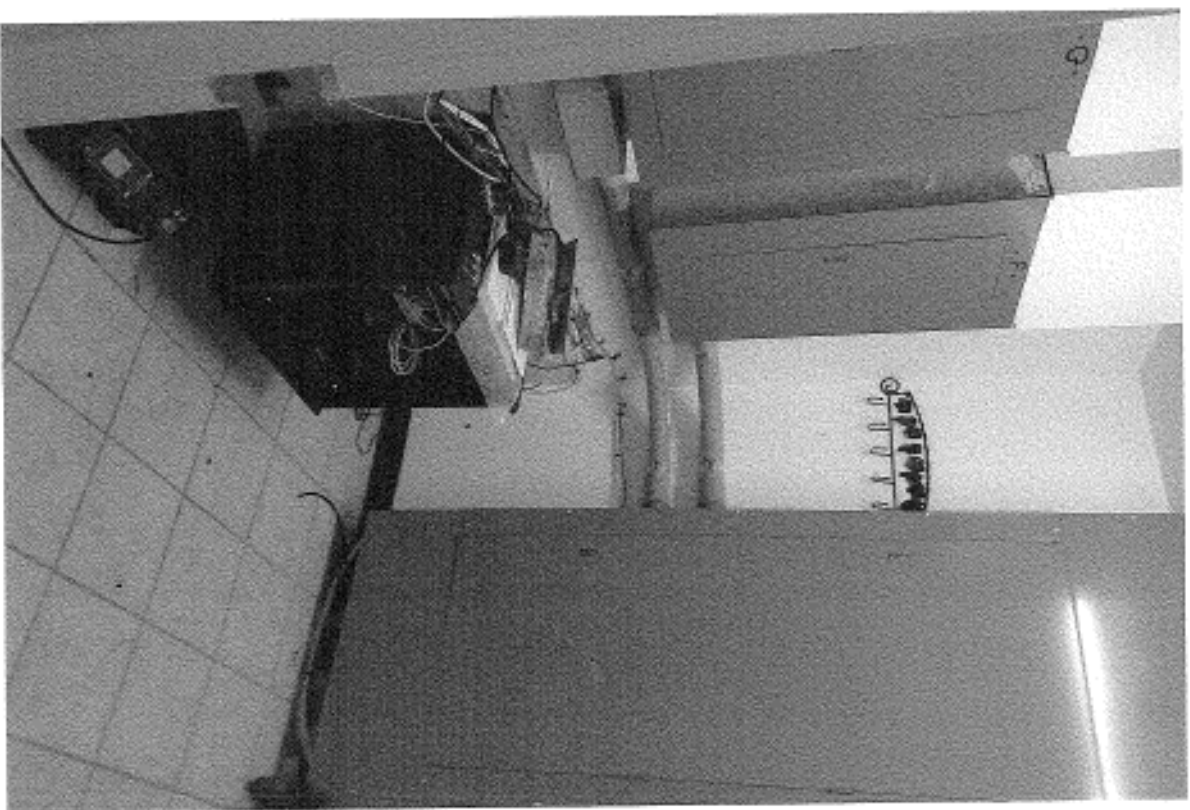
Exhibit 9a

| | 3. Based on observation, the electrical system was not being maintained safe.<br>Findings on March 14, 2017:<br>a. Electrical Room near Bedroom S10 - items were stored in front of the electric panels, limiting the required 36-inches working clearance. This prevents quick access in any emergency.<br>b. Electrical Room Across from Kitchen - items were stored in front of the electric panels, limiting the required 36-inches working clearance. This prevents quick access in any emergency.<br>c. Electrical Room Across from Kitchen - electric panel "H" had an open slot where a breaker had been removed or blanks fell out. This allows access to energized components that are not guarded against accidental contact. | | removed<br>Exhibit 9a<br>Exhibit removed - 9b<br>repaired with new slot<br>Exhibit 9c | | |

page 6 C189.3a  
items removed

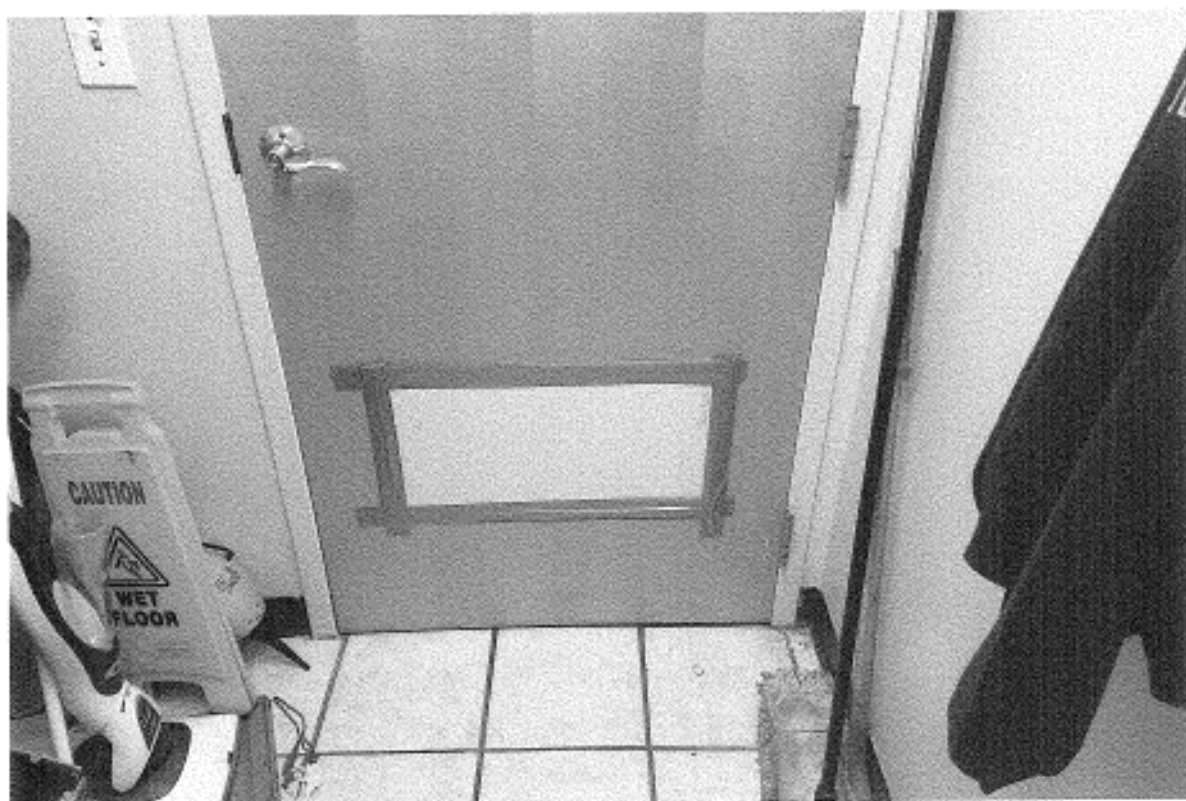
EXHIBIT 13

a. Housekeeping across from South Laundry -  
the corridor door had a 10x16 louver that did not  
resist the passage of smoke.

✓ repaired and sealed

page 8 - C189- 6-a  
door sealed

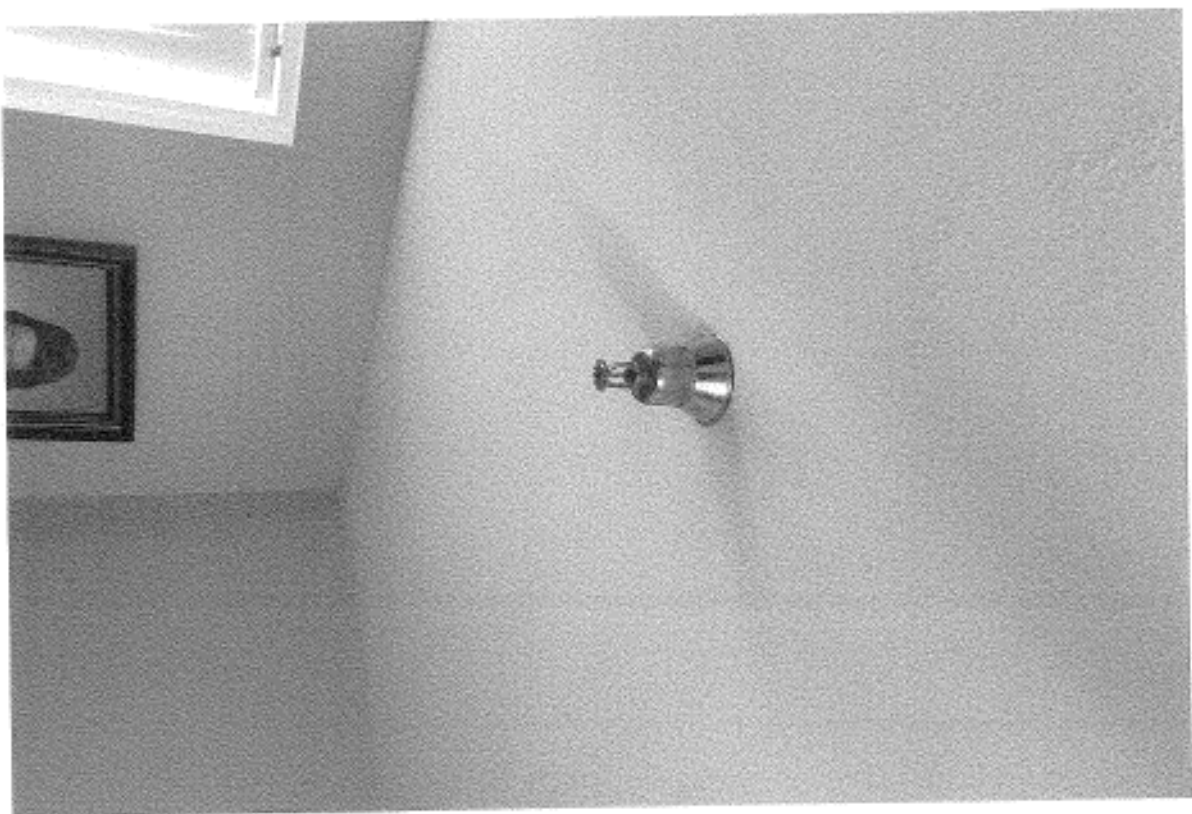
Exhibit-14 a

a. Bedroom N6 Closet - the fire sprinkler was  
covered with blue painter tape.  
b. Bedroom N12 - both fire sprinkler escutcheon  
plate had dropped down from the  
fire-resistance-rated ceiling exposing an opening  
that allows the spread of smoke and heat.

✓ tape removed

page 8 C-1878 a  
tape removed

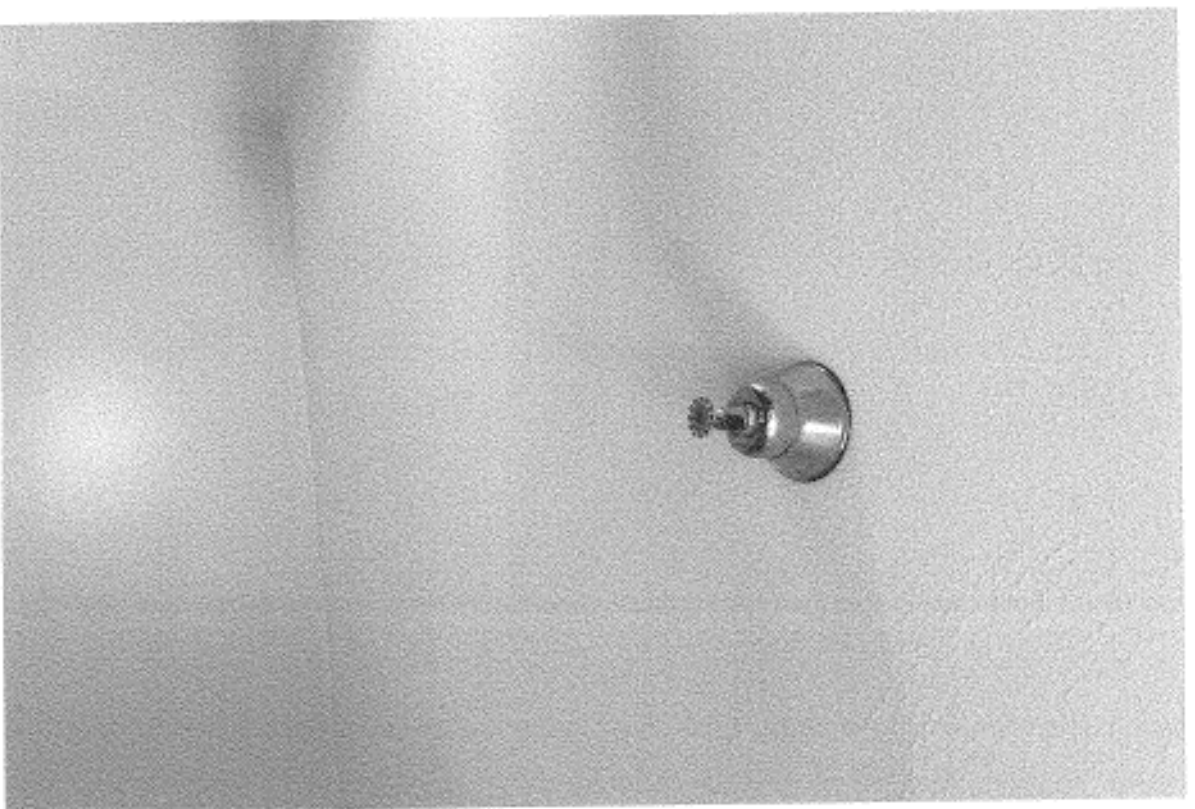
EXHIBIT 15

| C 189 | Continued From page 8<br><br>c. Bedroom N11 - the top half of the fire<br>sprinkler escutcheon plate was missing, exposing<br>an opening through the fire-resistance-rated<br>ceiling that allows the spread of smoke and heat.<br><br>9. Based on observation, the building was not<br>maintained in a safe and operating condition with<br>stable handrails/guardrails at steps, porches,<br>stoops and ramps. This would affect all residents,<br>staff and visitors who use these unstable<br>handrail/guardrails by not providing increasing<br>safety, stability/balance, and maneuverability<br>required of these devices.<br>Findings on March 14, 2017:<br>a. Kitchen - the North handrail was very loose. | C 189 | <i>Exhibit 14c</i><br>→ plate - installed<br><br><i>Exhibit 15a</i><br>✓ bolt tightened - handrail secure | 4-17-17<br><br>3-28-17 | |

Escutcheon plate installed

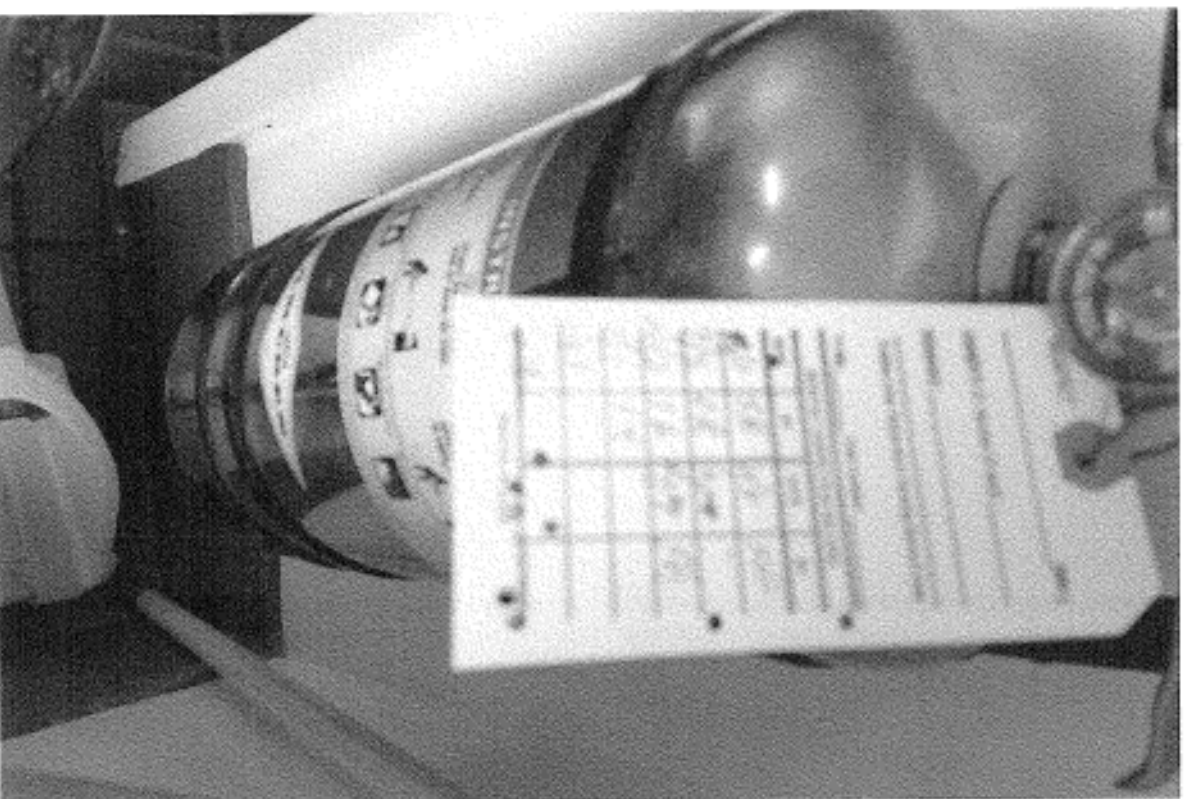
Exhibit 15 b

| | 10. Based on observation, the facility failed to<br>properly maintain the fire extinguishers and<br>associated equipment. This could hamper staffs<br>ability to extinguish a small fire and permit it to<br>grow larger..<br>Findings on March 14, 2017:<br>a. Kitchen - the documentation of the portable<br>fire extinguisher's monthly inspections stopped in<br>July 2016. | | ✓ inspection updated | 3-17-17 | |

Page 9 - C189 10 a  
axlunguisher inspected

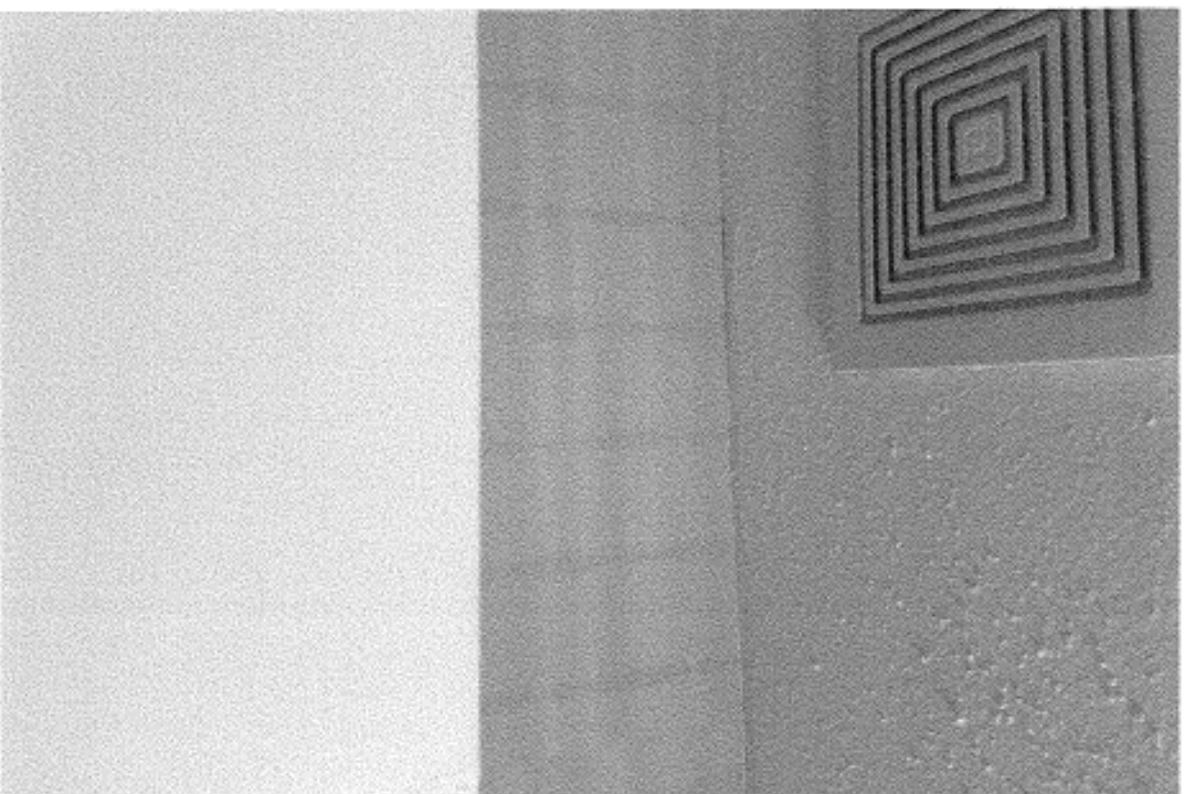
Exhibit 16

| C 199 | Continued From page 10<br><br>could affect all residents, staff and visitors by<br>preventing the exhausting of odors.<br>Findings on March 14, 2017:<br>a. Rest Room near Bedroom N1 - the exhaust<br>ventilation system did not work, allowing a<br>build-up of odors. | C 199 | EXHIBIT 16<br>7 exhaust fan was unplugged -<br>fan unit was fixed by plugging<br>back in. | 3-23-17 | |

Page 11 C 199 a  
exhaust fan fixed -  
wire was loose
