Division of Health Service Regulation

| STATEMENT OF DEFICIENCIES AND PLAN OF CORRECTION | | (X1) PROVIDER/SUPPLIER/CLIA IDENTIFICATION NUMBER:<br><br><b>HAL023042</b> | (X2) MULTIPLE CONSTRUCTION<br>A. BUILDING: <b>01</b><br><br>B. WING: _____ | (X3) DATE SURVEY COMPLETED<br><br><b>08/03/2017</b> |
| NAME OF PROVIDER OR SUPPLIER<br><br><b>SUMMIT PLACE OF KINGS MOUNTAIN</b> | | STREET ADDRESS, CITY, STATE, ZIP CODE<br><b>1001 PHIFER ROAD<br/>KINGS MOUNTAIN, NC 28086</b> | | |
| C 000 | Initial Comments<br><br>Construction Section Biennial Survey report by Frank Strickland on 08/03/2017:<br><br>Records indicate this facility was first licensed on 02/04/1998. An addition was added in 2006. The facility is currently licensed for sixty-five residents. Based on this information, we are requiring that this facility to meet the 1996 "Homes for the Aged and Disabled - Minimum Standards and Regulations", the 1996 Edition of the North Carolina State Building Code; Institutional Occupancy, the 2002 Edition of the North Carolina State Building Code; Institutional Occupancy, - Group I-2 and the applicable portions of the 2005 Rules for Adult Care Homes of Seven or More Beds<br><br>Deficiencies

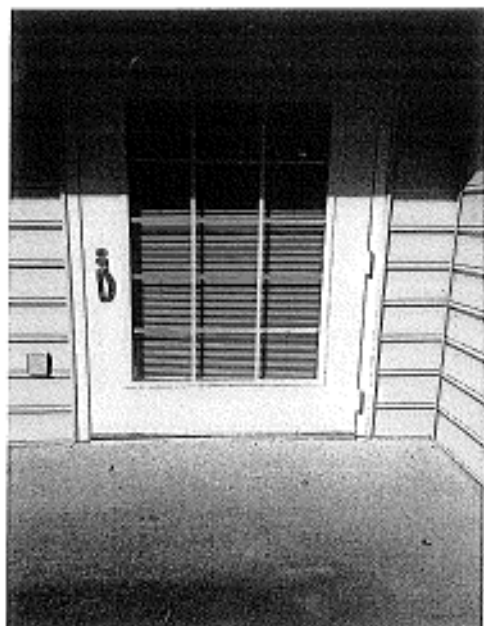
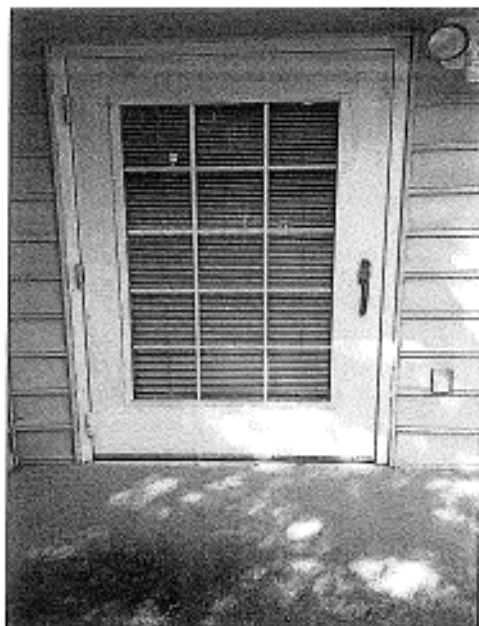
2 exterior doors

| C 160 | Outside Premises-Clean, Safe<br><br>SECTION .0300 - PHYSICAL PLANT<br>10A NCAC 13F .0305 PHYSICAL ENVIRONMENT<br>(m) The requirements for outside premises are:<br>(1) The outside grounds of new and existing facilities shall be maintained in a clean and safe condition;<br><br>This Rule is not met as evidenced by:<br>1-Based on observations, this facility has failed to maintain the exterior finishes of the exterior doors.<br><br>Findings on 08/02/2017:<br>The exterior metal doors and supporting frames have peeling paint that are located in the 200 | C 160 | Exterior metal doors and frames were painted (200 hall corridor) – Maintenance will continue to monitor and ensure the facilities premises are well maintained. See attached photo<br><br>August 23, 2017 | |

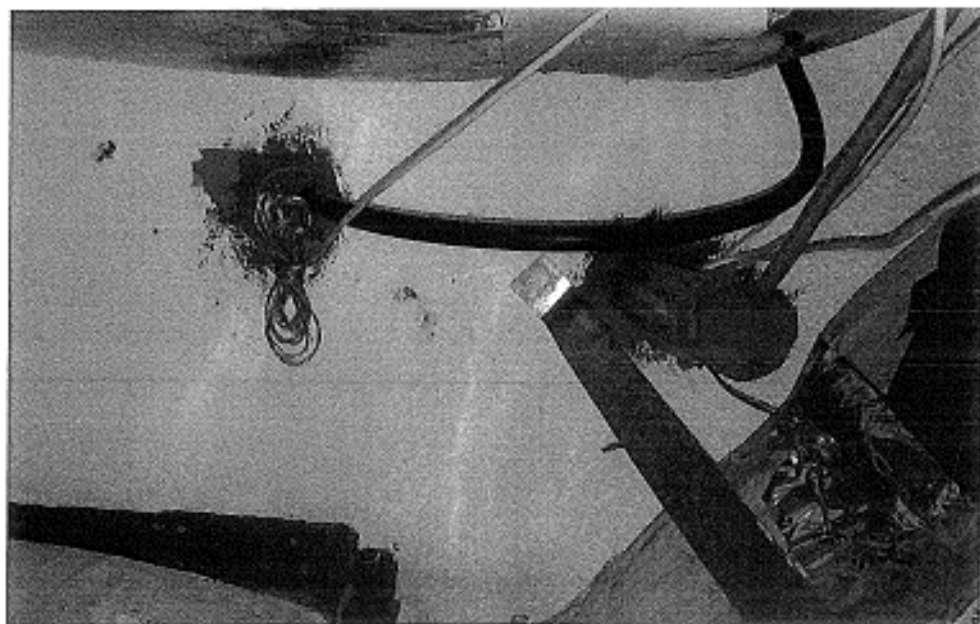
Fire caulk

| C 189 | <p>Continued From page 2</p> <p>penetrations through the fire rated roof/ceiling assemblies.</p> <p>Findings on 08/02/2017:<br/>There are 3-2" electrical conduits that are penetrating the ceiling in the Main Electrical Room that have incomplete fire-protection where the wiring goes up into the attic.</p> <p>3-Based on observation, the facility has not maintained the one-hour roof/ceiling assembly construction due to water migration that has invalidated its integrity. This could affect all residents and staff in the event that fire and/or smoke is not contained in a room or compartment of origin.</p> <p>Findings on 08/02/2017:<br/>The ceiling sheet-rock is damaged due to water migration that is located in the Main Sprinkler Riser Room located above the sprinkler riser.</p> <p>4-Based on observation, the facility has not maintained the one-hour roof/ceiling assembly construction that has invalidated its integrity.</p> <p>Findings on 11/18/2015:<br/>There is an opening in the ceiling construction that is adjacent to the emergency corridor light outside Room 323.</p> | C 189 | <p>Maintenance fire caulked penetrations in ceiling in Main Electrical Room. See attached photo</p> <p>August 7, 2017</p> <p>Ceiling sheet rock was repaired in Main Sprinkler Riser Room<br/>See attached photo</p> <p>August 7, 2017</p> <p>Maintenance Director repaired and fire caulked ceiling around emergency light located in shower room- adjacent to room 323. See attached photo</p> <p>August 19, 2017</p> | | |

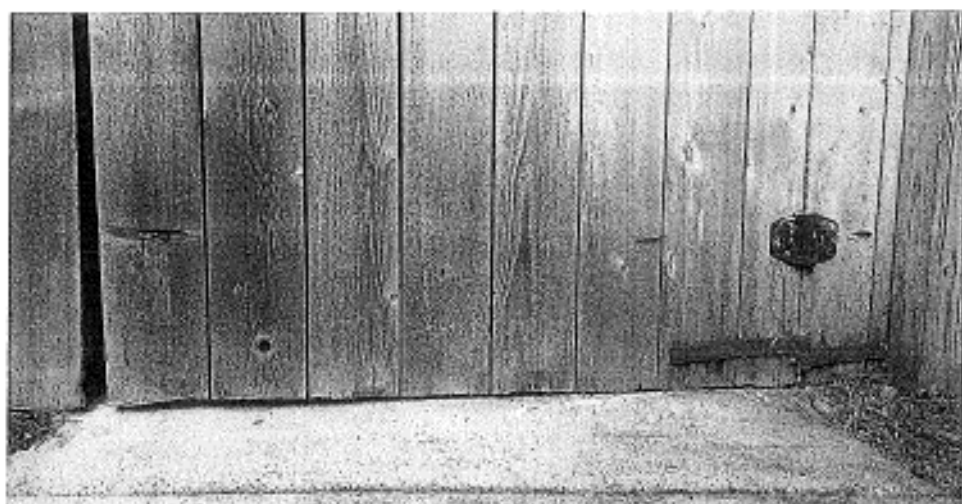
Gate BTR

| C 160 | Continued From page 1<br><br>HALL.<br><br>2-Based on observations, this facility has failed to maintain the exterior gates in the Courtyards.<br><br>Findings on 08/02/2017:<br>The wooden exit gate that is located in the Memory Care Courtyard, drags on the sidewalk and is difficult to open in the event of an emergency for evacuation. | C 160 | The wooden gate located in Memory Care courtyard was repaired- Maintenance Director shaved off bottom to allow gate to open more easily. See attached photo<br><br>August 23, 2017 | |

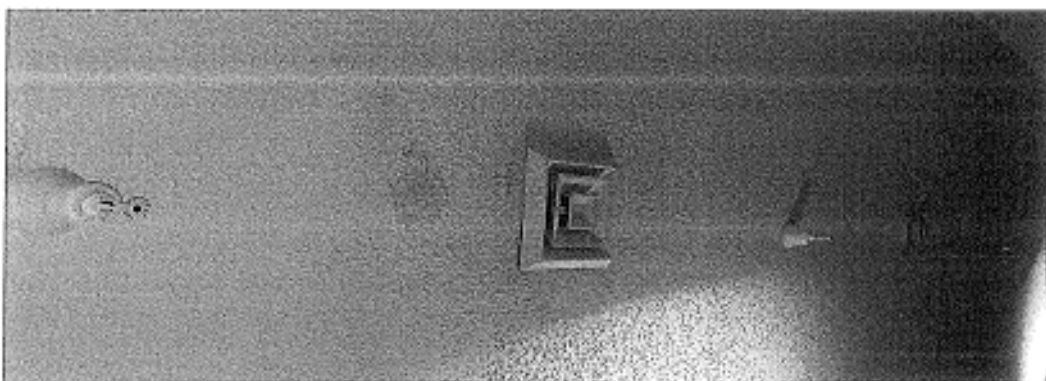
200 hall sprinkler heads

| C 189 | Building Equipment Maintained Safe, Operating<br><br>SECTION .0300 - PHYSICAL PLANT<br>10A NCAC 13F .0311 OTHER REQUIREMENTS<br>(a) The building and all fire safety, electrical, mechanical, and plumbing equipment in an adult care home shall be maintained in a safe and operating condition.<br>(k) This Rule shall apply to new and existing facilities with the exception of Paragraph (e) which shall not apply to existing facilities.<br><br>This Rule is not met as evidenced by:<br>1-Based on observations, this facility has failed to maintain the sprinkler head installation in the ceilings throughout the facility.<br><br>Findings on 08/02/2017:<br>The locations have openings in the ceilings adjacent to sprinkler head escutcheons due to service and repair:<br>(a) Room 201<br>(b) The entire exit corridor in the 200 HALL.<br><br>2-Based on observation, this facility has failed to provide fire protection in all electrical ceiling | C 189 | Maintenance Director Fire caulked sprinkler head escutcheons (room 201 and entire exit corridor on the 200 hall) See attached photo<br><br>August 7, 2017 | |
