Division of Health Service Regulation

| STATEMENT OF DEFICIENCIES<br>AND PLAN OF CORRECTION | | (X1) PROVIDER/SUPPLIER/CLIA<br>IDENTIFICATION NUMBER:<br><br><b>HAL039009</b> | (X2) MULTIPLE CONSTRUCTION<br>A. BUILDING: <b>01</b><br><br>B. WING: _____ | (X3) DATE SURVEY<br>COMPLETED<br><br><b>R</b><br><b>11/08/2017</b> |
| NAME OF PROVIDER OR SUPPLIER<br><br><b>GRANVILLE HOUSE</b> | | STREET ADDRESS, CITY, STATE, ZIP CODE<br><b>200 COVENTRY DRIVE<br/>OXFORD, NC 27565</b> | | |
| {C 000} | Initial Comments<br><br>Report of a Biennial Follow Up Construction<br>Survey by Suzanna Fay and Chris Sluder<br>conducted on November 8, 2017.<br><br>There are deficiencies that remain to be<br>corrected and one new deficiency has been<br>added. | {C 000} | | |

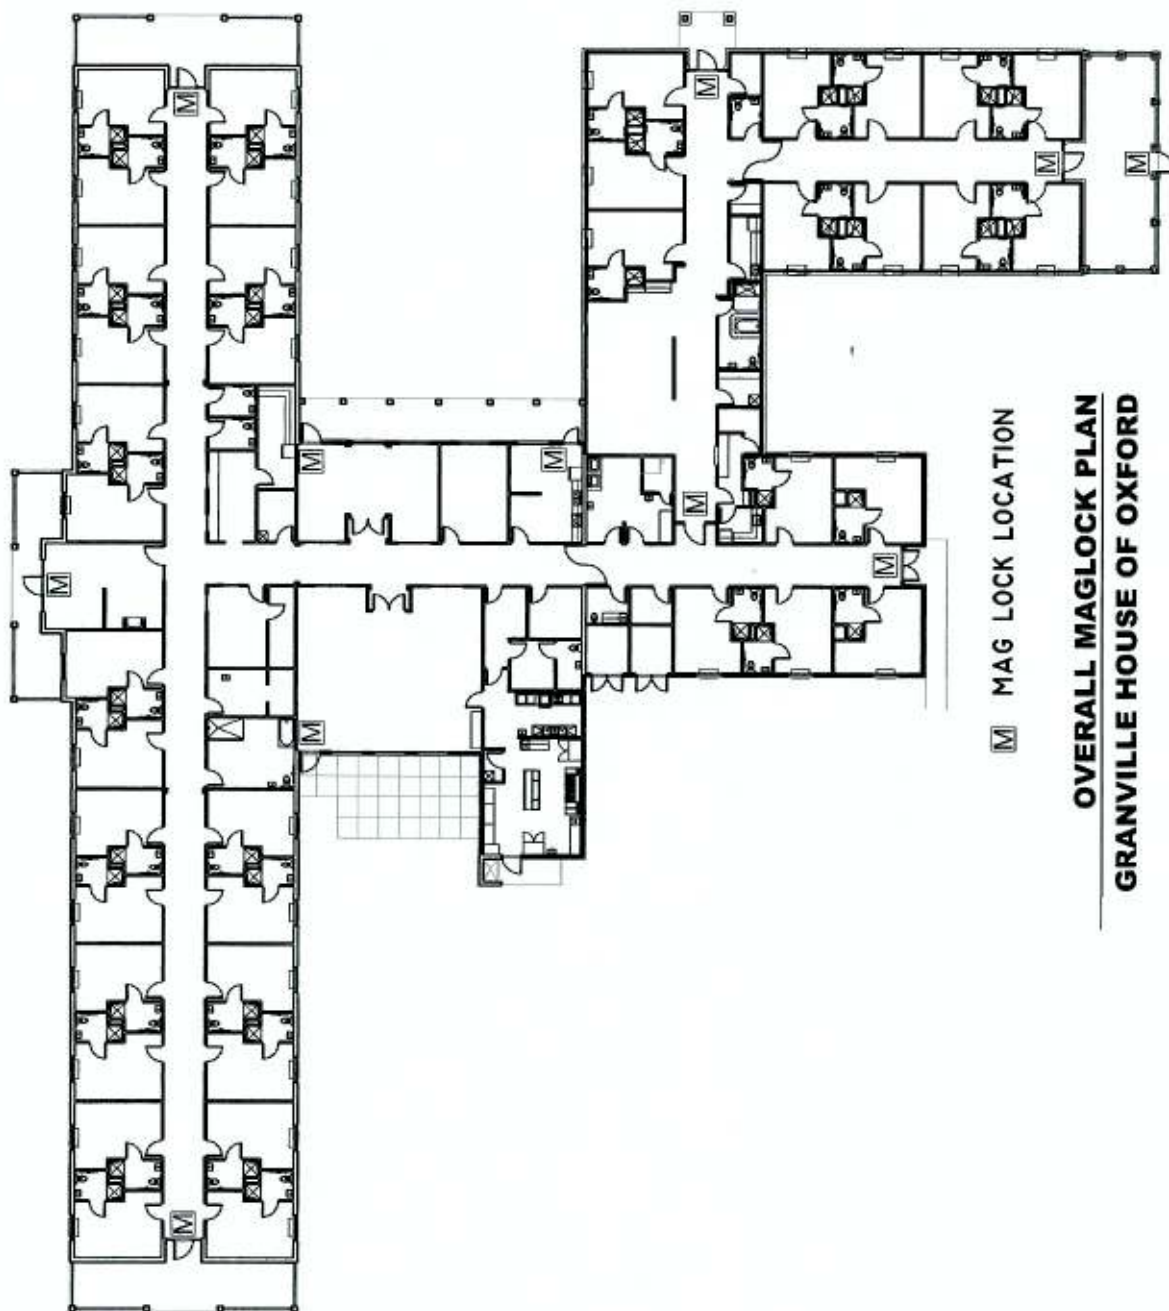
**OVERALL MAGLOCK PLAN  
GRANVILLE HOUSE OF OXFORD**

| {C 101} | Continued From page 1<br><br>a. AL Nurse Station - the special locking system does not have a wiring diagram and a system components location map posted at the Fire Alarm Control Panel. Interview with Staff revealed that the diagram is being produced by an outside vendor and has not been completed. | {C 101} | | |

| {C 101} | Existing Licensed Fac- No less than '71 Rules<br><br>SECTION .0300 - PHYSICAL PLANT<br>10A NCAC 13F .0301 APPLICATION OF<br>PHYSICAL PLANT REQUIREMENTS<br>The physical plant requirements for each adult<br>care home shall be applied as follows:<br>(2) Except where otherwise specified, existing<br>licensed facilities or portions of existing licensed<br>facilities shall meet licensure and code<br>requirements in effect at the time of construction,<br>change in service or bed count, addition,<br>renovation, or alteration; however in no case shall<br>the requirements for any licensed facility where<br>no addition or renovation has been made, be less<br>than those requirements found in the 1971<br>"Minimum and Desired Standards and<br>Regulations" for "Homes for the Aged and Infirm",<br>copies of which are available at the Division of<br>Health Service Regulation at no cost;<br><br>This Rule is not met as evidenced by:<br>1. Based on observation and interview with<br>Staff, the facility failed to meet the Code<br>requirements in effect at the time of construction<br>or alteration by not having all of the required<br>components for doors equipped with Special<br>Locking Arrangements.<br><br>Findings on November 8, 2017: | {C 101} | Map completed. See<br>attached. Sarah Grabu | 12/5/2017 |
