Division of Health Service Regulation

| STATEMENT OF DEFICIENCIES<br>AND PLAN OF CORRECTION | (X1) PROVIDER/SUPPLIER/CLIA<br>IDENTIFICATION NUMBER:<br><br><b>FCL082028</b> | (X2) MULTIPLE CONSTRUCTION<br>A. BUILDING: <b>01</b><br><br>B. WING: _____ | (X3) DATE SURVEY<br>COMPLETED<br><br><b>C</b><br><b>01/10/2018</b> |

| NAME OF PROVIDER OR SUPPLIER<br><br><b>SERENITY FAMILY CARE HOME # 3</b> | STREET ADDRESS, CITY, STATE, ZIP CODE<br><b>100 W MAGNOLIA / LISHON ROAD<br/>ROSE HILL, NC 28458</b> |

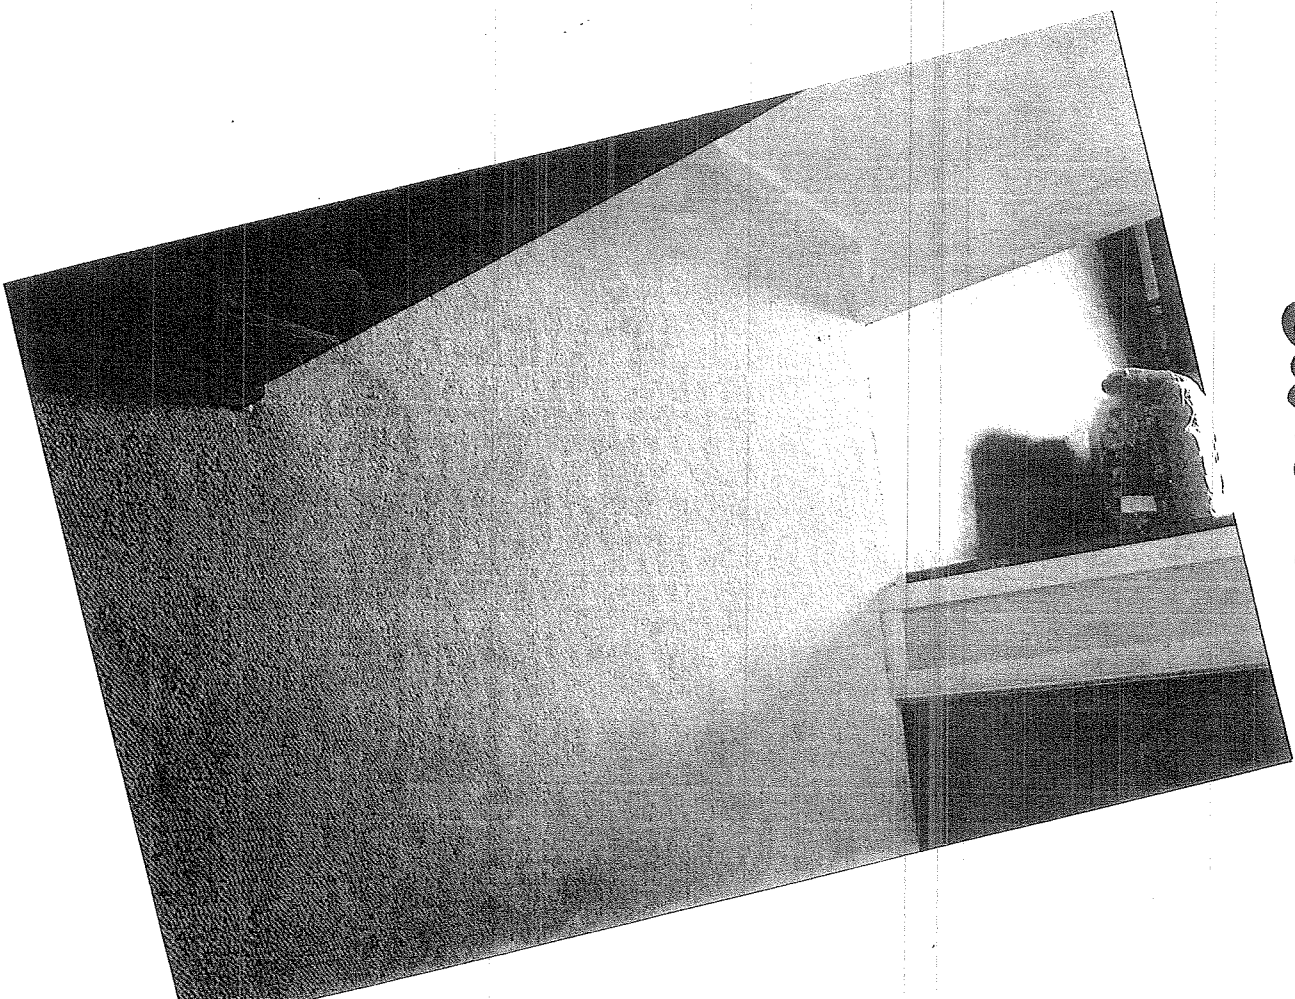
Out floor replaced  
outside bathroom
