TO: DHSR Construction Section FROM: Angela Hardy  
FAX: 919-733-6592 PAGES: 33 pages  
PHONE: 919-855-3883 DATE: 4-5-2018  
RE: Plan of Correction CC:

| NAME OF PROVIDER OR SUPPLIER<br><br>HOUSE OF LOVE FAMILY CARE HOME | | STREET ADDRESS, CITY, STATE, ZIP CODE<br>1904 JOHNSON RD<br>ELIZ CITY, NC 27909 | | |
| C 000 | Initial Comments<br><br>Report by Luis Padilla<br><br>DHSR Construction Section conducted a Biennial Survey on February 6, 2018 from 3:00 PM to 5:00 PM at the above referenced facility. DHSR records indicate the home was first licensed on July 17, 2013 as a Family Care Home for Six (6) ambulatory Residents (able to respond and evacuate without any physical or verbal assistance during a fire or other emergency). Based on this we are requiring the home to be in compliance with the following: the 2005 Rules 10A NCAC 13G for Family Care Homes and the applicable portions of the 2012 North Carolina Building Code - Section 425.2 - Residential Care Homes<br><br>At the time of our visit, we cited deficiencies that require an acceptable plan of correction. They are as follows: | C 000 | The corrective action that will be accomplished in 4 areas of the facility found to have be

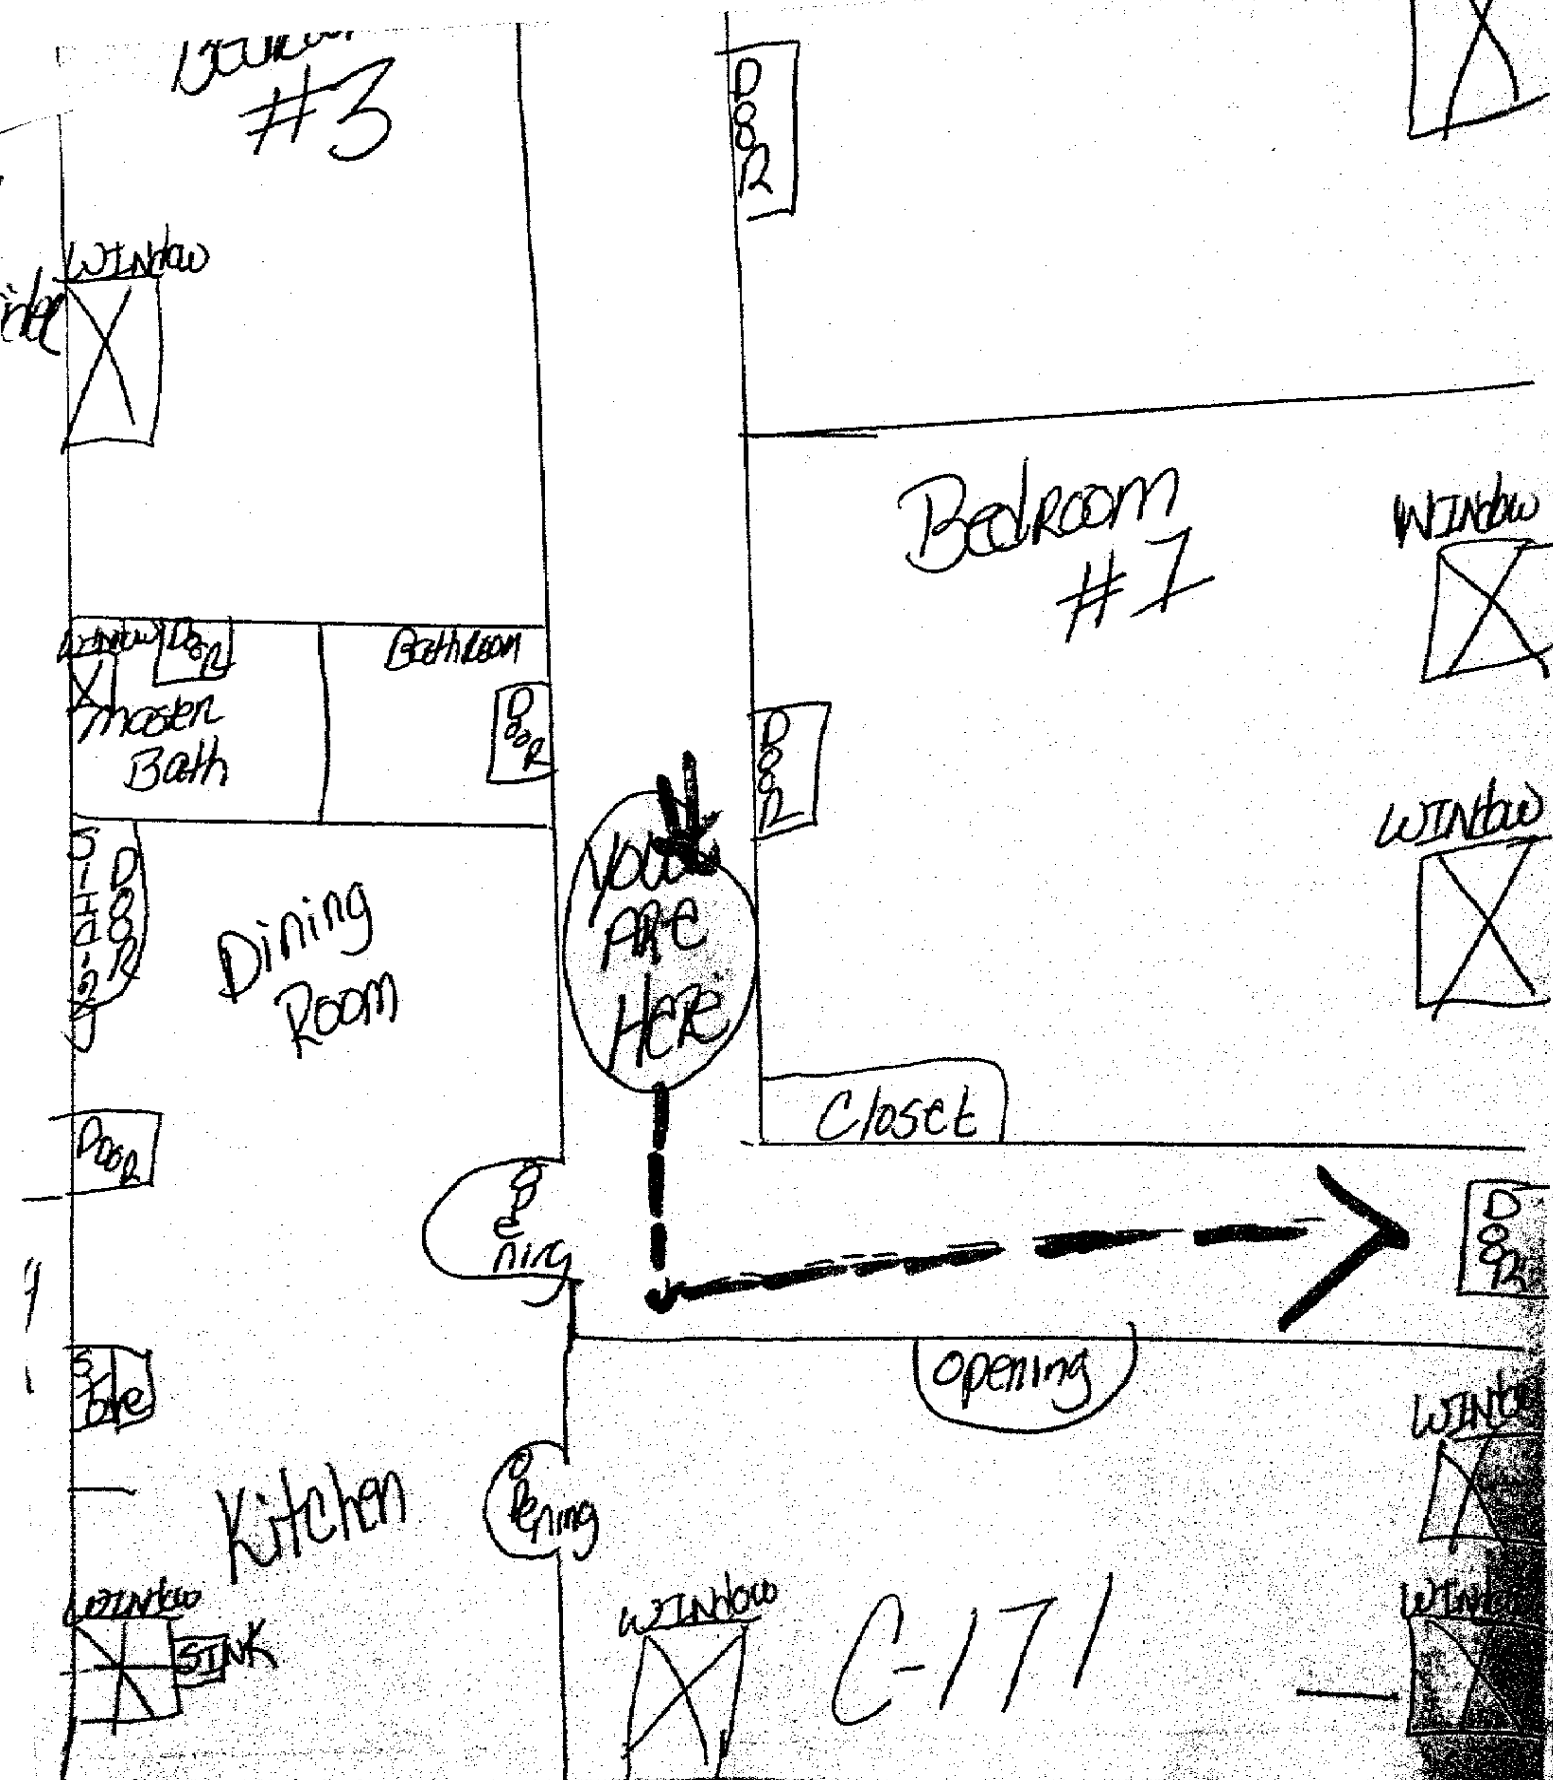
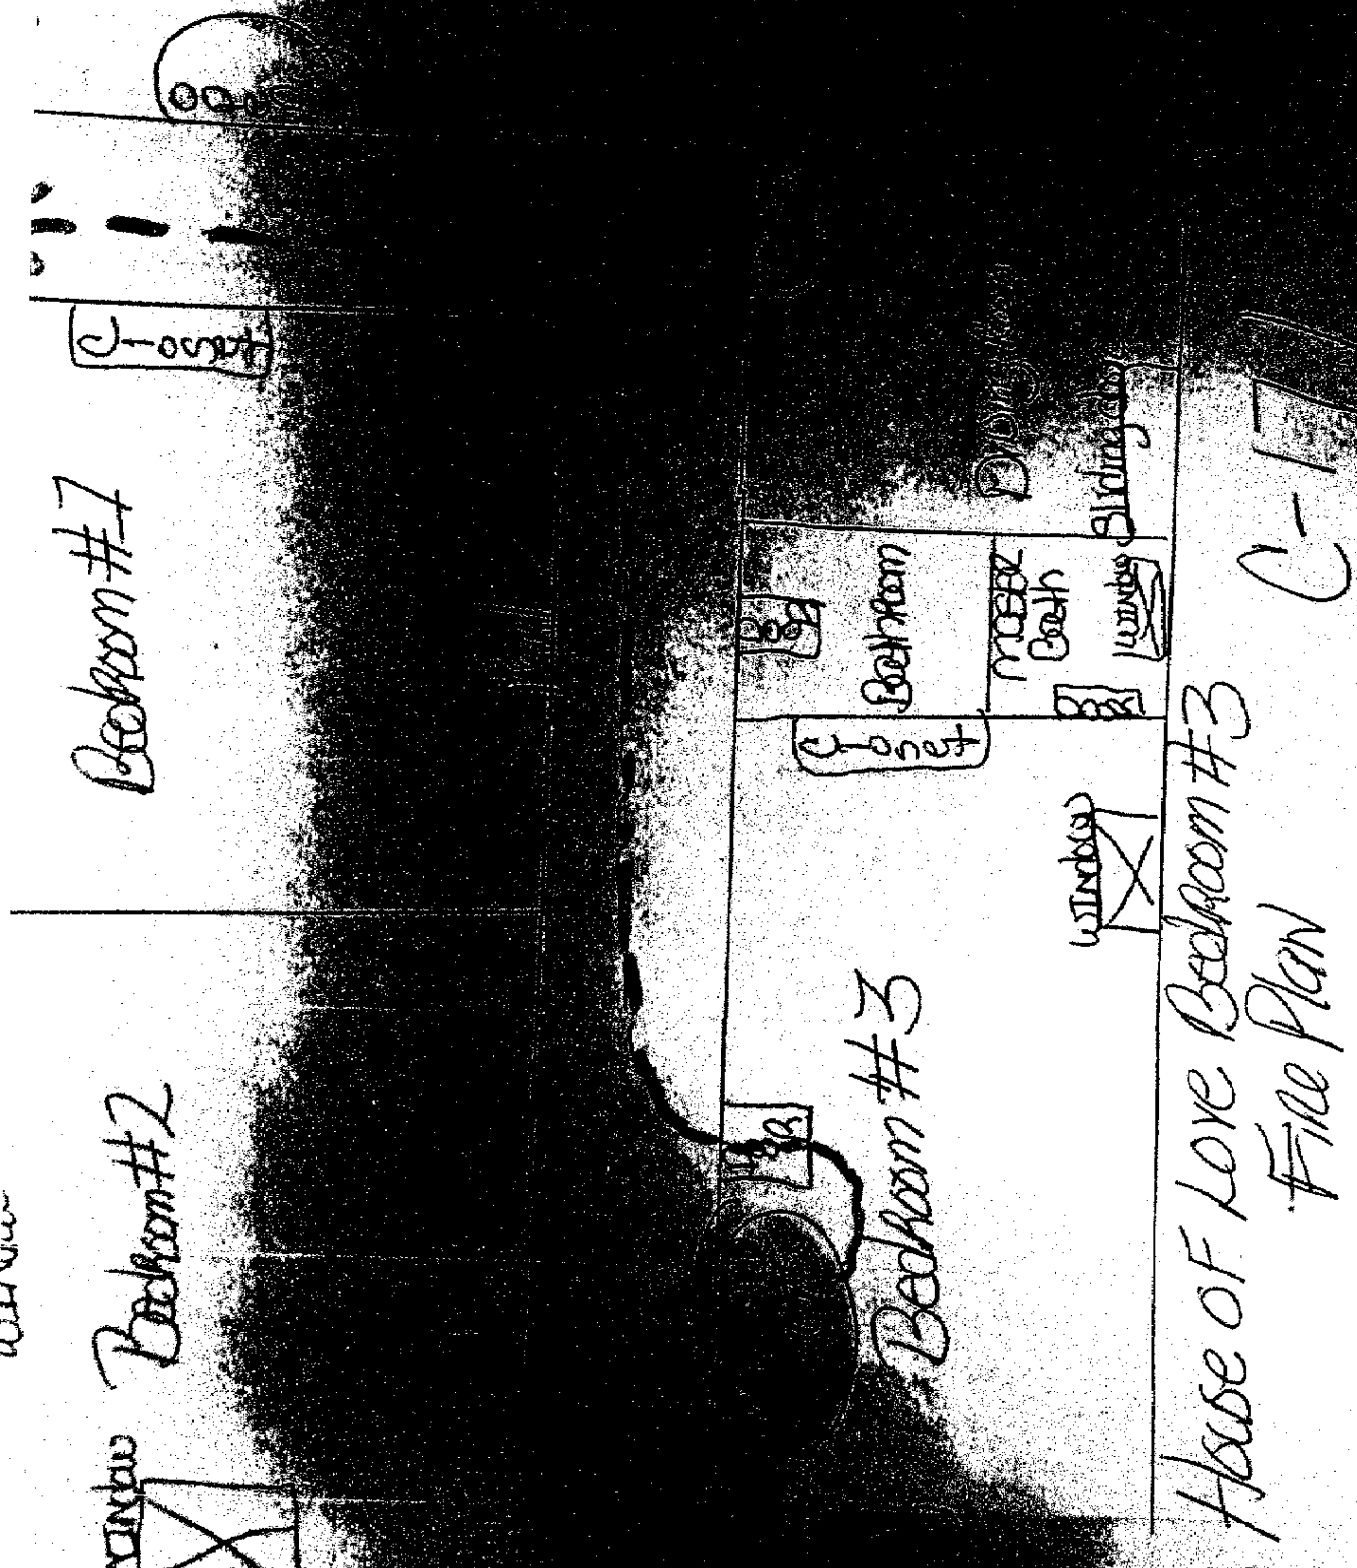
| C 171 | Continued From page 6<br><br>This Rule is not met as evidenced by:<br>1.) This rule requires that A written fire evacuation plan (including a diagrammed drawing) which has the approval of the local code enforcement official shall be prepared in large print and posted in a central location on each floor.<br><br>At the time of the survey it was observed the fire escape plan was not oriented correctly in both the corridor and bedroom #3. Failure to have these plans properly oriented may promote confusion among new residents.<br><br>Based on our findings have the fire escape plans properly oriented. It should be oriented to correspond with its specific location within the home. When the plan is located on a wall, up should be straight ahead. Once completed, provide photos to the DHSR Construction Section as verification of compliance. | C 171 | |

| Division of Health Service Regulation | | (X2) MULTIPLE CONSTRUCTION | (X3) DATE SURVEY COMPLETED |
|---|---|---|---|
| C 171 | <p>Fire Safety- Evacuation Plan</p> <p>SECTION .0300 - THE BUILDING<br/>10A NCAC 13G .0316 FIRE SAFETY AND DISASTER PLAN</p> <p>(d) A written fire evacuation plan (including a diagrammed drawing) which has the approval of the local code enforcement official shall be prepared in large print and posted in a central location on each floor. The plan shall be reviewed with each resident on admission and shall be a part of the orientation for all new staff.</p> | C 171 | <p>The corrective action for the fire escape plan for the corridor and bedroom #3 has been corrected and is oriented to correspond with it's specific location in the home. Photos are attached</p> |
