Division of Health Service Regulation

| STATEMENT OF DEFICIENCIES AND PLAN OF CORRECTION | | (X1) PROVIDER/SUPPLIER/CLIA IDENTIFICATION NUMBER:<br><br><b>HAL067008</b> | (X2) MULTIPLE CONSTRUCTION<br>A. BUILDING: <b>01</b><br><br>B. WING: _____ | (X3) DATE SURVEY COMPLETED<br><br><b>R</b><br><b>05/09/2018</b> |
| NAME OF PROVIDER OR SUPPLIER<br><br><b>LIBERTY COMMONS ASSISTED LIVING</b> | | STREET ADDRESS, CITY, STATE, ZIP CODE<br><b>3045 HENDERSON DRIVE EXTENSION<br/>JACKSONVILLE, NC 28546</b> | | |
| {C 000} | Initial Comments<br><br>Report of a Biennial Follow Up Constsruction Survey by Suzanna Fay conducted on May 9, 2018.<br><br>There are defienicies cited from the Biennial Construction Survey that remain to be corrected. | {C 000} | <p>CONSTRUCTION SECTION</p> <p>JUN 11 2018</p> <p>RECEIVED</p> <p>completed 6/1/18<br/>picture attached of<br/>sensor installed by<br/>Unifred Alarms<br/>(attachment #1)</p> | |

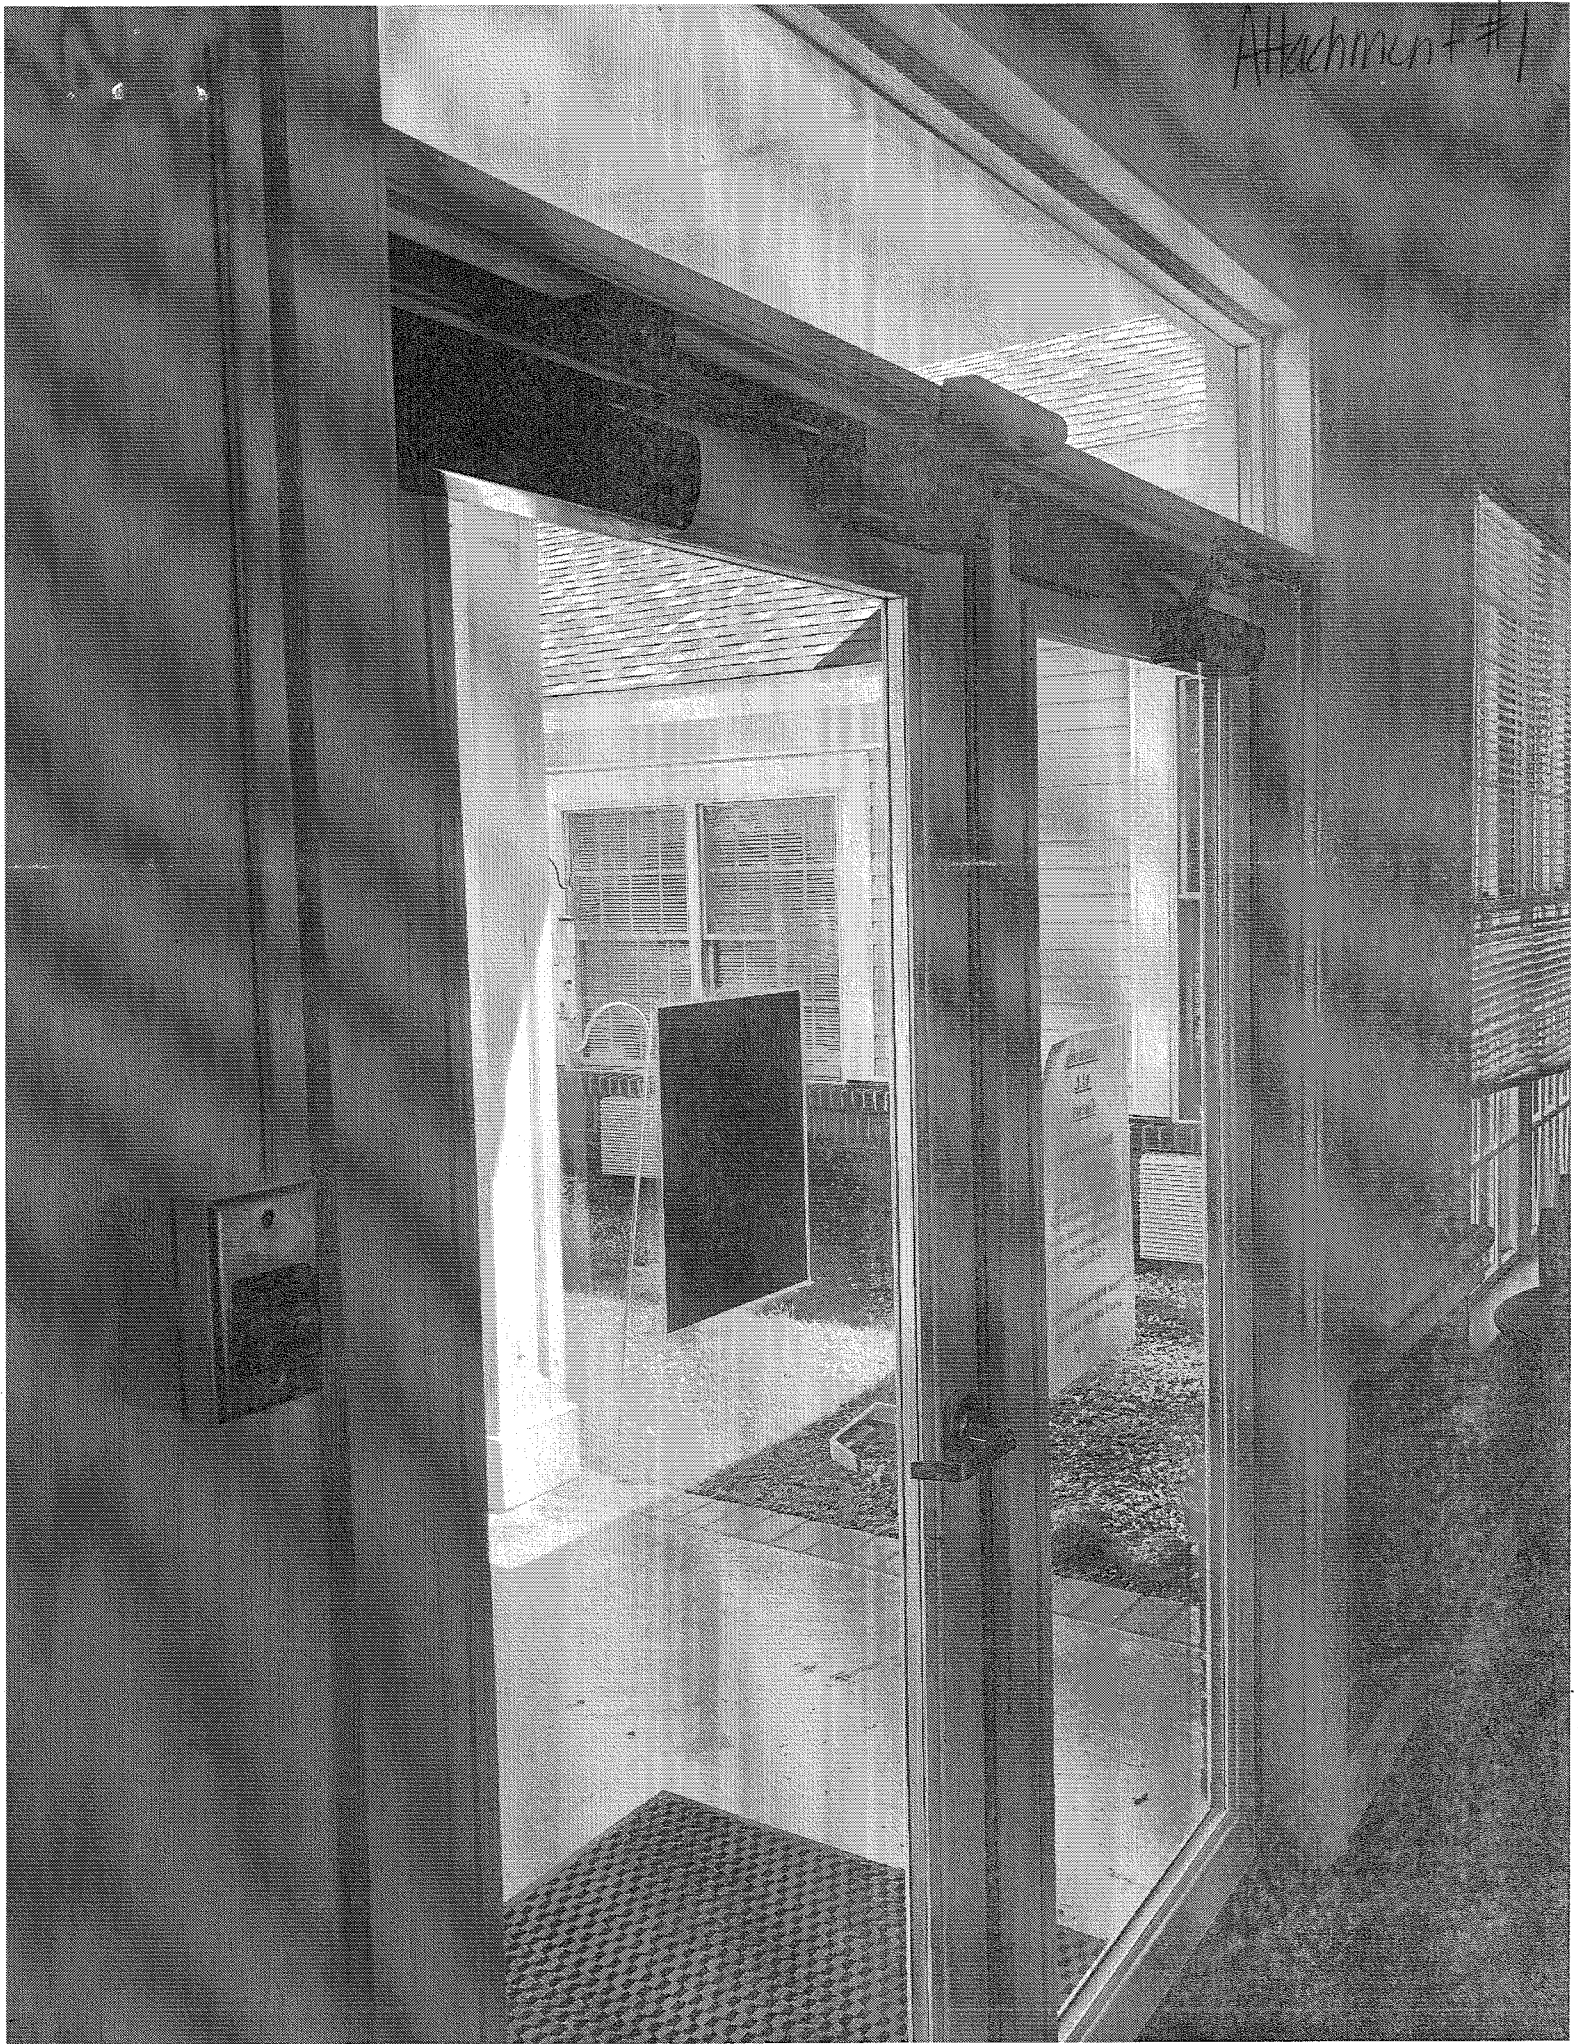
Attachment #1

| {C 101} | Existing Licensed Fac- No less than '71 Rules<br><br>SECTION .0300 - PHYSICAL PLANT<br>10A NCAC 13F .0301 APPLICATION OF PHYSICAL PLANT REQUIREMENTS<br>The physical plant requirements for each adult care home shall be applied as follows:<br>(2) Except where otherwise specified, existing licensed facilities or portions of existing licensed facilities shall meet licensure and code requirements in effect at the time of construction, change in service or bed count, addition, renovation, or alteration; however in no case shall the requirements for any licensed facility where no addition or renovation has been made, be less than those requirements found in the 1971 "Minimum and Desired Standards and Regulations" for "Homes for the Aged and Infirm", copies of which are available at the Division of Health Service Regulation at no cost;<br><br>This Rule is not met as evidenced by:<br>1. Based on observation and interview, the staff entrance door was provided with Access Controlled egress locking as allowed by Section 1008.1.4.4 of the 2012 NC State Building Code. The locking fails to comply with the Building Code.<br><br>Findings on May 9, 2018:<br>a. There was no sensor provided on the inside of | {C 101} | | |

| {C 101} | Continued From page 1<br><br>the exit to detect an occupant approaching the door to egress. | {C 101} | | |

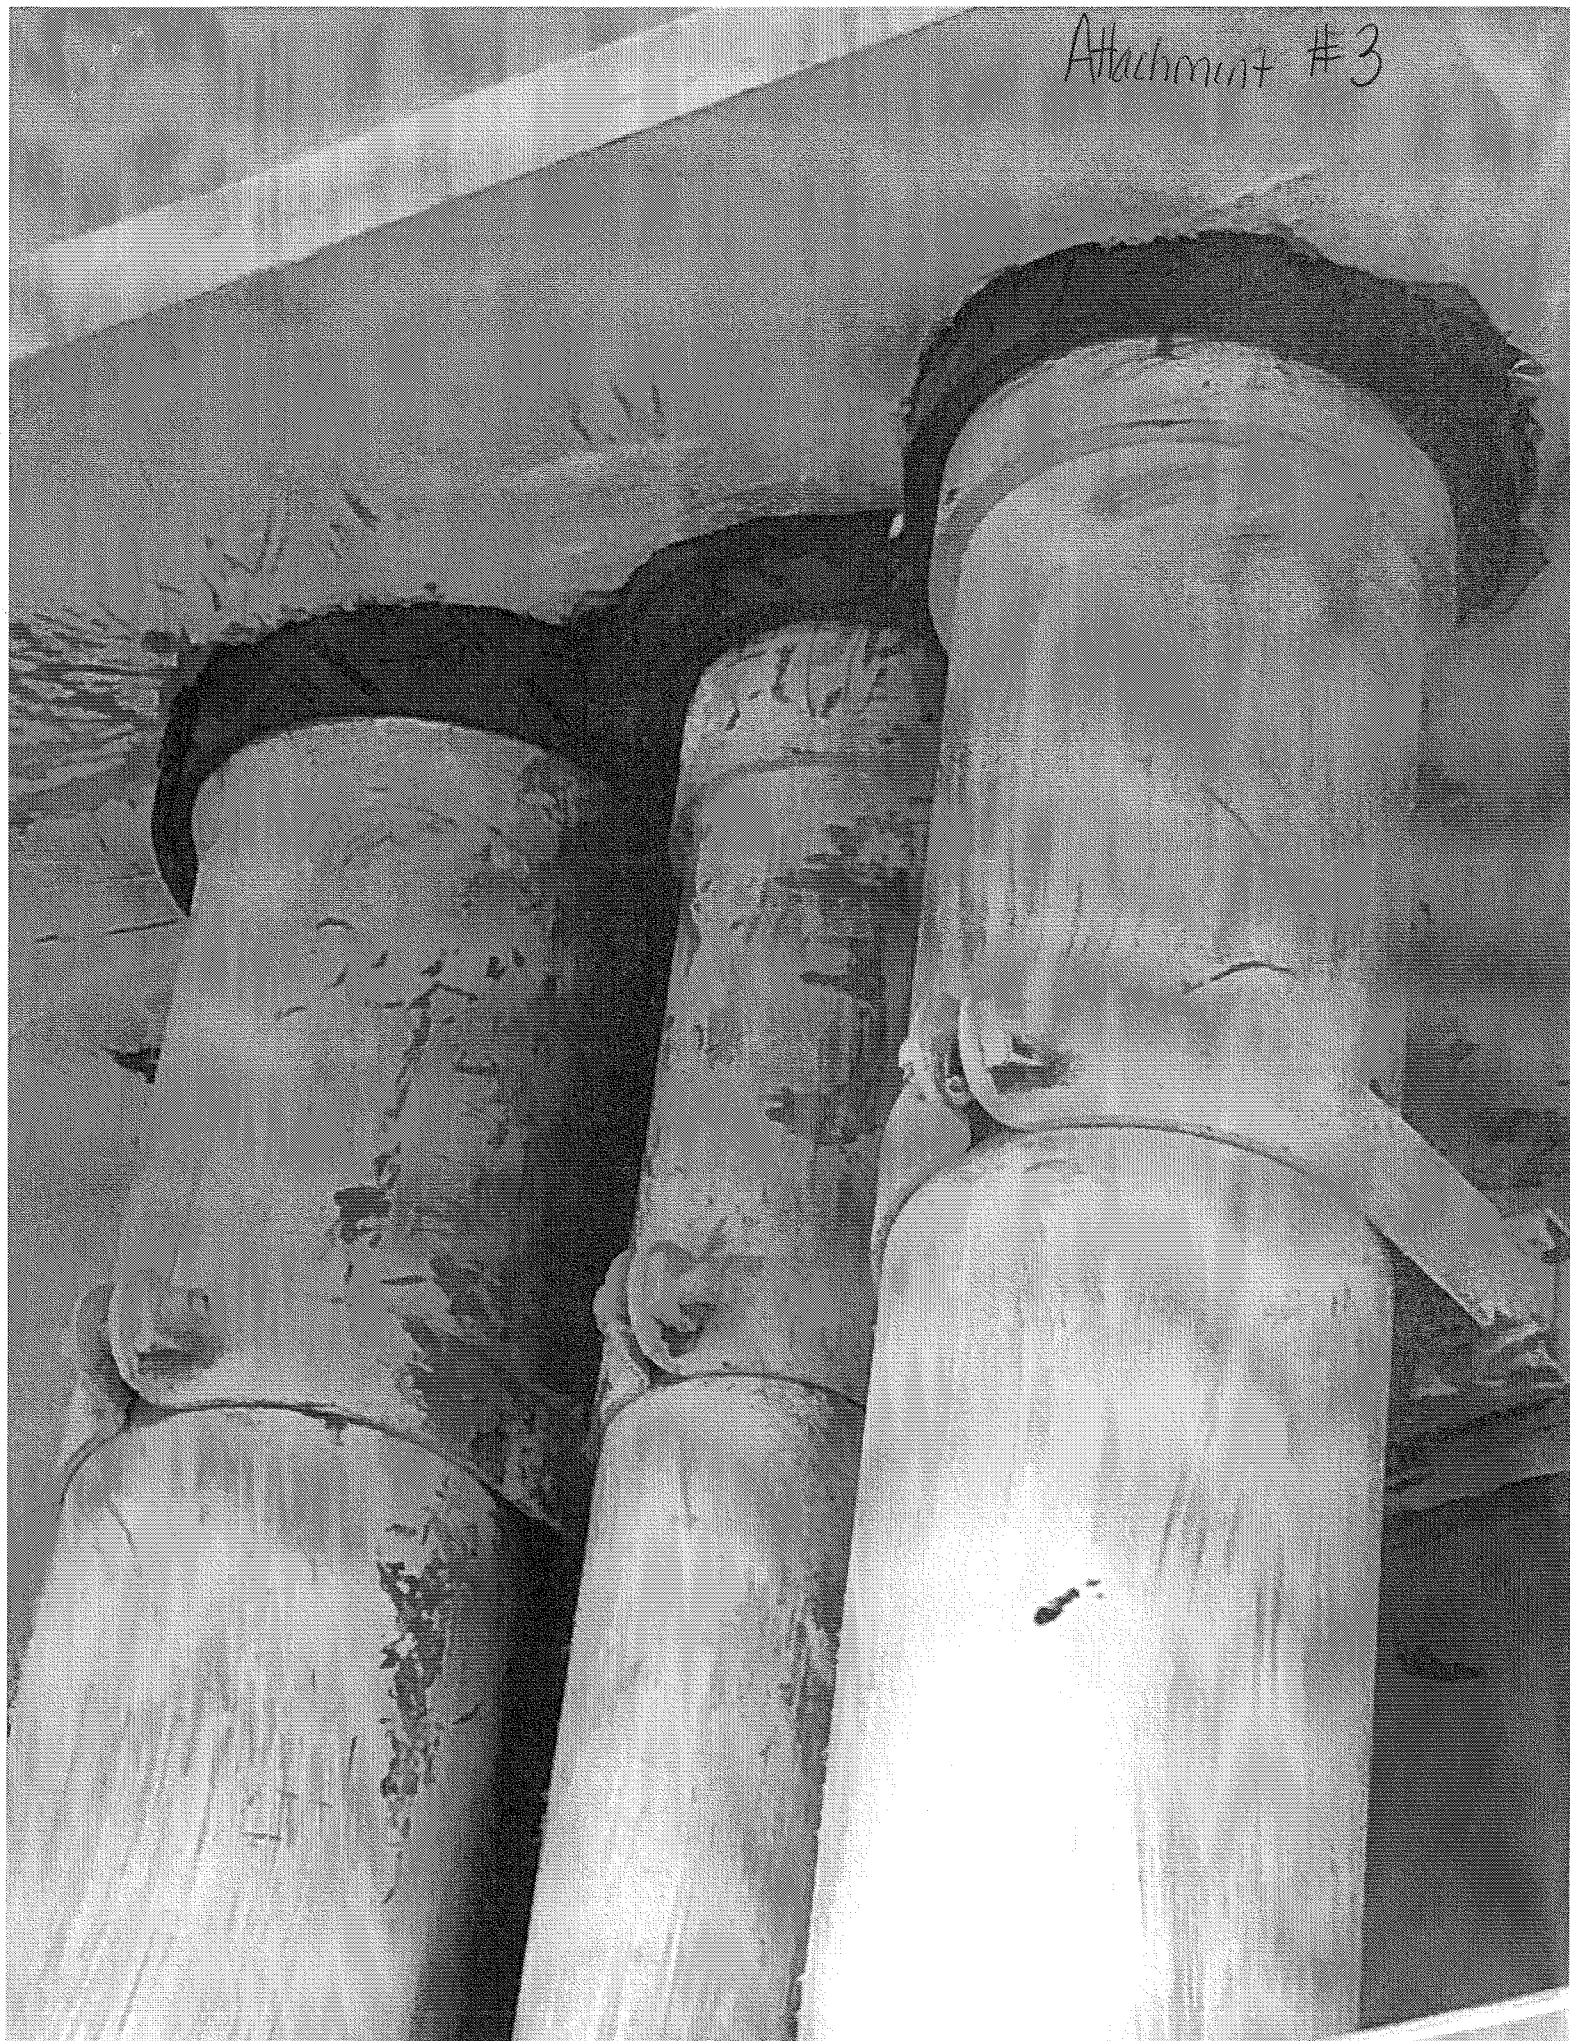
Attachment #3

| {C 189} | Building Equipment Maintained Safe, Operating<br><br>SECTION .0300 - PHYSICAL PLANT<br>10A NCAC 13F .0311 OTHER<br>REQUIREMENTS<br>(a) The building and all fire safety, electrical, mechanical, and plumbing equipment in an adult care home shall be maintained in a safe and operating condition.<br>(k) This Rule shall apply to new and existing facilities with the exception of Paragraph (e) which shall not apply to existing facilities.<br><br>This Rule is not met as evidenced by:<br>1. Based on observation and record review, the fire alarm system has an alarm verification feature enabled that delays the fire alarm activation for 30 seconds before activating the alarm. Delays in fire alarm activation could result in delays in evacuating the facility during a fire or other emergency, therefore endangering the residents.<br><br>Findings on May 9, 2018:<br>a. The corridor smoke detector near the Administrator's office was sprayed continuously for 30 seconds before it would activate the fire alarm.<br>A fire alarm vendor service record indicated the system had verification enabled.<br>There was no justification provided as to why this feature is enabled.<br><br>2. Based on observation the required one-hour fire rated ceilings may be compromised in several | {C 189} | | |

| {C 189} | Continued From page 2<br><br>locations by improperly protected conduit penetrations. Verify that the following penetrations meet Section 705.4 of the 1996 NCSBC in effect at the time of construction.<br><br>Findings on May 9, 2018:<br>a. The ceiling of the main electrical room was penetrated by 10 - 2.5 inch PVC conduits and 2 - 4 inch PVC conduits.<br>b. The ceiling of Panel PP1 closet was penetrated by 2- 2.5 inch PVC conduits.<br>c. The ceiling of Panel PP2 closet was penetrated by 2- 2.5 inch PVC conduits.<br>d. The ceiling of Panel PP3 closet was penetrated by 2- 2.5 inch PVC conduits.<br>e. The ceiling of Panel PP4 closet was penetrated by 2- 2.5 inch PVC conduits. | {C 189} | completed 6/5/18<br>attached picture of fire<br>tape installed to meet<br>requirement<br>(attachment #3) | | |
