| STATEMENT OF DEFICIENCIES AND PLAN OF CORRECTION | | (X1) PROVIDER/SUPPLIER/CLIA IDENTIFICATION NUMBER:<br><br>HAL041079 | (X2) MULTIPLE CONSTRUCTION<br>A. BUILDING 01<br><br>B. WING _____ | | (X3) DATE SURVEY COMPLETED<br><br>09/27/2018 |
| NAME OF PROVIDER OR SUPPLIER<br><br>VERRA SPRINGS AT HERITAGE GREENS | | | STREET ADDRESS, CITY, STATE, ZIP CODE<br>803 MEADOWOOD STREET<br>GREENSBORO, NC 27409 | | |
| C 000 | Initial Comments<br><br>Report of a Construction Section Biennial Survey by Suzanna Fay conducted on September 27, 2018.<br><br>Records indicate this facility was first licensed as a Home for the Aged on August 1, 1994. The facility is currently licensed for Forty-Five (45) Beds. Based on this information, we are requiring the facility to meet the 1993 Homes for the Aged and Disabled - Minimum Standards and Regulations, the applicable portions of the 2005 Rules for Adult Care Homes of Seven or More Beds, and the 1991 Edition of the North Carolina State Building Code, with 1993 Revision Section 409.1, Institutional Occupancy Group<br><br>Deficiencies were cited that require a Plan of Correction. | C 000 | | | |

This letter concerns today's Structural inspection of the

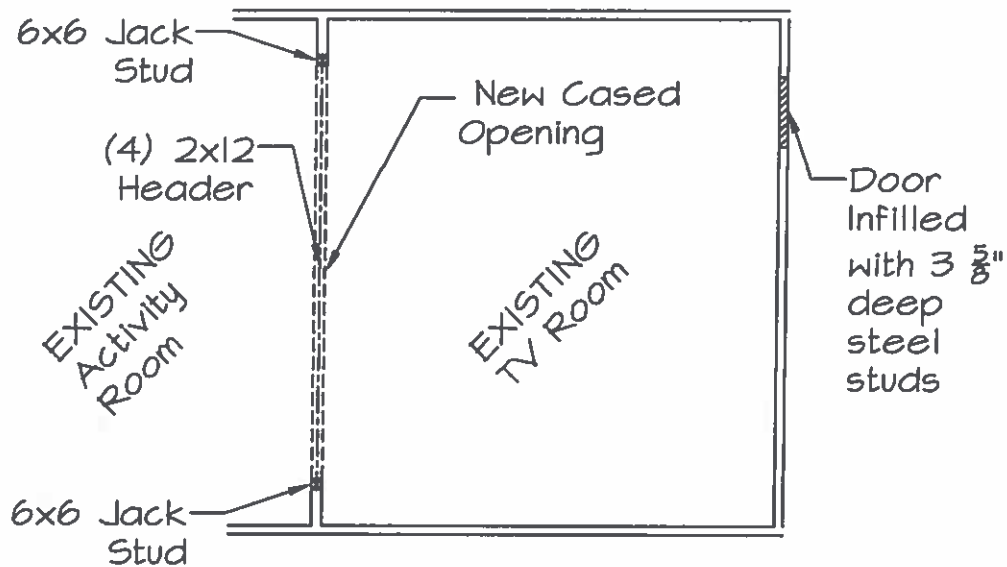
① Approximate TV Room Wall Modification Layout  
 SK1 SCALE: 1/8"=1'-0"

Please find the attached sketch, SK1, illustrating the recent wall modifications made.

There was a new wall opening installed at the common wall between the TV room and the Activity room. The wall opening was about 18 feet wide and was constructed with a (4) 2x12 header and 6x6 wood jack studs. Because the pre-engineered roof trusses run parallel with the wall, the new header and jack studs were found to be supporting only about a 4'-8" high bulkhead wall above the new header beam.

We have found that the new header beam and jack studs to be structurally adequate to support the bulkhead wall. We would not recommend any additional structural modifications for the new wall opening, as the structural integrity of the building has been maintained with the addition of the new wall opening.

There was a walk door infilled at the Right wall of the TV room. The wall opening was infilled with 3 5/8" deep steel studs to match the existing wall framing.

We have found that the steel studs and to be structurally adequate, as they are infilling a non-load bearing. We would not recommend any additional modifications for the infilled wall.
