Division of Health Service Regulation

| STATEMENT OF DEFICIENCIES AND PLAN OF CORRECTION | (X1) PROVIDER/SUPPLIER/CLIA IDENTIFICATION NUMBER:<br><br>FCL082028 | (X2) MULTIPLE CONSTRUCTION<br>A. BUILDING: 01<br><br>B. WING: _____ | (X3) DATE SURVEY COMPLETED<br><br>01/10/2018 |
| NAME OF PROVIDER OR SUPPLIER<br><br>SERENITY FAMILY CARE HOME # 3 | | STREET ADDRESS, CITY, STATE, ZIP CODE<br>100 W MAGNOLIA / LISHON ROAD<br>ROSE HILL, NC 28458 | |

Report by Wendy Chester

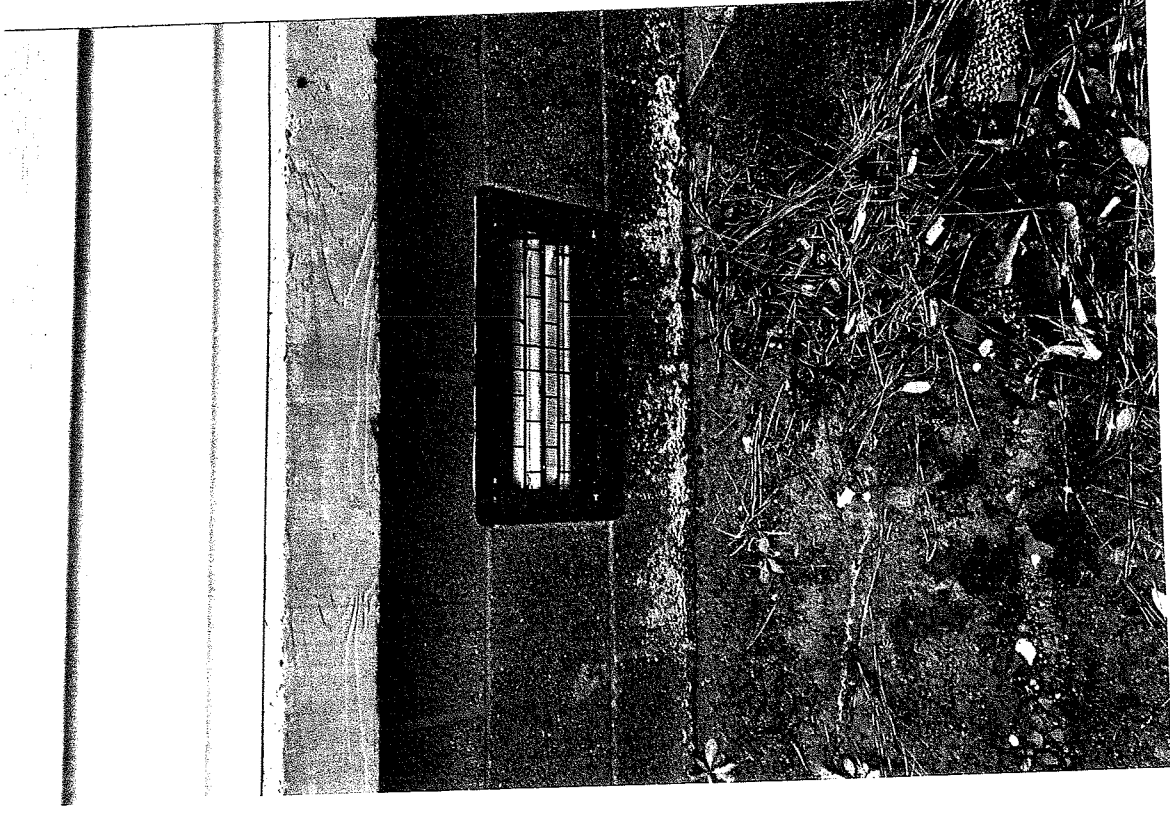
At the time of the survey it was found that the Laundry Room had lint on the walls and floor behind and around the dryer.

Lint is flammable and poses a fire hazard. It is unclean and unattractive.

Floor Cleaned  
Behind Washer  
Laundry Room

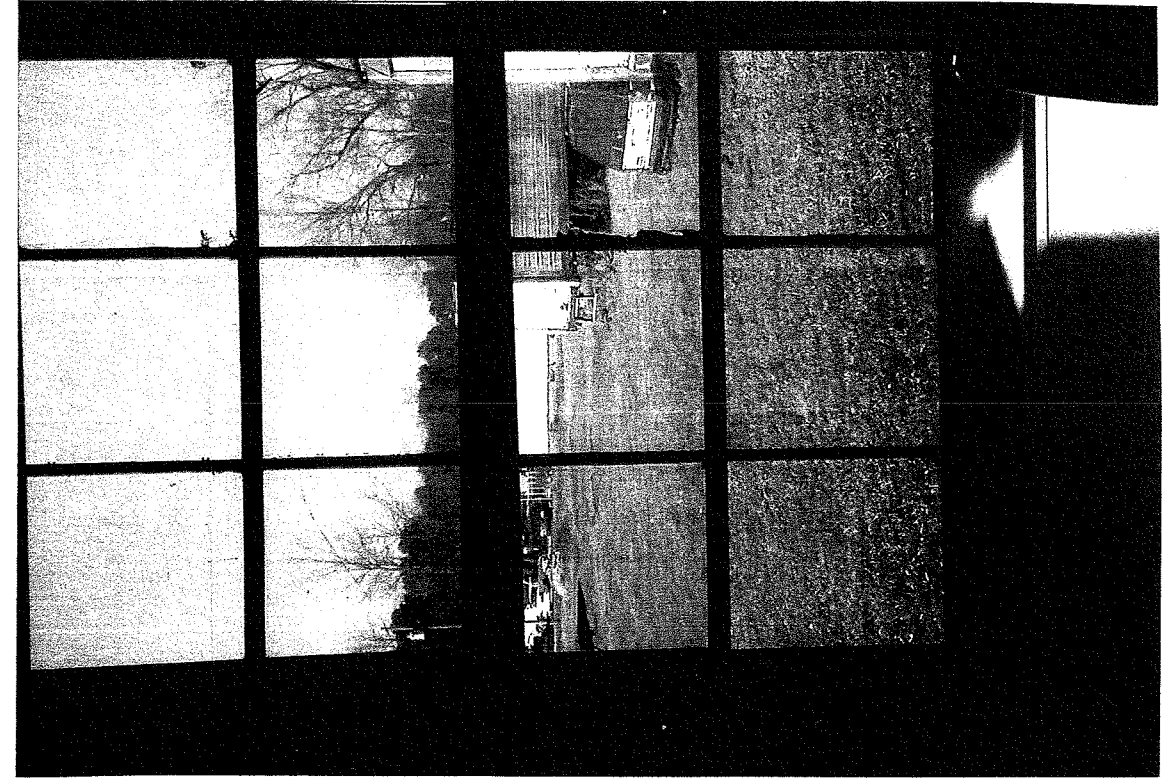
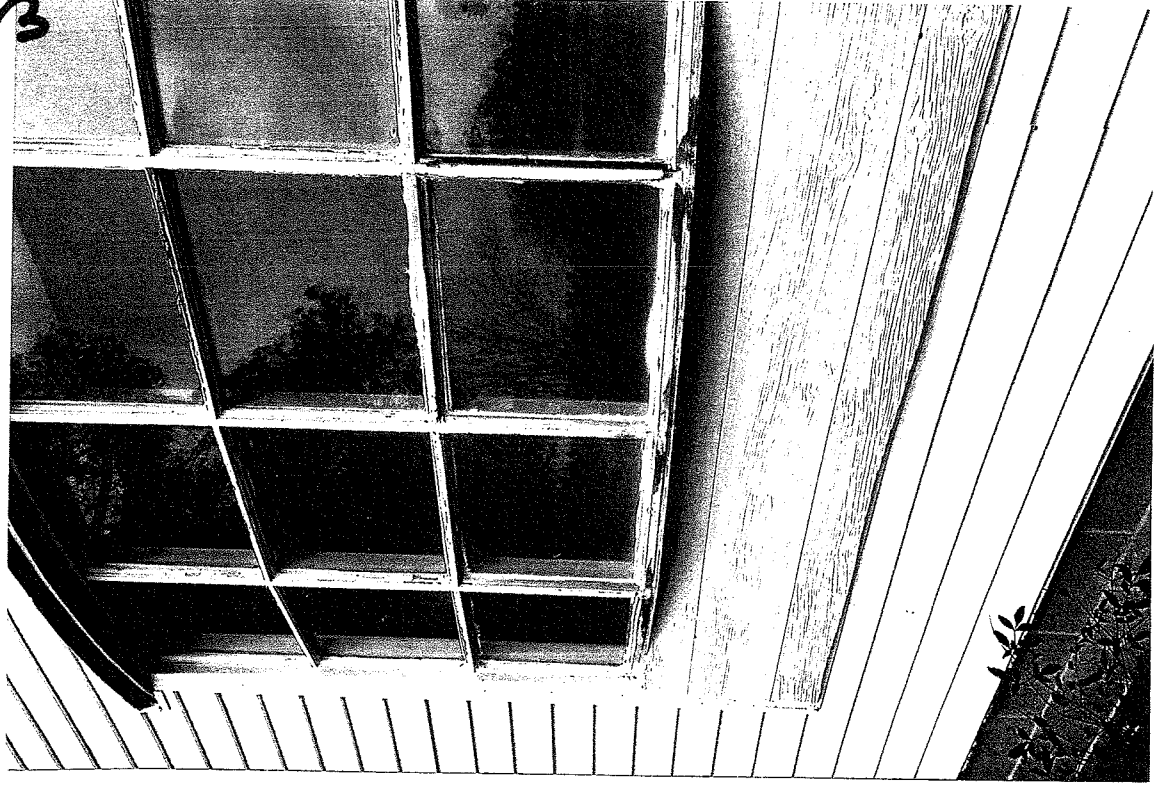
At the time of the survey it was observed that the window in Resident Bedroom # 4 would open but would not stay in an open position without human intervention.

Windows are a secondary means of emergency egress. If the window does not stay open on its own it can impede immediate exit in the time of an emergency which poses a life safety hazard.

# Windows Repaired

will paint  
when  
weather  
permitted

All  
strips  
replaced
