Division of Health Service Regulation

| STATEMENT OF DEFICIENCIES AND PLAN OF CORRECTION | | (X1) PROVIDER/SUPPLIER/CLIA IDENTIFICATION NUMBER:<br><br><b>HAL013006</b> | (X2) MULTIPLE CONSTRUCTION<br>A. BUILDING: <b>01</b><br><br>B. WING: _____ | | (X3) DATE SURVEY COMPLETED<br><br><b>08/21/2019</b> |
| NAME OF PROVIDER OR SUPPLIER<br><br><b>ST ANDREWS LIVING CENTER</b> | | STREET ADDRESS, CITY, STATE, ZIP CODE<br><b>246 CABARRUS WEST<br/>CONCORD, NC 28025</b> | | | |

Statement of Deficiencies  
And Plan of Correction

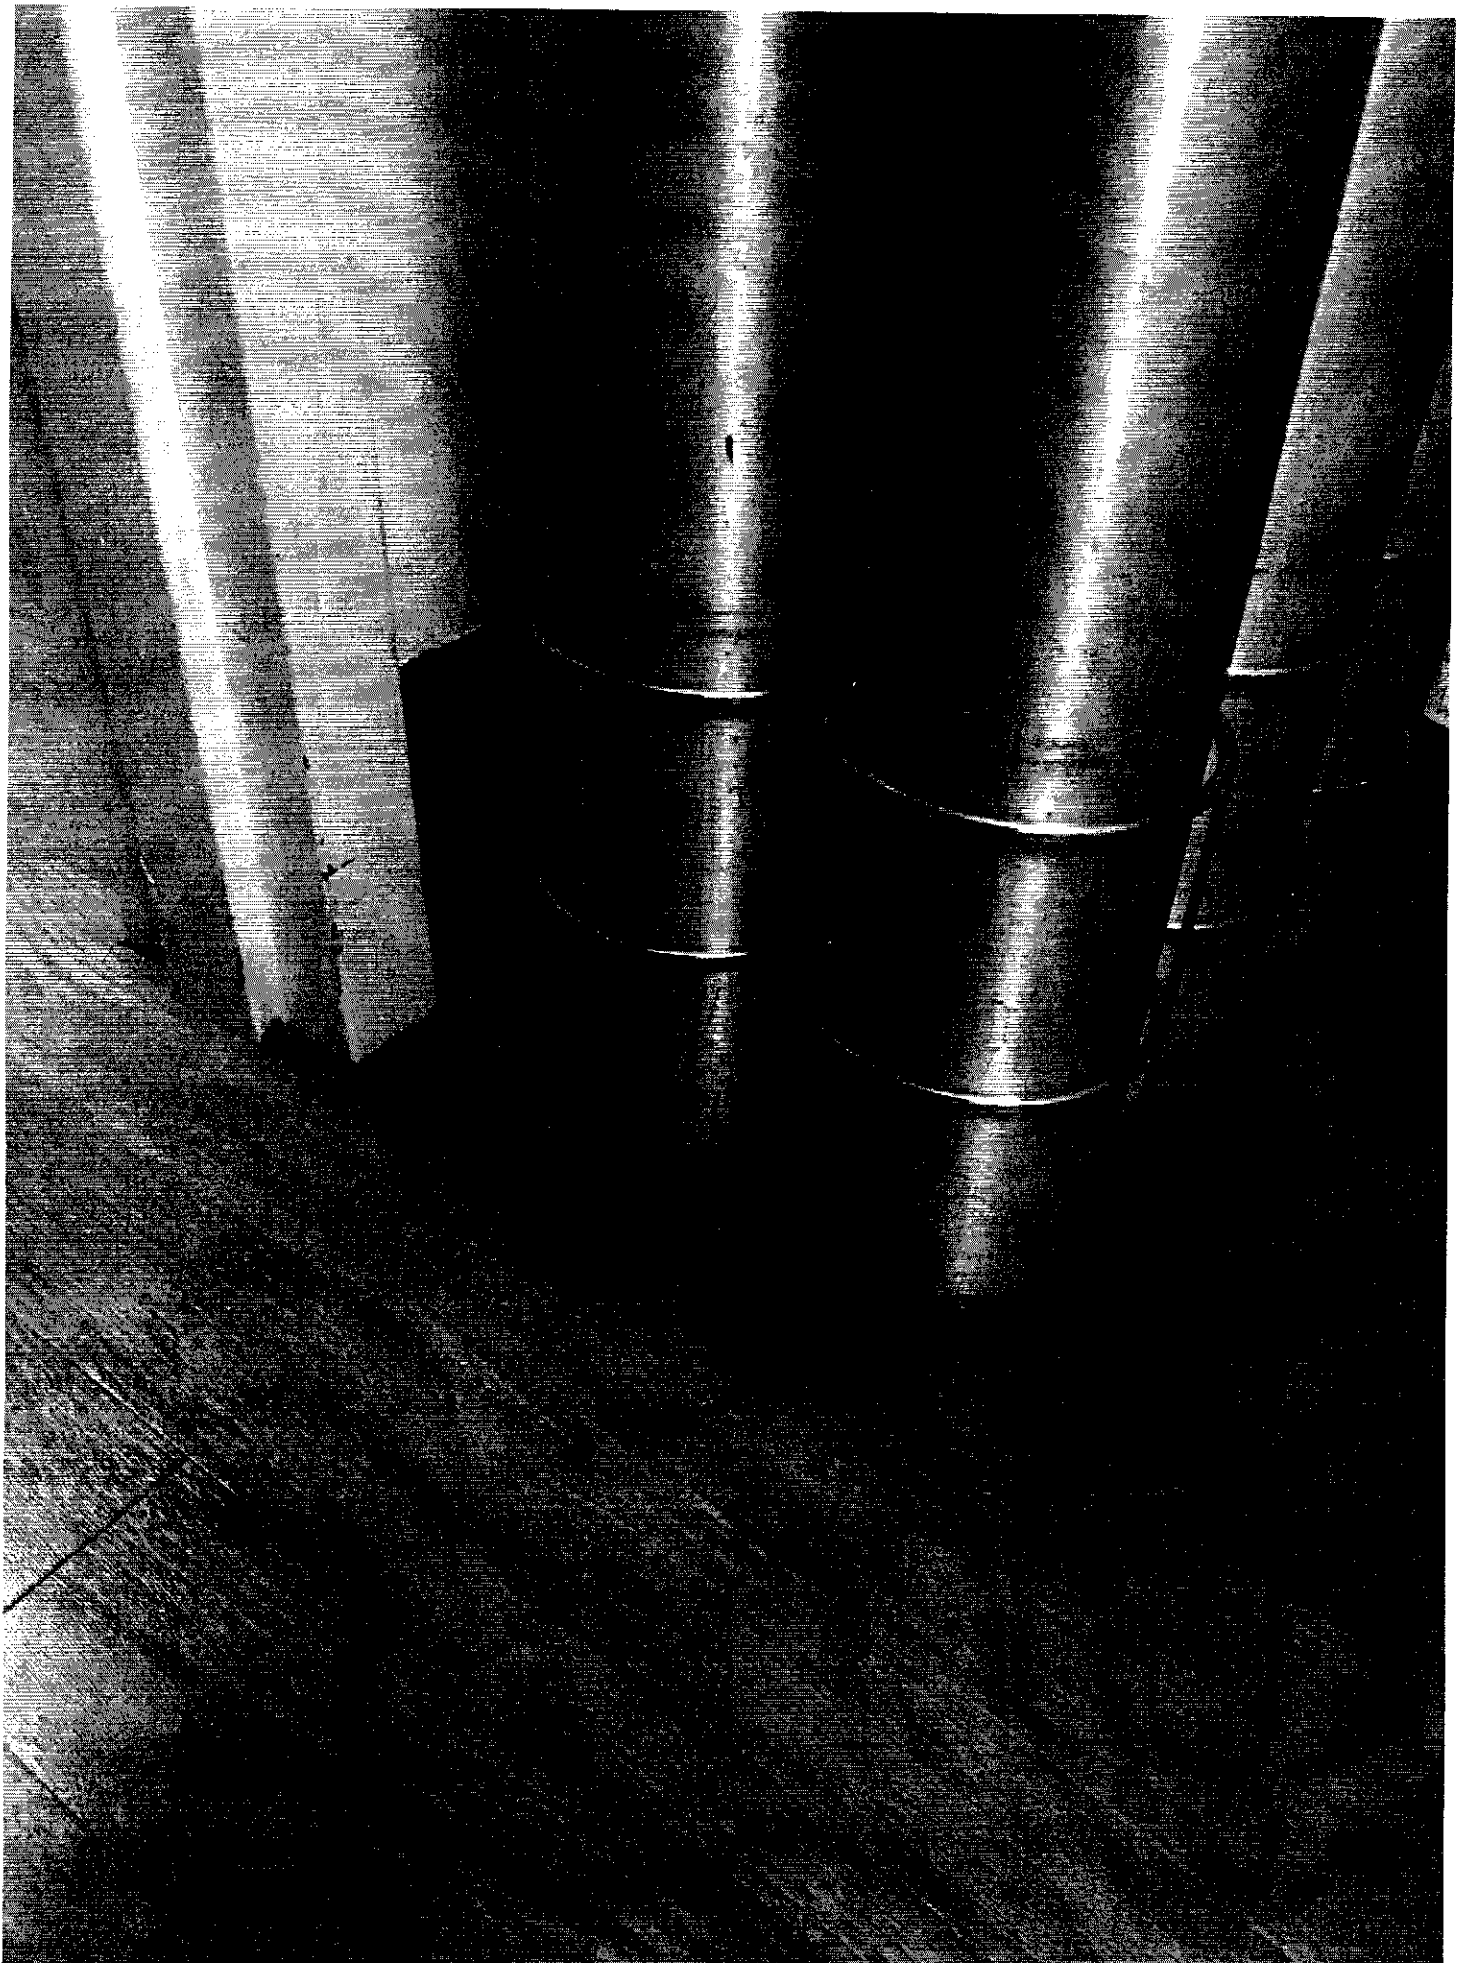
C-161 STAFF BATH ROOM

| (X4) ID<br>PREFIX<br>TAG | SUMMARY STATEMENT OF DEFICIENCIES<br>(EACH DEFICIENCY MUST BE PRECEDED BY FULL<br>REGULATORY OR LSC IDENTIFYING INFORMATION) | ID<br>PREFIX<br>TAG | PROVIDER'S PLAN OF CORRECTION<br>(EACH CORRECTIVE ACTION SHOULD BE<br>CROSS-REFERENCED TO THE APPROPRIATE<br>DEFICIENCY) | (X5)<br>COMPLETE<br>DATE |
|---|---|---|---|---|
| C 166 | Continued From page 3<br><br>fall, breaking their valves, propelling the cylinder, and turning it into a dangerous projectile.<br>Findings on August 21, 2019:<br>a. Staff Bathroom - seven portable medical oxygen cylinders are standing up on the floor in an unapproved plastic beverage crate not physically secured in racks, stands or chained to the structure.<br>b. Bedroom 108 - four portable medical oxygen cylinders are standing up on the floor in an unapproved plastic beverage crate not physically secured in racks, stands or chained to the structure.<br>c. Diaper Room near Bedroom 112 - five portable medical oxygen cylinders are standing up on the floor in an unapproved plastic beverage crate not physically secured in racks, stands or chained to the structure. | C 166 | | |

| ID<br>PREFIX<br>TAG | POC | Complete<br>Date |
|---|---|---|
| C166 | On 8/22/19 the Oxygen provider was notified to supply approved metal containers for oxygen storage inside our facility. Oxygen provider brought in metal containers as requested, | 8/26/19 |
| | Staff Bathroom- Photo Attached<br>Bedroom 108- Photo Attached<br>Diaper Room- Cylinders were removed by the Oxygen Supplier. | |

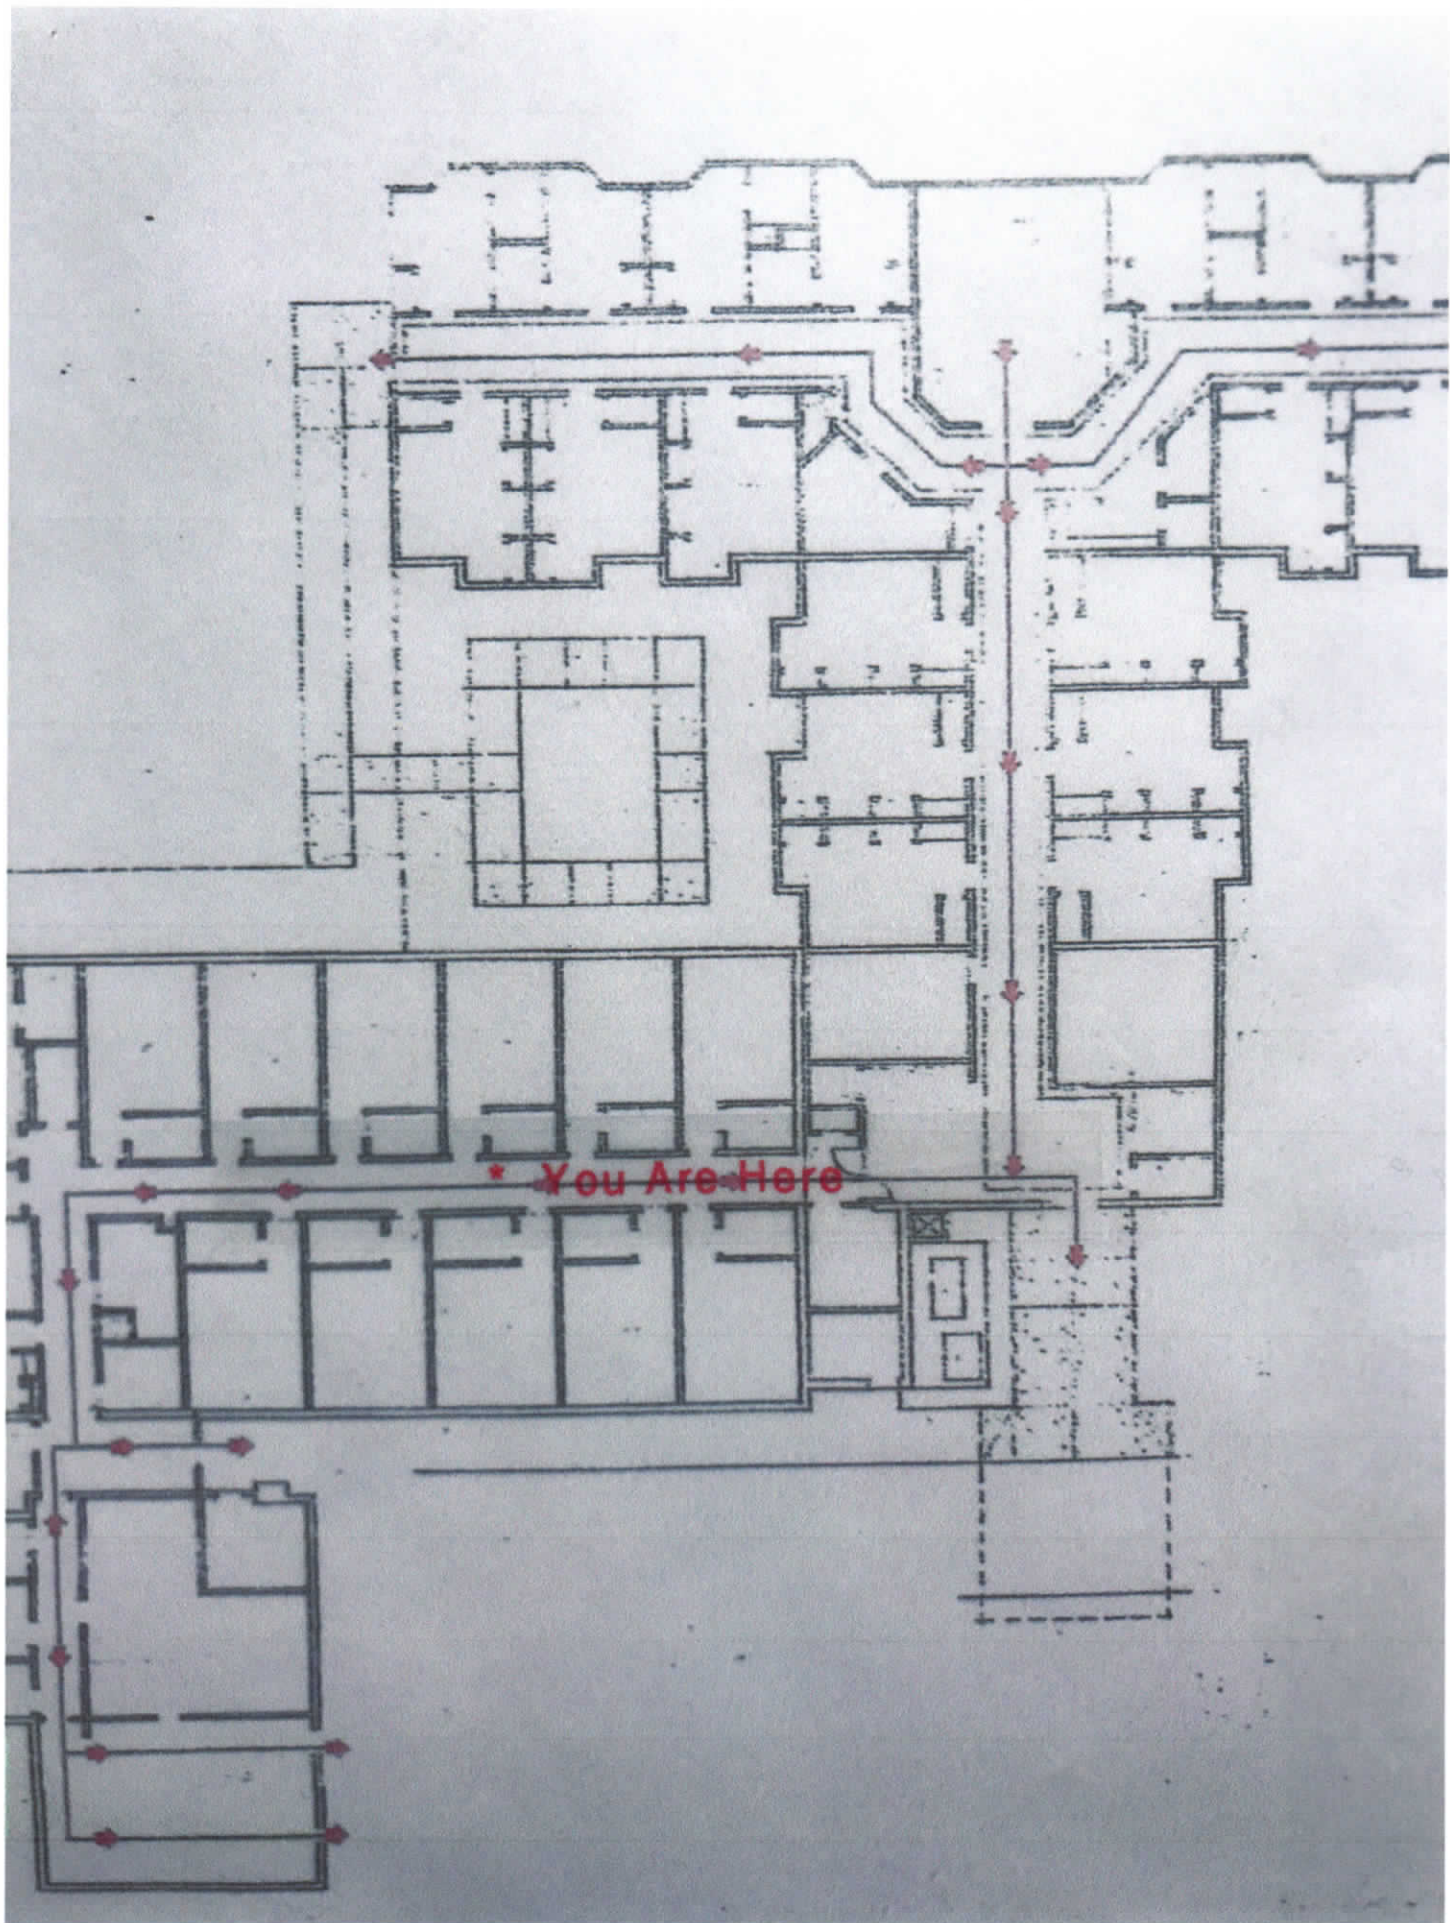
C 184 CORRIDOR NEAR ROOM 107

| C 184 | Continued From page 4<br><br>guidance during an emergency.<br>Findings on August 21, 2019:<br>a. Corridor near Bedroom 107 - the mounted<br>evacuation map does not identified the viewer's<br>location. ("You Are Here"). | C 184 | | |

| ID<br>PREFIX<br>TAG | POC | Complete<br>Date |
|---|---|---|
| C184 | An identifier of " You are Here" added to the evacuation map outside room 107. Going Forward, identifier "You are Here" was added to the other evacuation maps throughout the facility. Photo Attached | 9/5/19 |

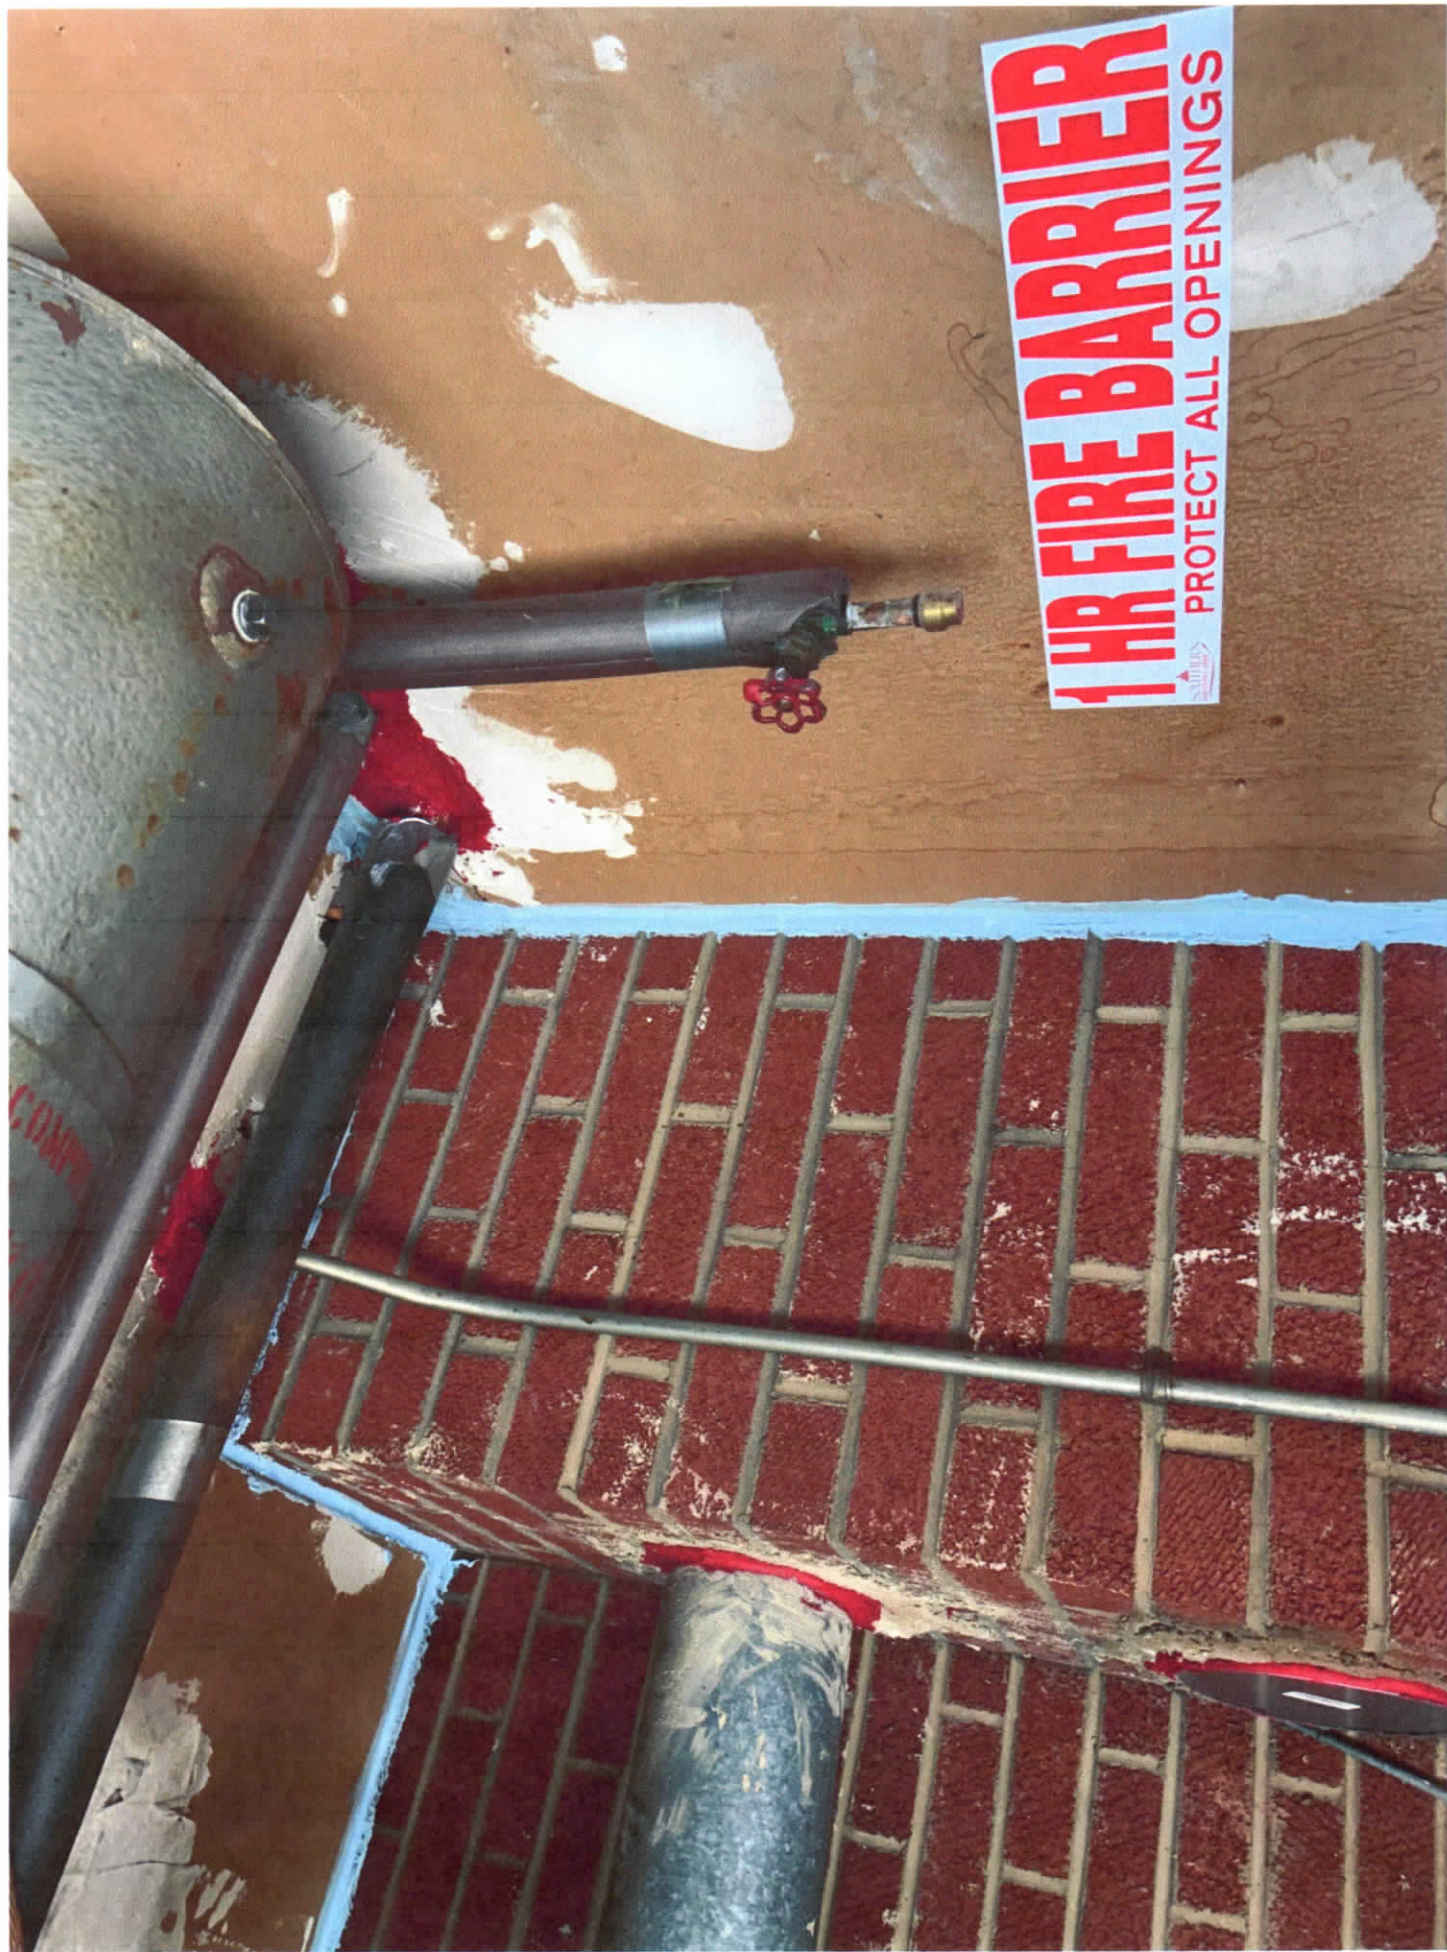
#3 F. + H.

| C 189 | <p>Continued From page 6</p> <p>3. Based on observations, the Building fire safety was not maintained in a safe and operating condition. This could expose all to fire/smoke if not contained in room of origin.<br/>Findings on August 21, 2019:</p> <p>a. RCC Office (behind drapes and room)- there are several holes with conduit not firestopped as they penetrate the fire-resistance-rated ceiling assembly.</p> <p>b. Front Lobby Housekeeping - there is a PVC conduit not firestopped as it penetrates the fire-resistance-rated ceiling assembly.</p> <p>c. Med Room - there is an EMT conduit not firestopped as it penetrates the fire-resistance-rated ceiling assembly.</p> <p>d. Mechanical Room near Kitchen - there are multiple holes, pipes, and cables not firestopped as they penetrate the fire-resistance-rated ceiling assembly.</p> <p>e. Riser Room - there are two holes not firestopped as they penetrate the fire-resistance-rated ceiling assembly.</p> <p>f. Front Entrance Exterior Mechanical Room - there many holes, gaps around pipes and cables not firestopped as they penetrate the fire-resistance-rated ceiling assembly.</p> <p>g. Front Entrance Exterior Mechanical Room - the attic access panel is missing, permitting a large penetration of the fire-resistance-rated ceiling assembly.</p> <p>h. Front Entrance Exterior - there are multiple penetration sealed with orange foam. This orange foam is not approved for penetrations through fire-resistance-rated construction.</p> <p>i. Refrigerator Room - a new refrigerator was built into this room and fills-up the room. There is no means to inspect the rated ceiling above the acoustical ceiling tile and the corridor door is a siding barn style that is not smoke tight.</p> | C 189 | | | |

- d. Mechanical Room near Kitchen-Will treat all Penetrations, 16-20th
  - e. Riser Room- Will treat all Penetrations, 9-13th
  - f. Front Entrance Exterior Mechanical Room- Treated all Penetrations, Photos Attached. 9/6/19

- g. Front Entrance Exterior Mechanical Room-Will Patch access Panel Hole. Week of Sept. 23-27th
  - h. Front Entrance Exterior Mechanical Room-Removed Orange Foam and Treated all Penetrations. Photo Attached 9/6/19
