Division of Health Service Regulation

| STATEMENT OF DEFICIENCIES AND PLAN OF CORRECTION | | (X1) PROVIDER/SUPPLIER/CLIA IDENTIFICATION NUMBER:<br><br><b>FCL092153</b> | (X2) MULTIPLE CONSTRUCTION<br>A. BUILDING: <b>01</b><br><br>B. WING: _____ | (X3) DATE SURVEY COMPLETED<br><br><b>08/28/2019</b> |
| NAME OF PROVIDER OR SUPPLIER<br><br><b>THE MANOR AT EDGEWATER</b> | | STREET ADDRESS, CITY, STATE, ZIP CODE<br><b>1038 STORMY LANE<br/>RALEIGH, NC 27610</b> | | |
| C 000 | Initial Comments<br><br>Report by David Hickman<br><br>DHSR Construction Section conducted a Biennial Survey on August 28, 2019 from 10:10 AM to 11:30 AM at the above referenced facility. DHSR records indicate the home was first licensed on August 14, 2009 as a Family Care Home for six ambulatory Residents (able to evacuate and respond without any physical or verbal assistance during a fire or other emergency.) Based on this information we are requiring the home to maintain compliance with the following: the 2005 Rules 10A NCAC 13G for Family Care Homes and the 2006 North Carolina State Building Code - Section 421.2 - Residential Care Homes.<br><br>1. At the time of our visit, we cited deficiencies that require an

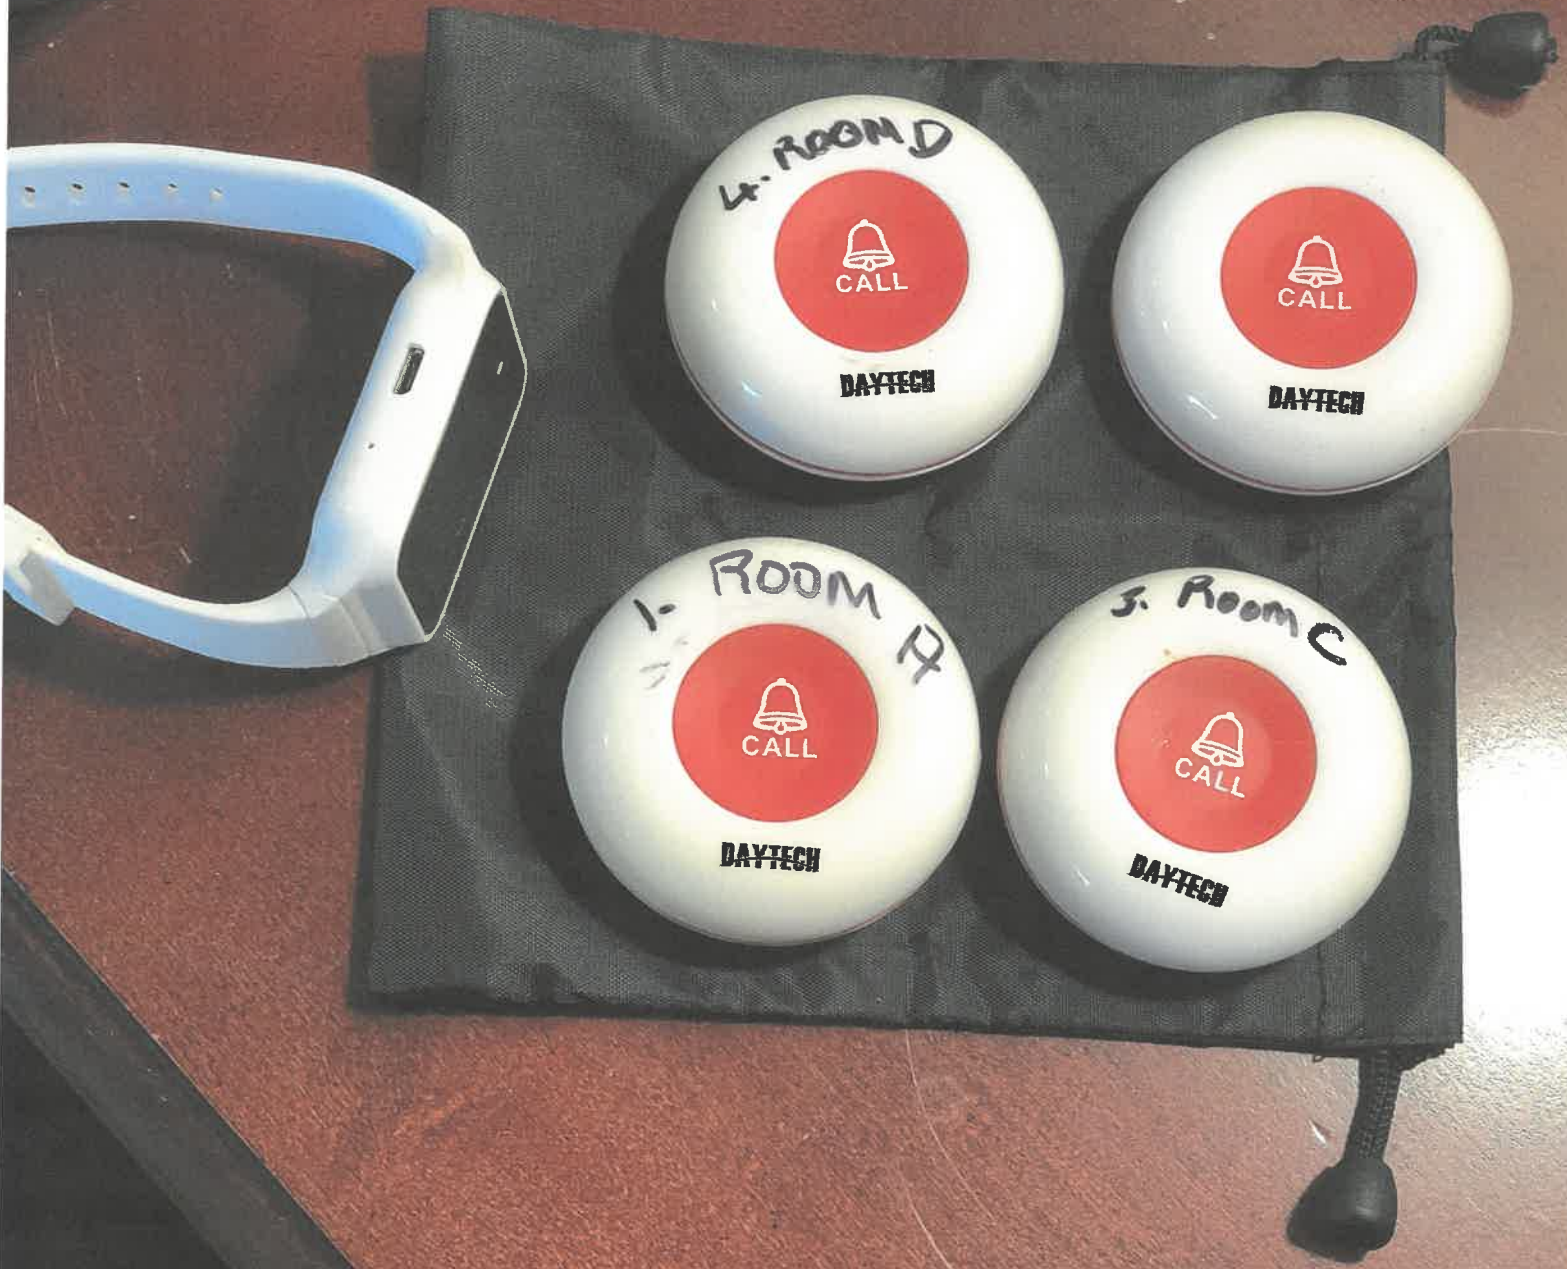
This Rule is not met as evidenced by:  
1. At the time of the survey it was observed that there was no call system available for the residents to alert the sleeping staff. This is not compliant with the rule. Take the necessary steps to install a call system to alert the staff.

⑬ 180. Facility has purchased a call system for each room in the facility and has made it available to all residents to alert staff whenever staff is needed and wherever in facility staff is at. Facility will ensure that call system remain in place at all times.
