| STATEMENT OF DEFICIENCIES<br>AND PLAN OF CORRECTION | (X1) PROVIDER/SUPPLIER/CLIA<br>IDENTIFICATION NUMBER:<br><br><b>FCL030002</b> | (X2) MULTIPLE CONSTRUCTION<br>A. BUILDING: <b>01</b><br><br>B. WING: _____ | (X3) DATE SURVEY<br>COMPLETED<br><br><b>03/14/2024</b> |

**MAGNOLIA PLACE**

**270 DUKE STREET  
MOCKSVILLE, NC 27028**

Report by Kelly Myers

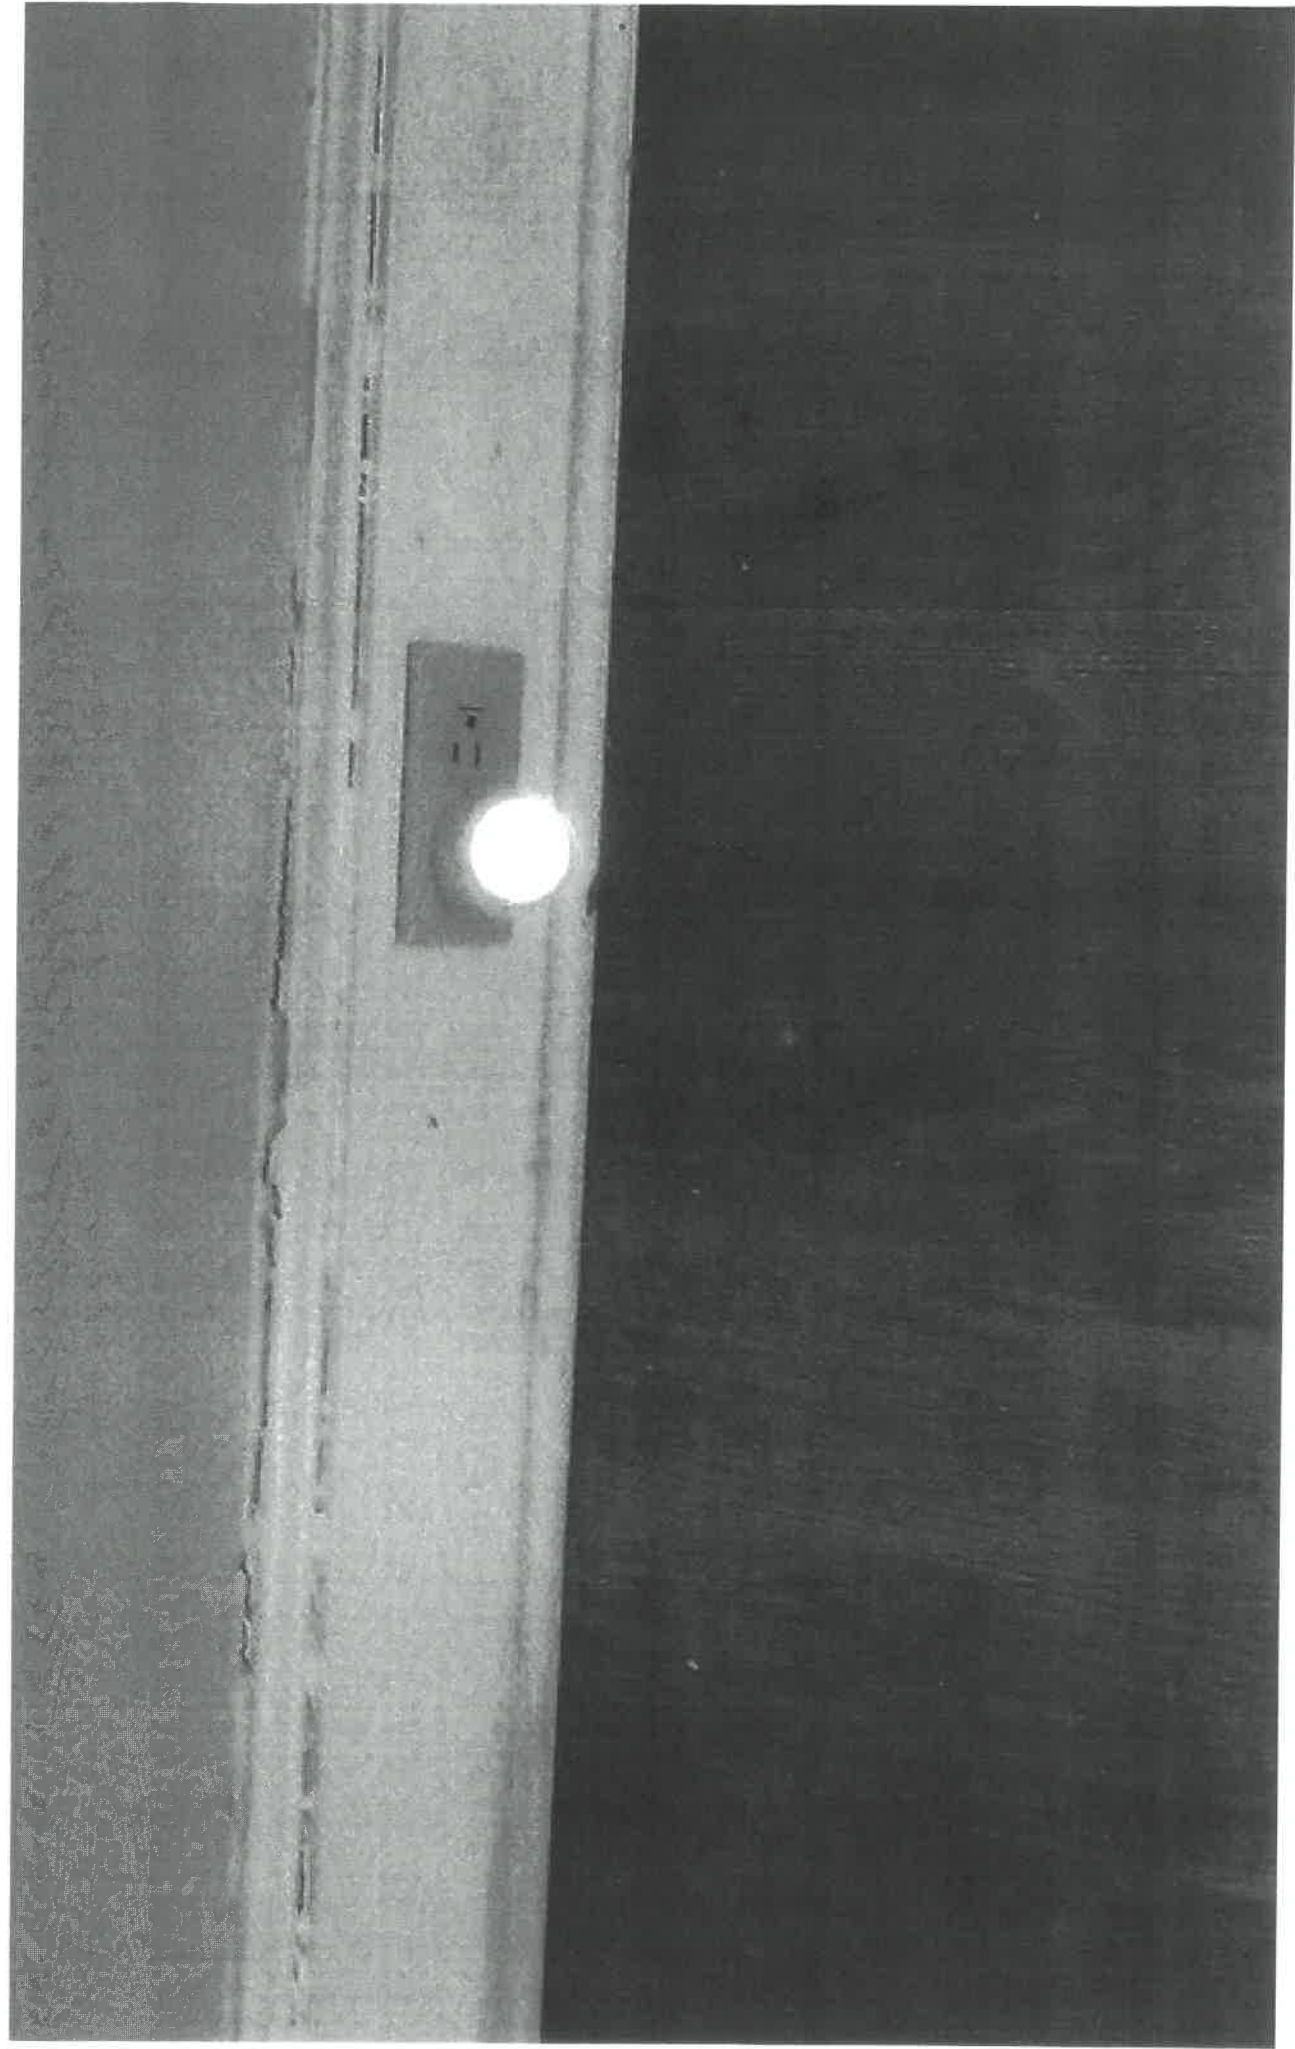
EXHIBIT A

| C 142 | Corridor-Night Lights<br><br>SECTION .0300 - THE BUILDING<br>10A NCAC 13G .0311 CORRIDOR<br>(b) Corridors shall be lighted with night lights providing 1 foot-candle power at the floor.<br><br>This Rule is not met as evidenced by:<br>1. At the time of the survey it was observed that there was only one night light between bedroom number five and bedroom #3. There was not a night light in the hallway between the living room and the kitchen. This is not compliant with the rule. Take the necessary steps to ensure that all hallways have night lights that illuminate at nighttime. | C 142 | 10ANCAC 13G .0311<br>Nightlights have been installed:<br><br><i>EXHIBIT A</i> | 3/15/24 |

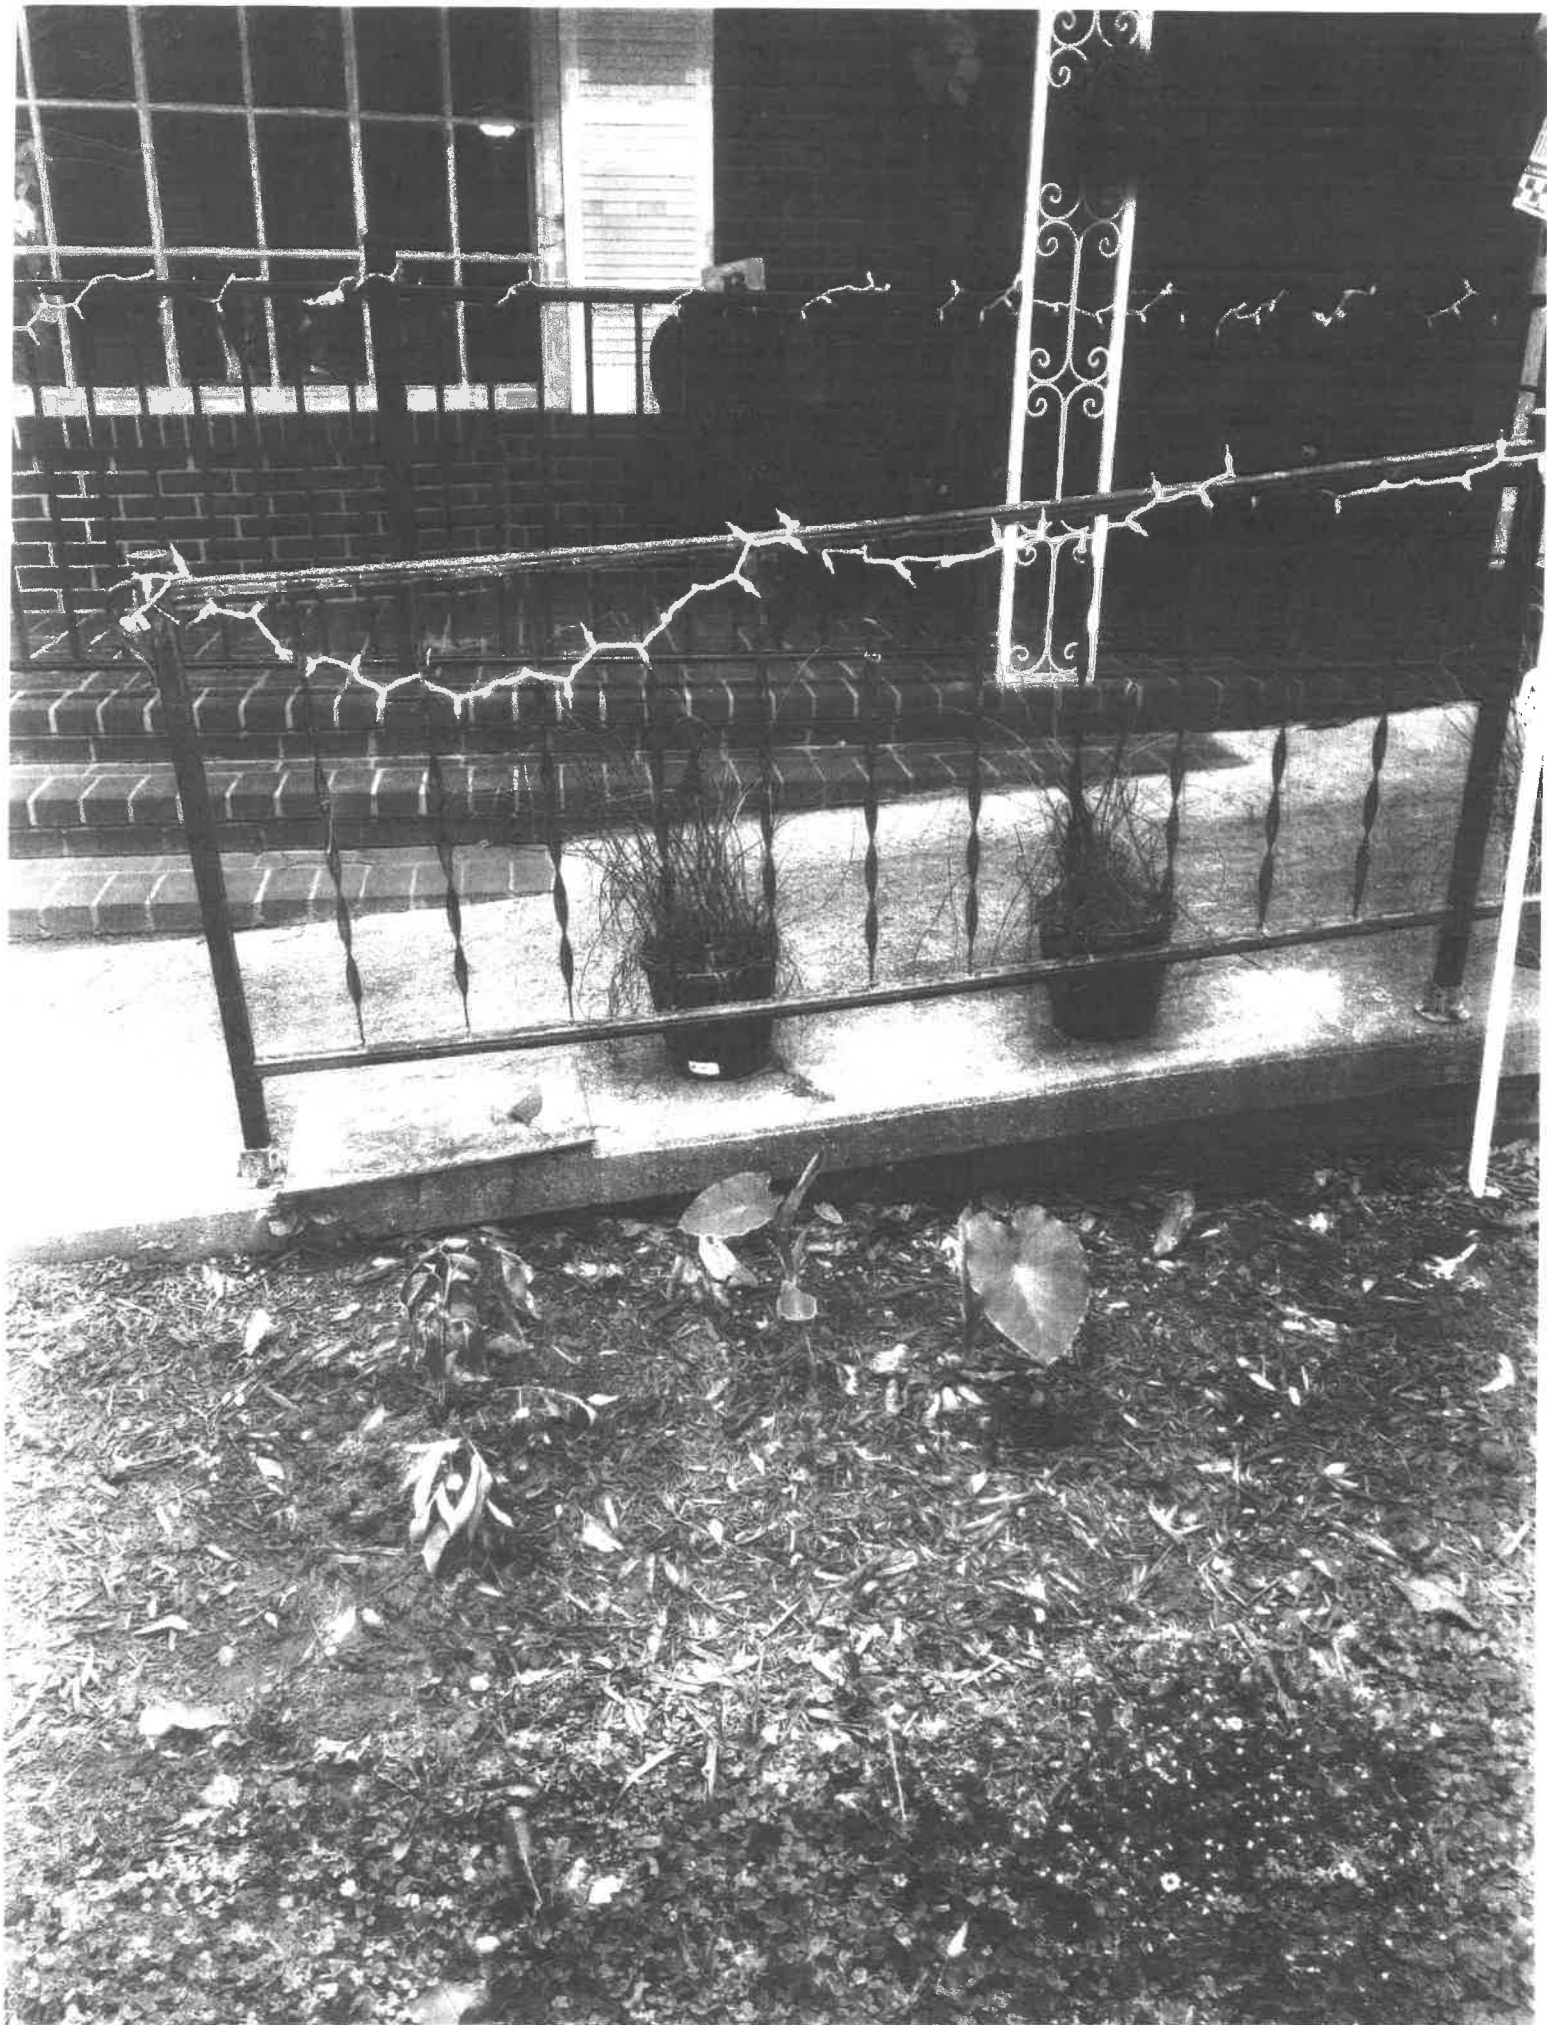
EXHIBIT B1

| C 149 | Continued From page 2<br><br>porch side. This is not compliant with the rule.<br>Take the necessary steps to add a handrail.<br>* This deficiency was previously cited during<br>our March 16, 2022 Biennial Survey, and March<br>22, 2023 Biennial Follow-up survey, take action to<br>correct this deficiency.<br><br>2. At the time of the survey it was observed that<br>there was not a handrail or grab bar at the<br>transition ramp located at the back door. This is<br>not compliant with the rule. Take the necessary<br>steps to install a grab bar or handrail on the latch<br>side of the storm door. | C 149 | 10A NCAC 13G 0312<br>The front porch has a handrail on<br>The porch side. It has always had a<br>Handrail on the porch side ever since<br>The home was opened in 1995.<br>We do not know why surveyor sited<br>This rule. Please explain?<br><br><i>Exhibit B-1+2</i> | |

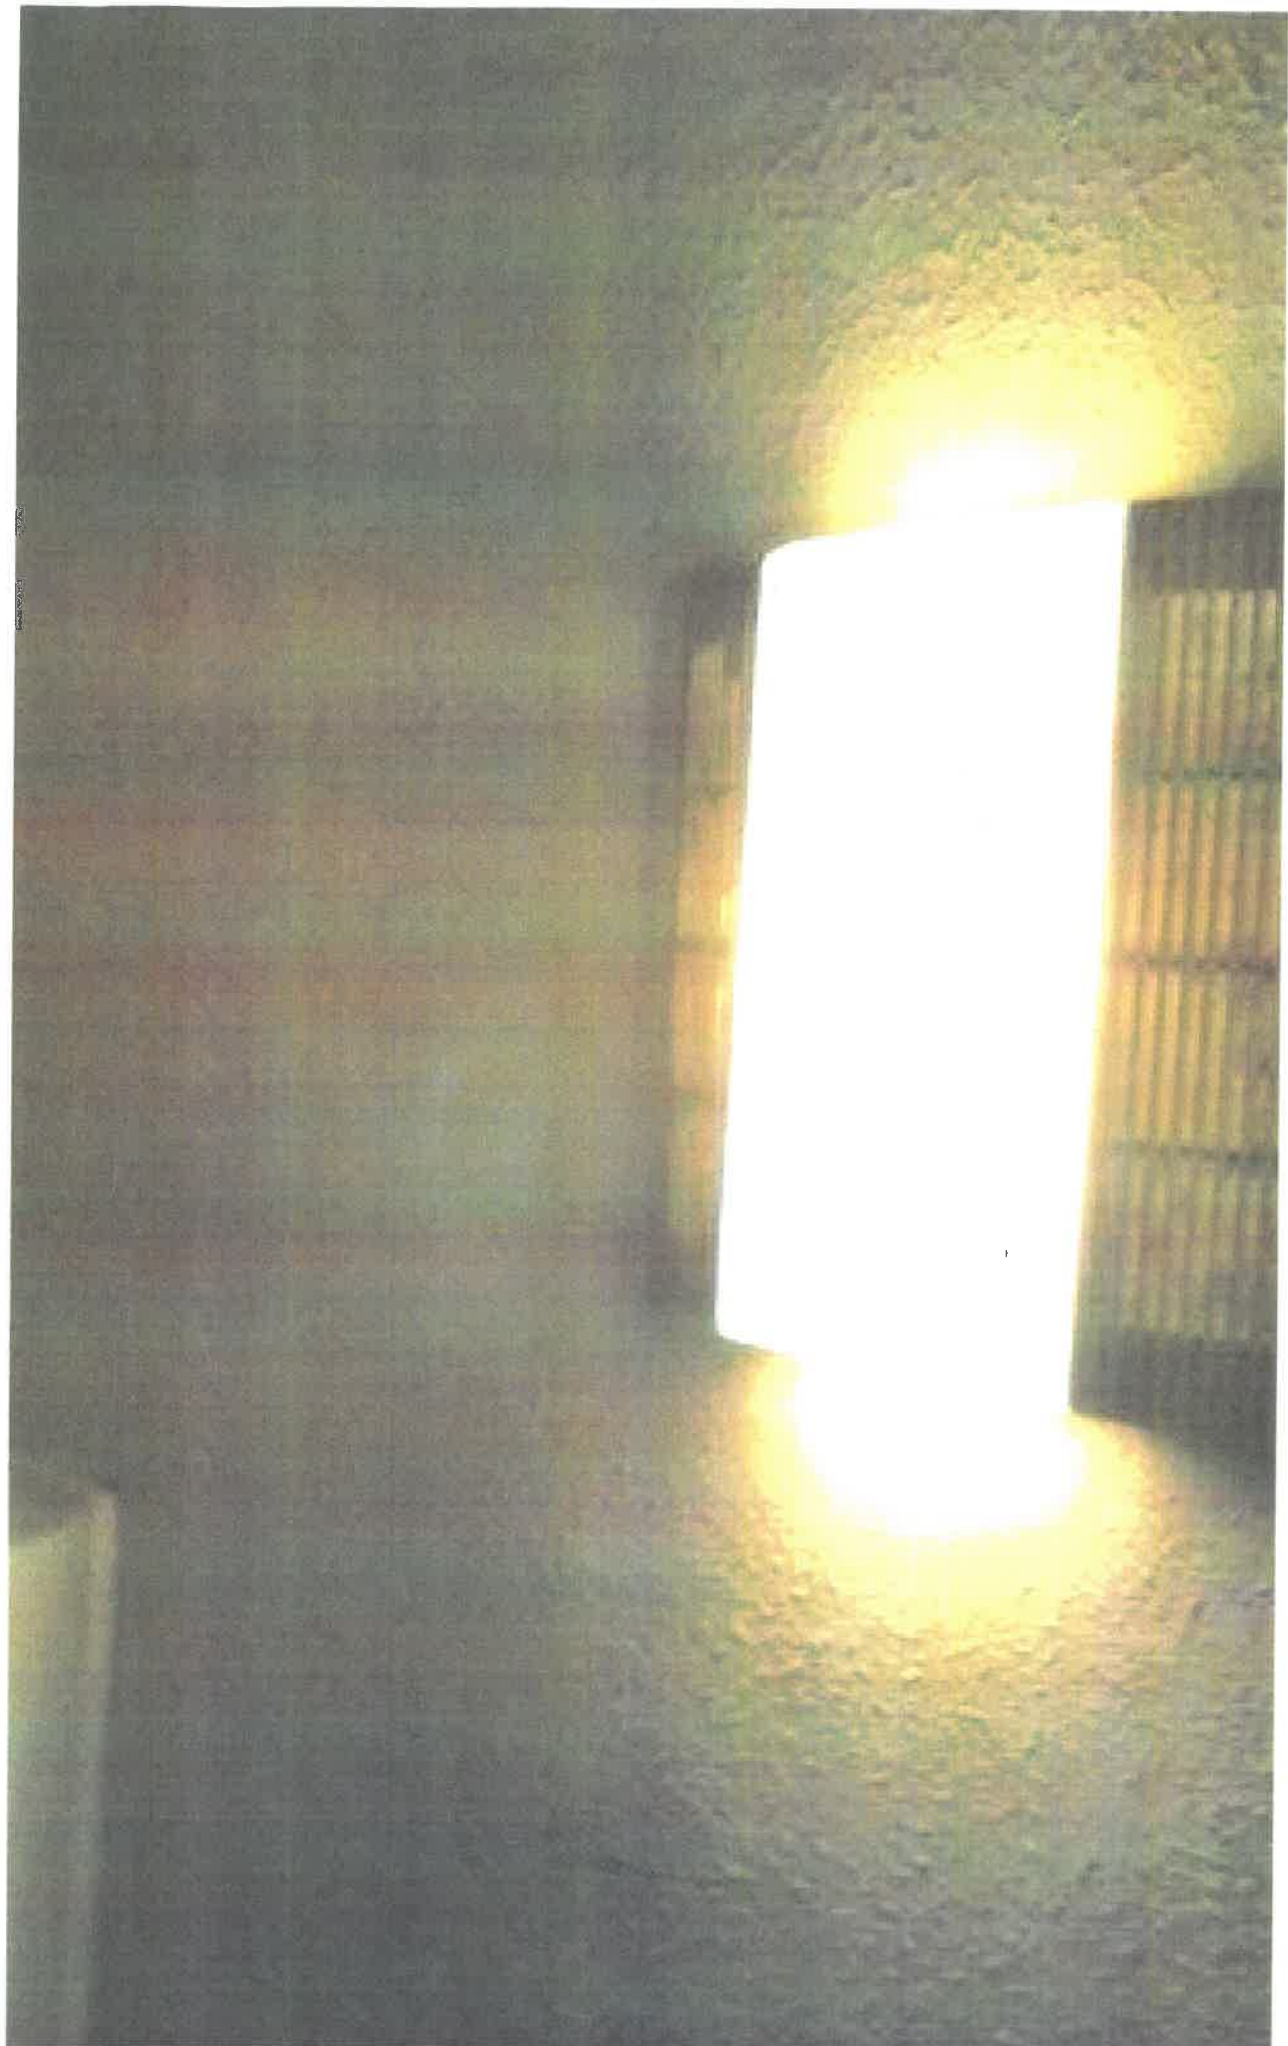
8-11-18 F-8

| | 8. At the time of the survey it was observed that there were multiple areas of peeling paint at doors and door trim. This is not compliant with the rule. Take the necessary steps to repair the peeling paint. | | | | |

| | | | 8. Doors and trim has been repainted<br><i>EXHIBIT F-8</i> | 4/22/24 | |

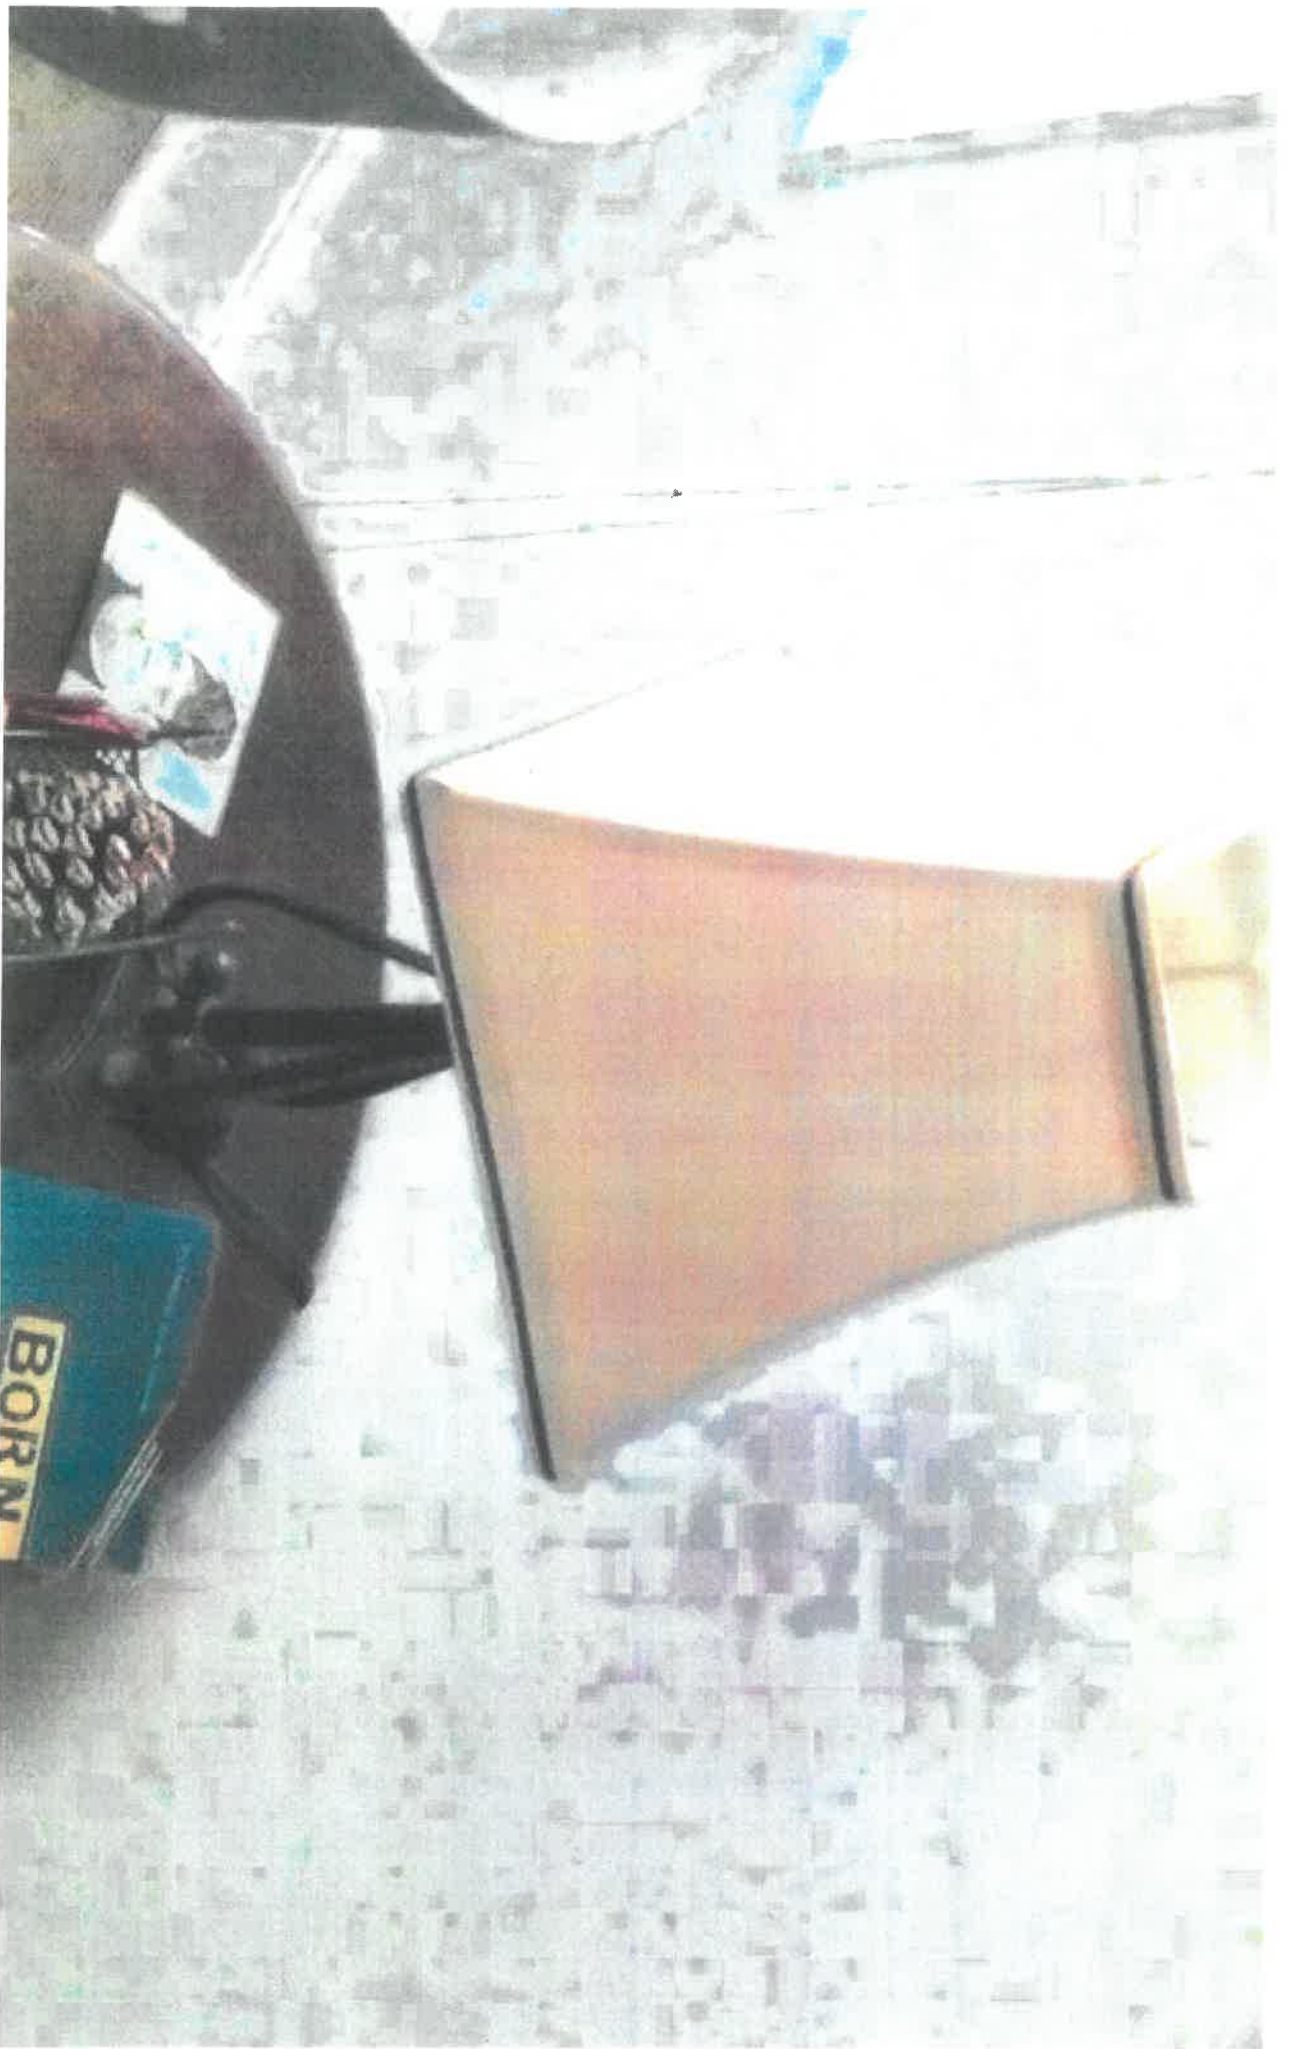
EXHIBIT F-9

| | 9. At the time of the survey it was observed that there was peeling paint on the corridor wall between bedroom number five and bedroom #3. This is not compliant with the rule. Take the necessary steps to repair the peeling paint. | | | | |

| | | | 9. Peeling paint has been repainted<br><i>EXHIBIT F-9</i> | 4/22/24 | |
