| STATEMENT OF DEFICIENCIES<br>AND PLAN OF CORRECTION | (X1) PROVIDER/SUPPLIER/CLIA<br>IDENTIFICATION NUMBER:<br><br><b>HAL019020</b> | (X2) MULTIPLE CONSTRUCTION<br>A. BUILDING: <b>01</b><br><br>B. WING: _____ | (X3) DATE SURVEY<br>COMPLETED<br><br><b>01/08/2025</b> |

**CAROLINA MEADOWS FAIRWAYS**

| (X4) ID<br>PREFIX<br>TAG | SUMMARY STATEMENT OF DEFICIENCIES<br>(EACH DEFICIENCY MUST BE PRECEDED BY FULL<br>REGULATORY OR LSC IDENTIFYING INFORMATION) | ID<br>PREFIX<br>TAG | PROVIDER'S PLAN OF CORRECTION<br>(EACH CORRECTIVE ACTION SHOULD BE<br>CROSS-REFERENCED TO THE APPROPRIATE<br>DEFICIENCY) | (X5)<br>COMPLETE<br>DATE |
|---|---|---|---|---|
| C 111 | <p>Must Have Current San. &amp; Fire Safety Reports</p> <p>SECTION .0300 - PHYSICAL PLANT<br/>10A NCAC 13F .0302 DESIGN AND CONSTRUCTION(<br/>f) The facility shall have current sanitation and fire and building safety inspection reports which shall be maintained in the home and available for review.</p> <p>This Rule is not met as evidenced by:<br/>1. Based on an interview with the Executive Director and Maintenance Director, the facility failed to maintain in the facility, current (completed within the last twelve months) sanitation

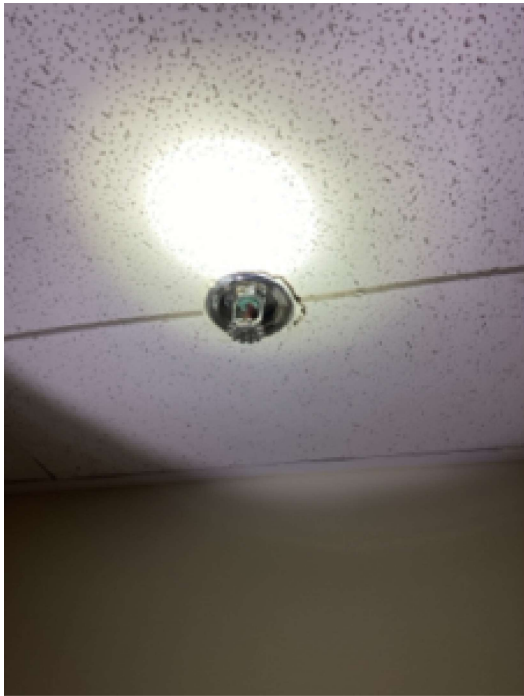
### Deficiency #2 - Photo #1

**Are visible sprinklers free of corrosion and physical damage?:** No

Notes: Material  
(1) 1/2" vk 1021 SR 155° chrome  
Corroded pendent  
(1) 107

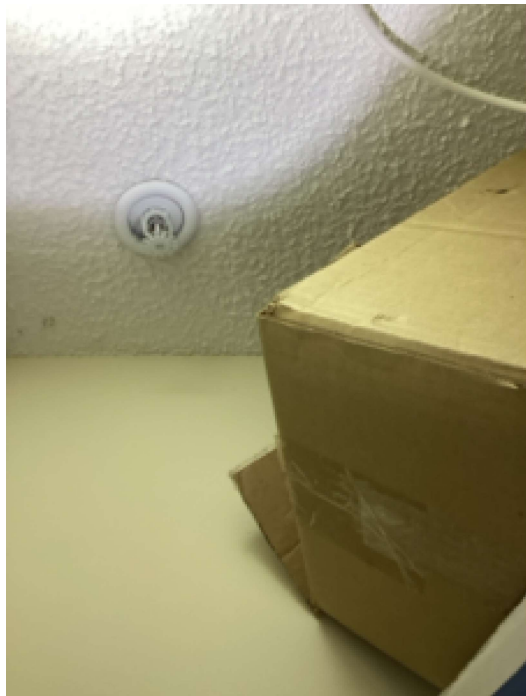
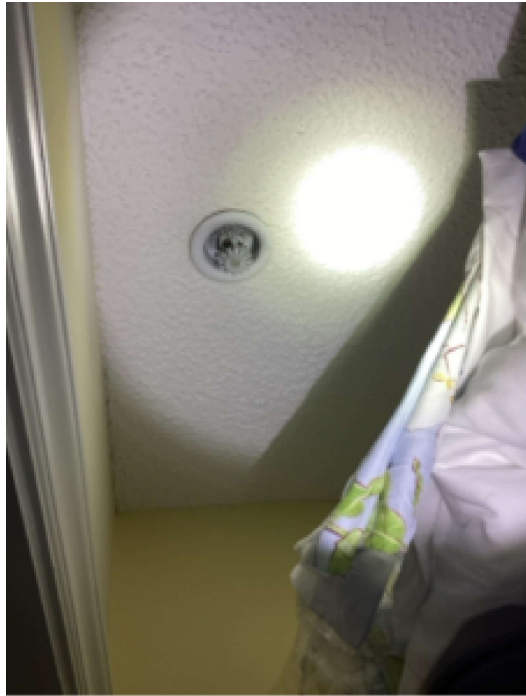
Painted  
(2) hall closet rm 109 & bed closet

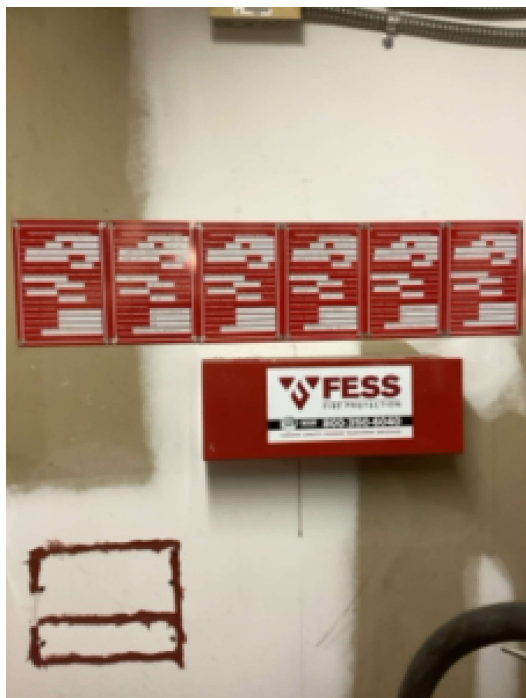
### Deficiency #1 - Photo #1

Notes: Data plates faded. Can not read description or data

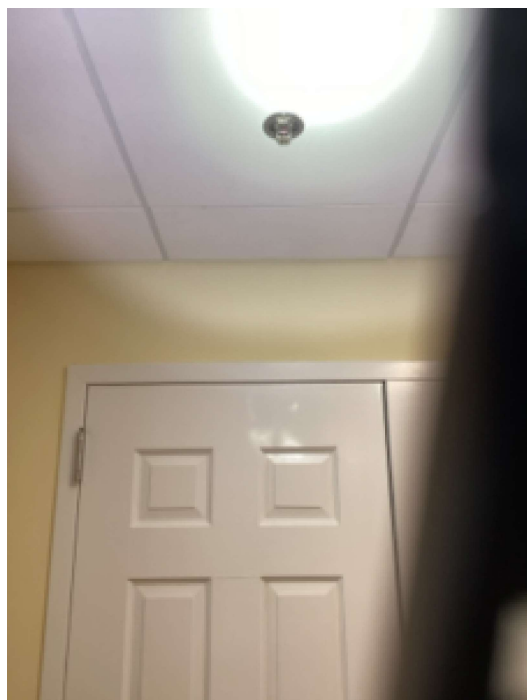
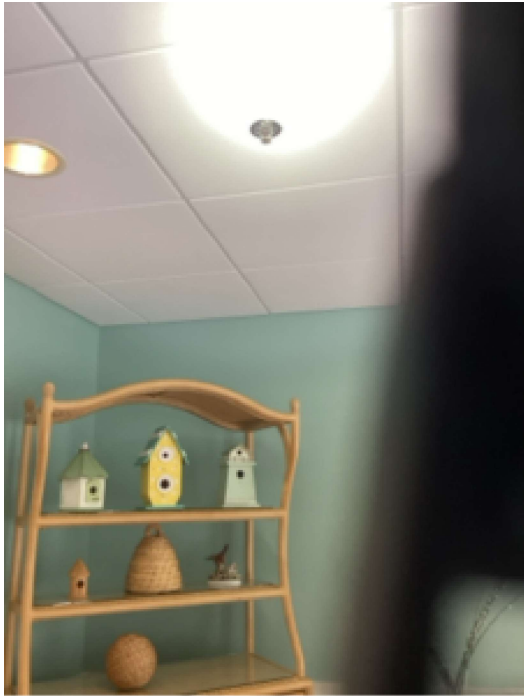
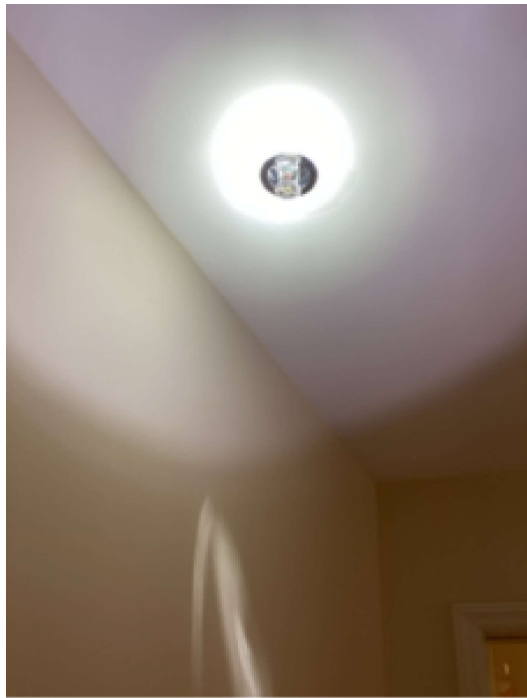
**Are visible sprinklers free of corrosion and physical damage?:** No

Corrosion  
1st floor  
(2) outside sunroom  
(3) inside sunroom

3rd floor  
(2)Laundry room
