Jun. 15. 2023 10:22AM firemarshall me state  
 DEPARTMENT OF HEALTH AND HUMAN SERVICES  
 CENTERS FOR MEDICARE & MEDICAID SERVICES

| STATEMENT OF DEFICIENCIES<br>AND PLAN OF CORRECTION | (X1) PROVIDER/SUPPLIER/CLIA<br>IDENTIFICATION NUMBER:<br><br>205134 | (X2) MULTIPLE CONSTRUCTION<br>A. BUILDING 01<br><br>B. WING _____ | (X3) DATE SURVEY<br>COMPLETED<br><br>06/13/2023 |

| NAME OF PROVIDER OR SUPPLIER<br><br>ST JOSEPH'S REHABILITATION AND RESIDENCE | STREET ADDRESS, CITY, STATE, ZIP CODE<br>1133 WASHINGTON AVE<br>PORTLAND, ME 04103 |

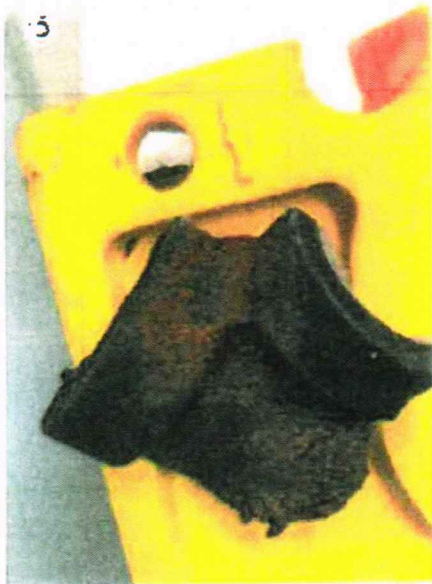
Broken fitting in D Wing dirty utility room

| Item | Description | Service Date | Amount |
|---|---|---|---|
| df | Requisition for the Day Work completed by Field Dept. for the fire protection sprinkler system. Labor, travel and material for Technician to respond to ER Service Call (leak)(premium time). Technician found broken 2" feed line due to freeze. Technician pulled line from adjoining room and plugged off, measured and listed material for repair. System left in service with one feed line down. | 2/4/2023 | 935.48 |
| df | Labor, travel and material for Technician to return to location to complete repair. Technician shut down Fire Sprinkler system and replaced 8ft of 2" feed pipe/fittings and (1) one chrome pendant head. Technician returned system to normal and checked repair area for leaks. None found. System left in service. | 2/6/2023 | 993.28 |
