TO: DHSR Construction Section FROM: Angela Hardy  
FAX: 919-733-6592 PAGES: 33 pages  
PHONE: 919-855-3883 DATE: 4-5-2018  
RE: Plan of Correction CC:

| NAME OF PROVIDER OR SUPPLIER<br><br>HOUSE OF LOVE FAMILY CARE HOME | | STREET ADDRESS, CITY, STATE, ZIP CODE<br>1904 JOHNSON RD<br>ELIZ CITY, NC 27909 | | |
| C 000 | Initial Comments<br><br>Report by Luis Padilla<br><br>DHSR Construction Section conducted a Biennial Survey on February 6, 2018 from 3:00 PM to 5:00 PM at the above referenced facility. DHSR records indicate the home was first licensed on July 17, 2013 as a Family Care Home for Six (6) ambulatory Residents (able to respond and evacuate without any physical or verbal assistance during a fire or other emergency). Based on this we are requiring the home to be in compliance with the following: the 2005 Rules 10A NCAC 13G for Family Care Homes and the applicable portions of the 2012 North Carolina Building Code - Section 425.2 - Residential Care Homes<br><br>At the time of our visit, we cited deficiencies that require an acceptable plan of correction. They are as follows: | C 000 | The corrective action that will be accomplished in 4 areas of the facility found to have be

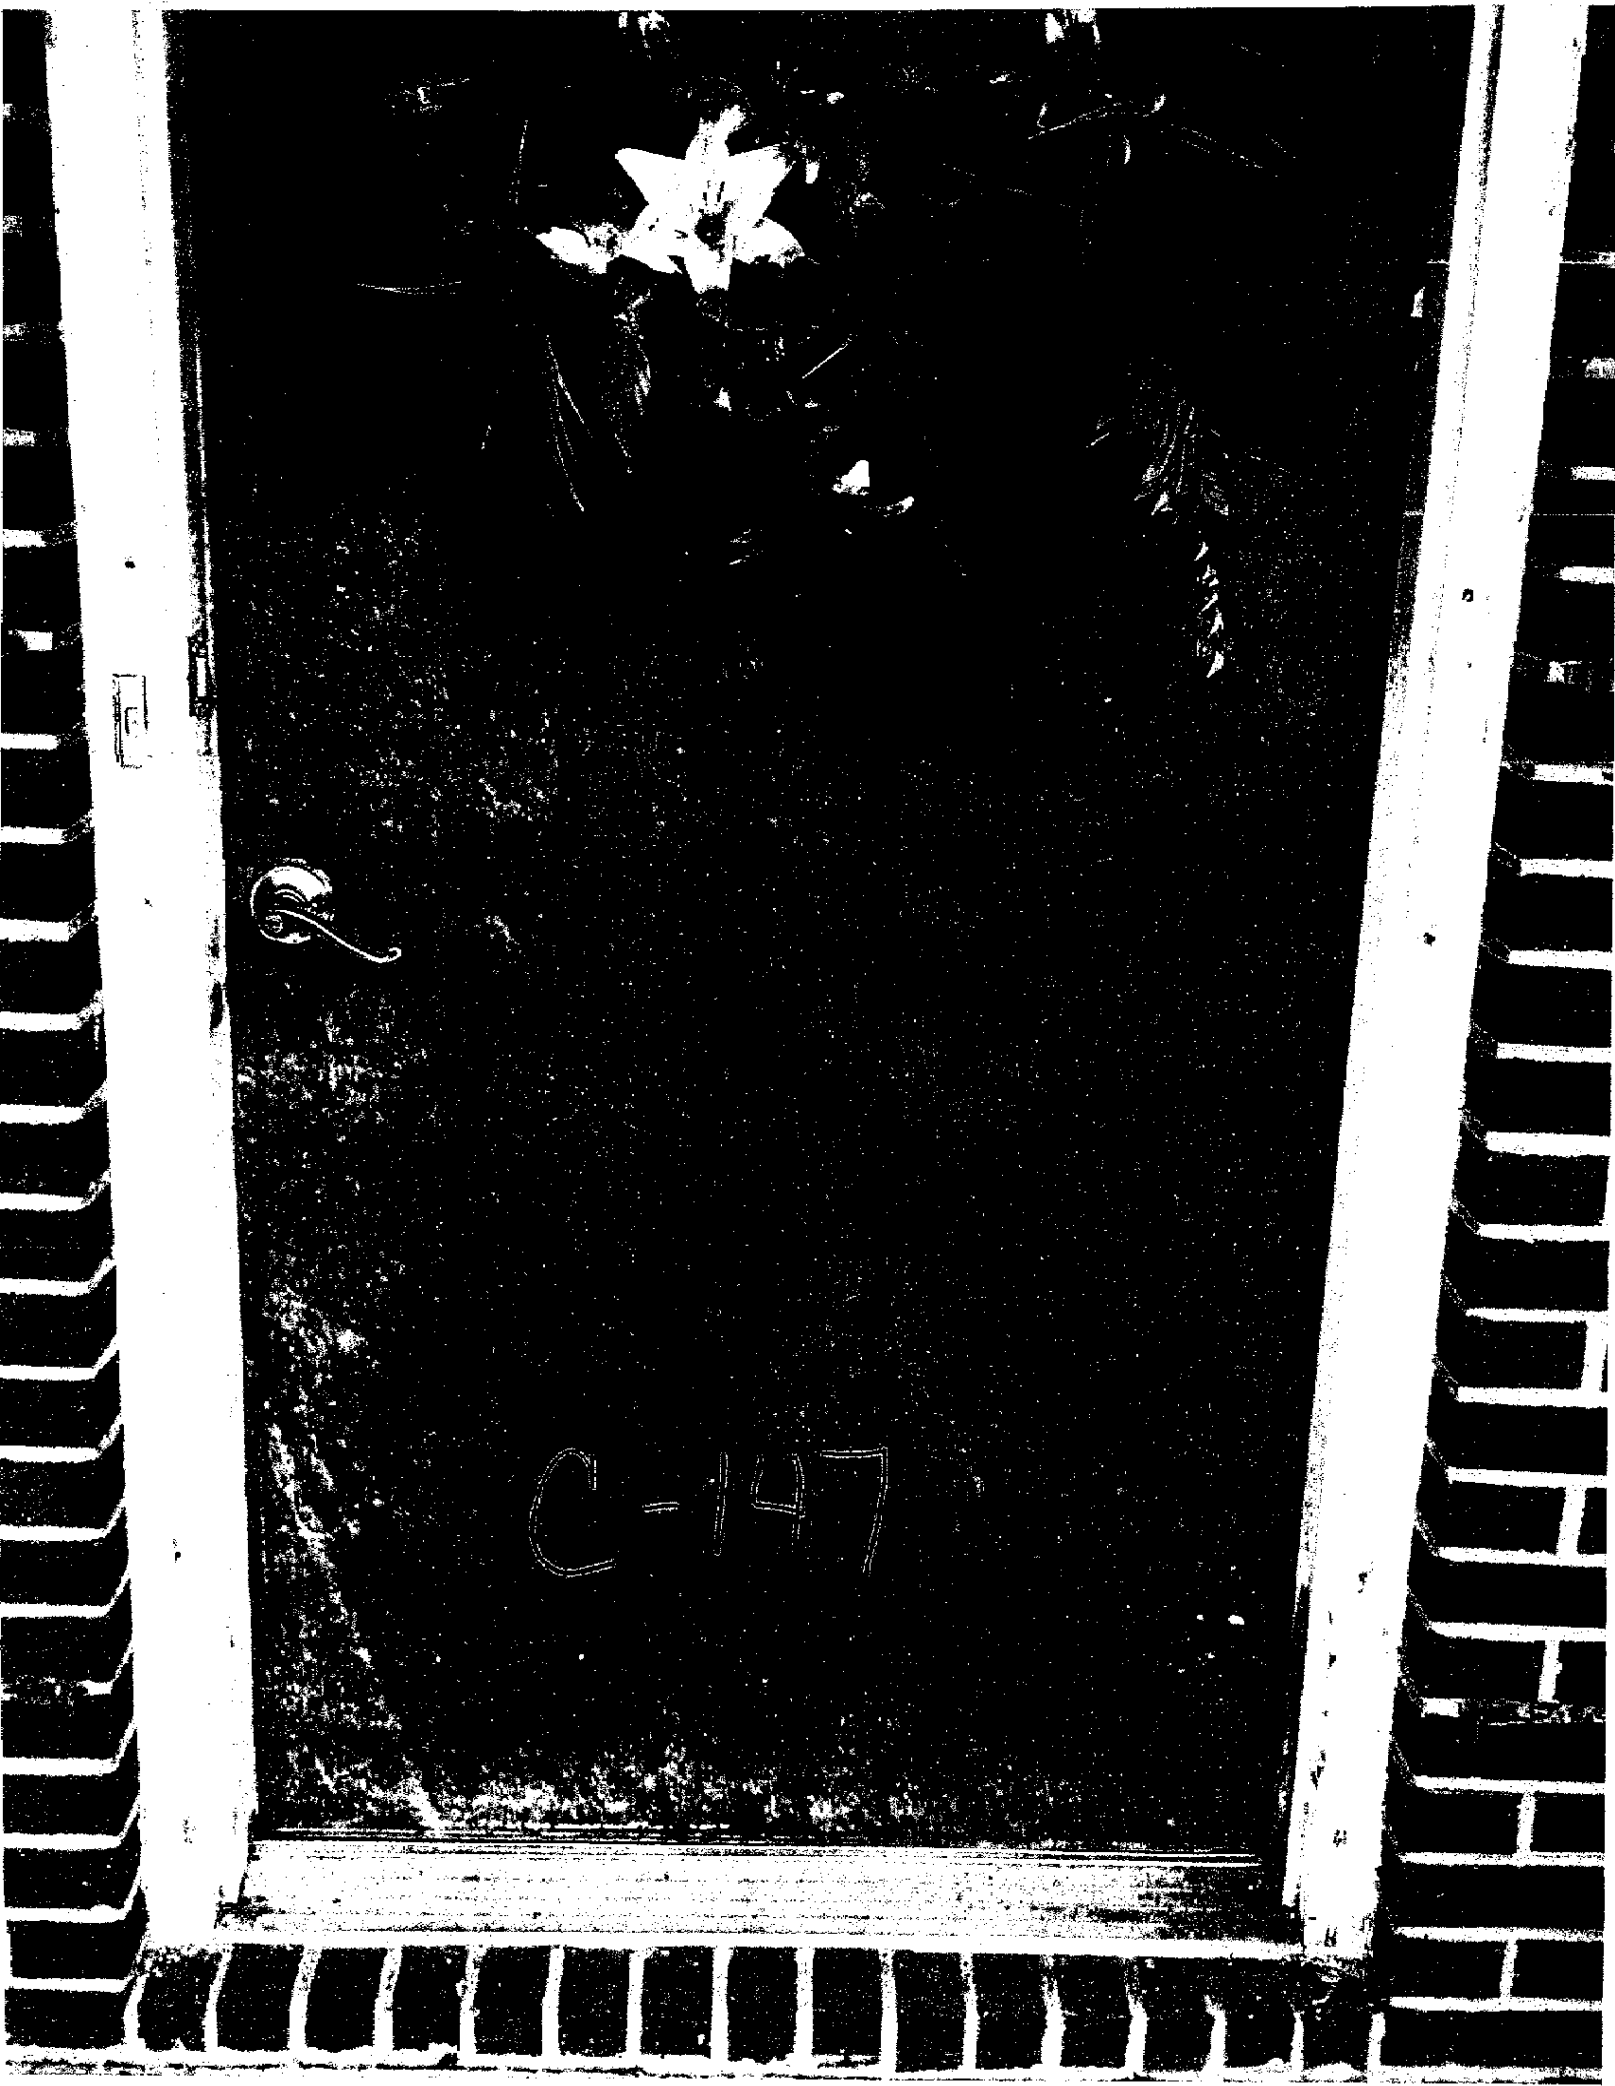
C-147

| C 147 | Continued From page 2<br><br>At the time of the survey it was observed that both the front and rear entrances to the facility had locks on the screen doors. This can impede the egress of residents during emergency situations<br><br>Based on our findings make arrangements to remove or disable the lock from the screen doors. Once completed, provide photos of the completed work to the DHSR Construction Section as verification of compliance. | C 147 | The corrective action for both screen doors front and rear having locks on them, the screen doors was removed if and when they are replaced, we will ensure that there are no devices to be locked or the lock will be disabled. Photos are attached | |
