Division of Health Service Regulation

| STATEMENT OF DEFICIENCIES AND PLAN OF CORRECTION | | (X1) PROVIDER/SUPPLIER/CLIA IDENTIFICATION NUMBER:<br><br><b>HAL041010</b> | (X2) MULTIPLE CONSTRUCTION<br>A. BUILDING: <b>01</b><br><br>B. WING: _____ | (X3) DATE SURVEY COMPLETED<br><br><b>08/17/2017</b> |
| NAME OF PROVIDER OR SUPPLIER<br><br><b>PIEDMONT CHRISTIAN HOME</b> | | STREET ADDRESS, CITY, STATE, ZIP CODE<br><b>1510 DEEP RIVER ROAD<br/>HIGH POINT, NC 27265</b> | | |

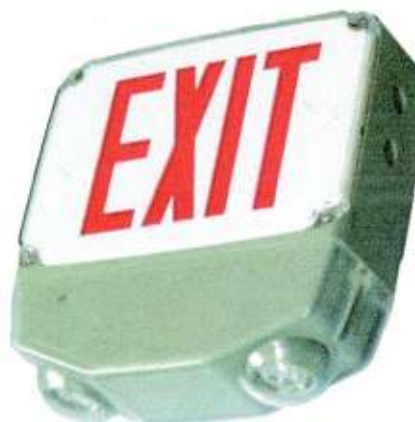
#### ORDERING INFORMATION Example: VEX-WPC-1-R-W-G2

The VEX-WPC consists of a precision-molded housing constructed of 5VA flame retardant, impact resistant, corrosion proof, UV stable polycarbonate plastic with one-piece, molded, weatherproof gasket. Units resist denting, peeling and scratching.

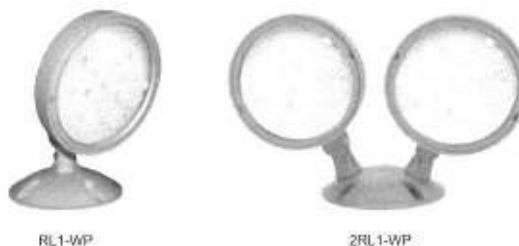
## REMOTE LAMPS (Order Separately)

- Each lamp contains 15 long lasting, efficient ultra-bright white LEDs totalling 1 watt per head
